PEUGEOT 308

308 PureTech 130ch S&S EAT8 Allure

VIN NO VF3LPHNSRJS241861

Inspection Report Summary

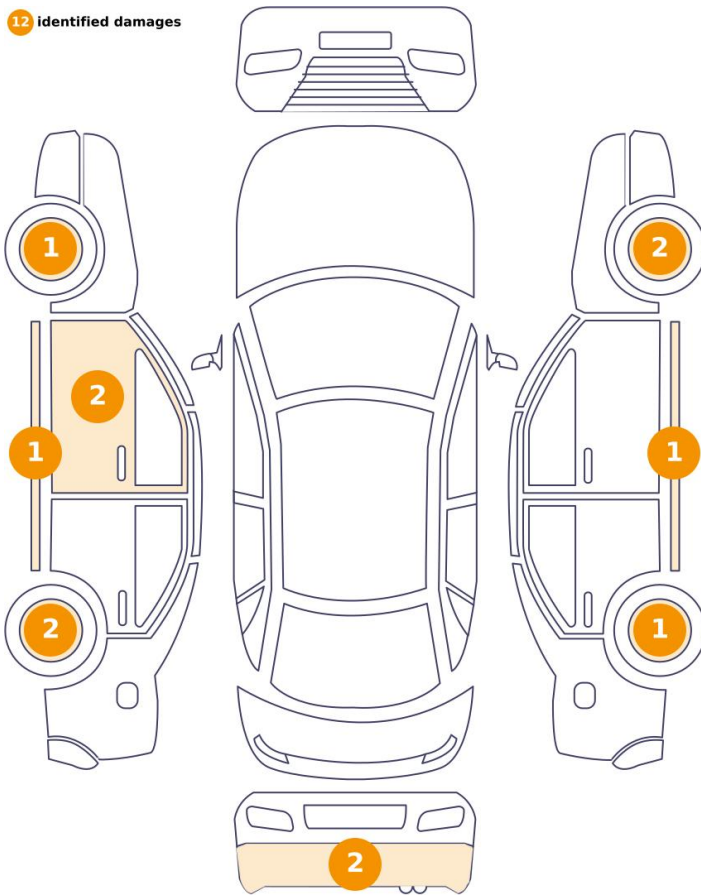
12 identified damages

Component	Damage	Comments
1 Rim / Front Right	Out of Bodywork / Scratch	
2 Rim / Back Right	Out of Bodywork / Scratch	
3 Rocker Panel / Center Left	Bodywork / Dent / Deformation	
4 Rim / Back Left	Out of Bodywork / Scratch	
5 Rocker Panel / Center Right	Bodywork / Dent / Deformation	
6 Rim / Front Left	Paint / Stone Chip	
7 Rim / Front Right	Out of Bodywork / Scratch	
8 Rim / Back Left	Out of Bodywork / Scratch	
9 Bumper / Back	Paint / Stone Chip	
10 Door / Front Left	Paint / Scratch / Line	
11 Bumper / Back	Paint / Stone Chip

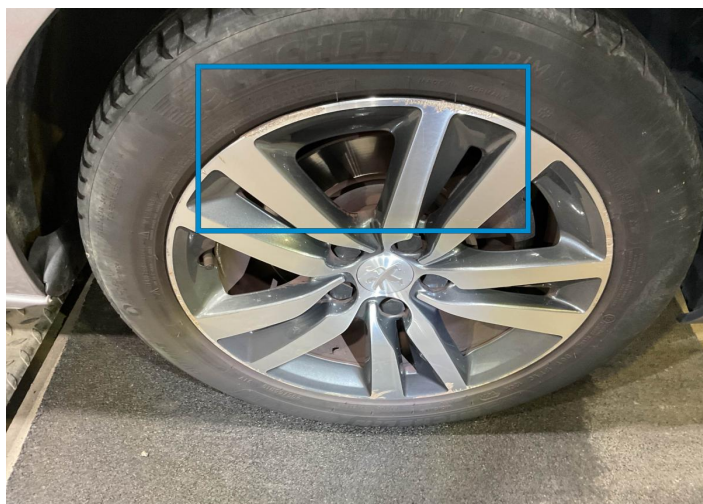
1. Rim / Front Right
Out of Bodywork / Scratch -

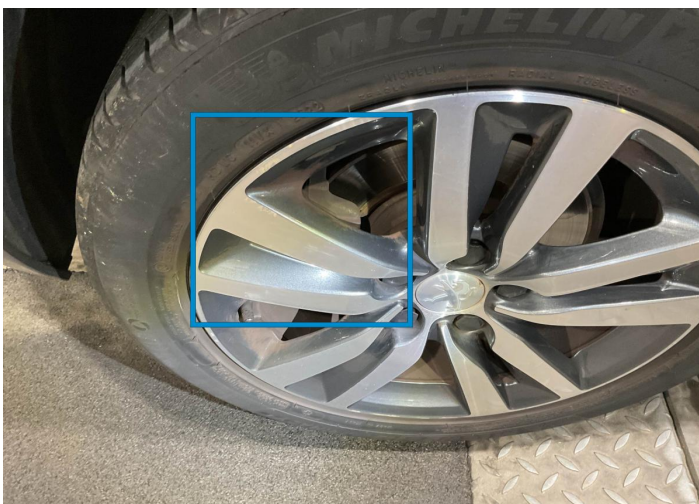
2. Rim / Back Right
Out of Bodywork / Scratch -

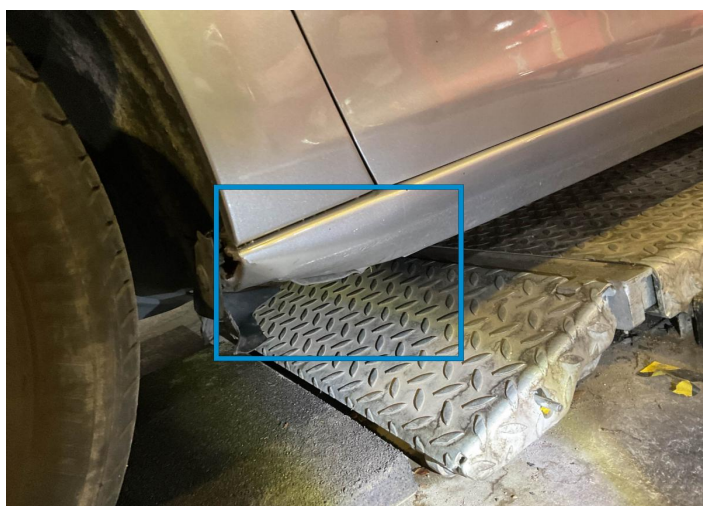
3. Rocker Panel / Center Left
Bodywork / Dent / Deformation -

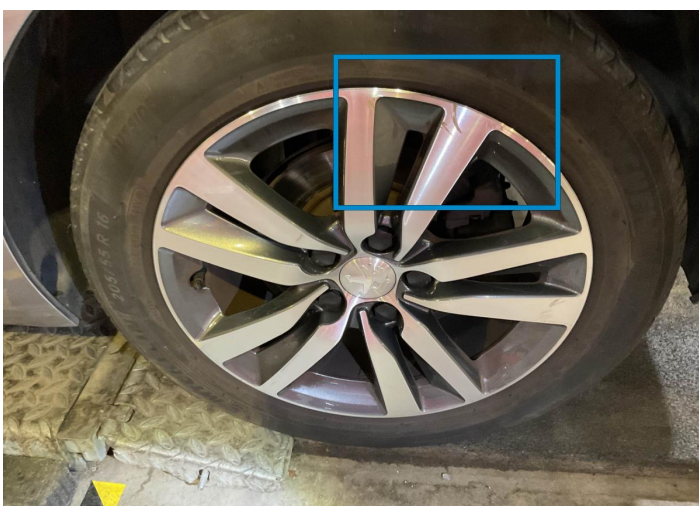
4. Rim / Back Left
Out of Bodywork / Scratch -

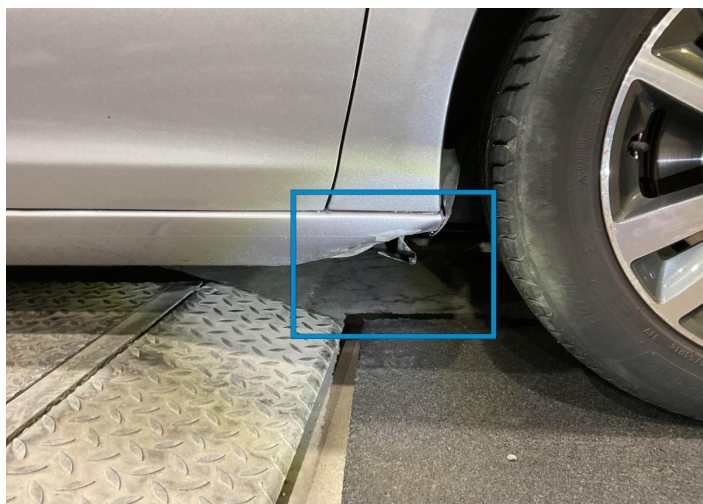
5. Rocker Panel / Center Right
Bodywork / Dent / Deformation -

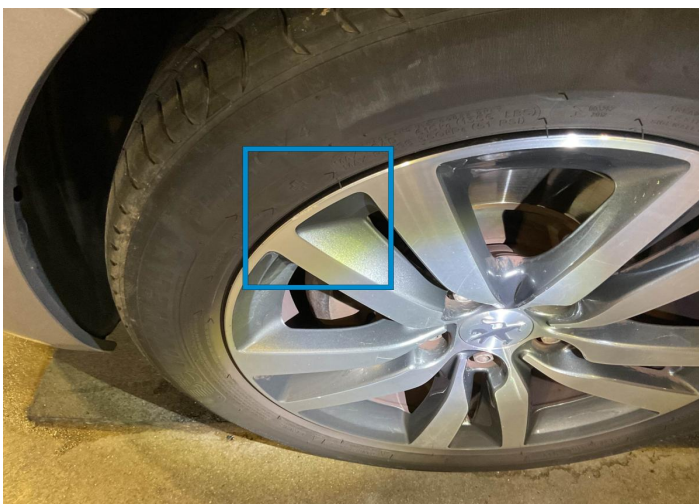
6. Rim / Front Left
Paint / Stone Chip -

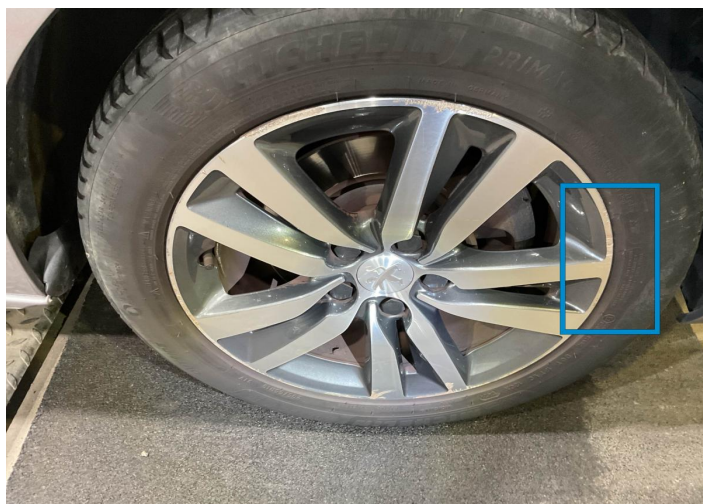
7. Rim / Front Right
Out of Bodywork / Scratch -

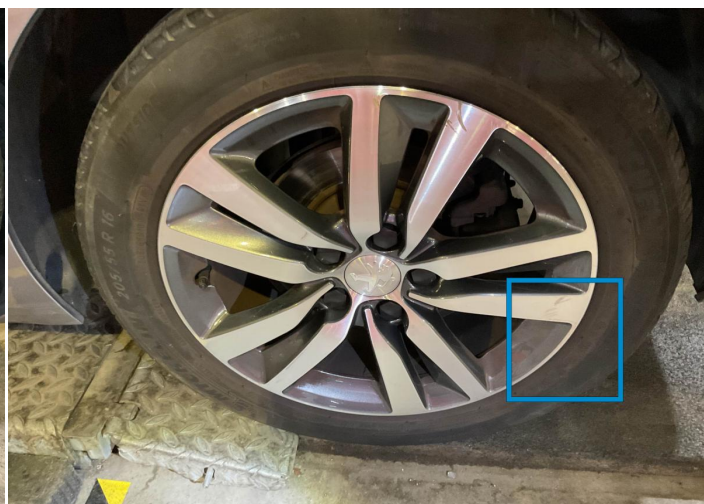
8. Rim / Back Left
Out of Bodywork / Scratch -

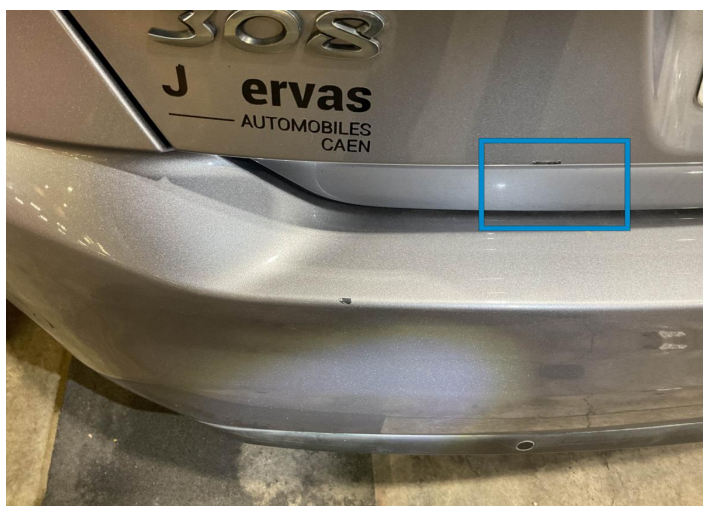
9. Bumper / Back
Paint / Stone Chip -

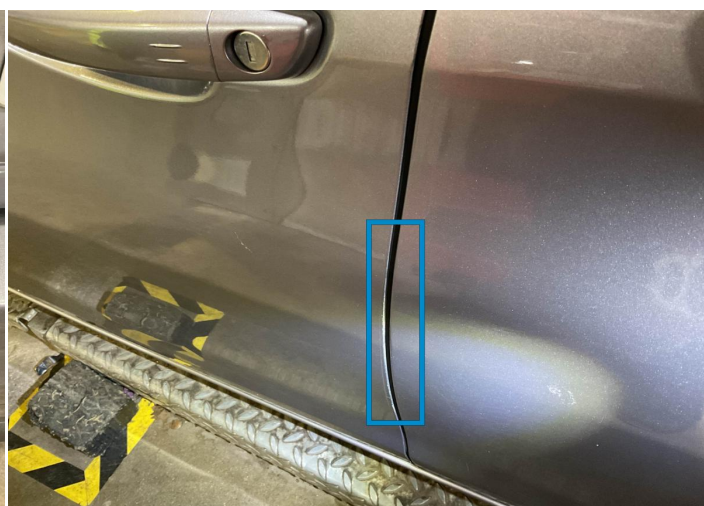
10. Door / Front Left
Paint / Scratch / Line -

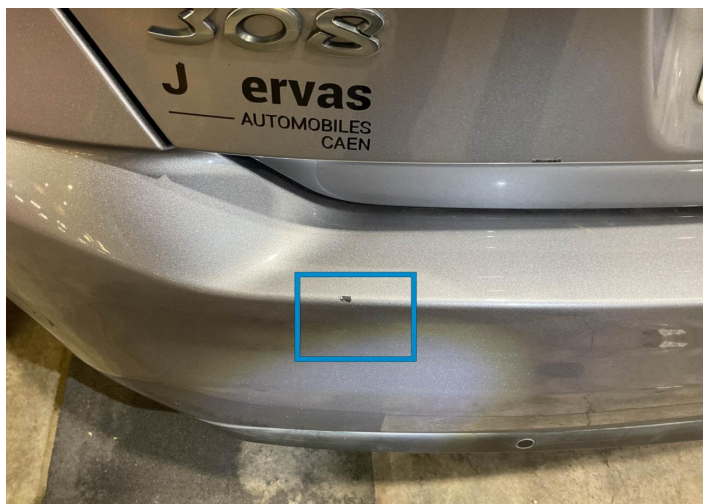
11. Bumper / Back
Paint / Stone Chip -

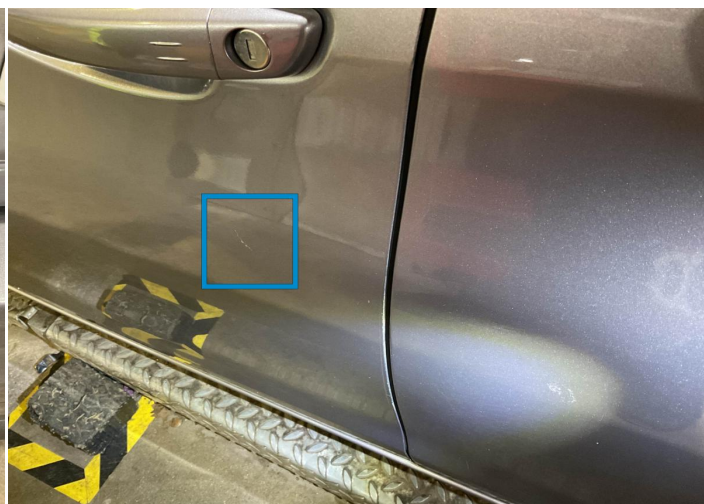
12. Door / Front Left
Paint / Scratch / Line -
