# PEUGEOT 2008

## 2008 Electrique 136 ch Allure Pack

VIN NO VR3UKZXZMJ917675  
Registration Number GH200LB

### Inspection Report Summary

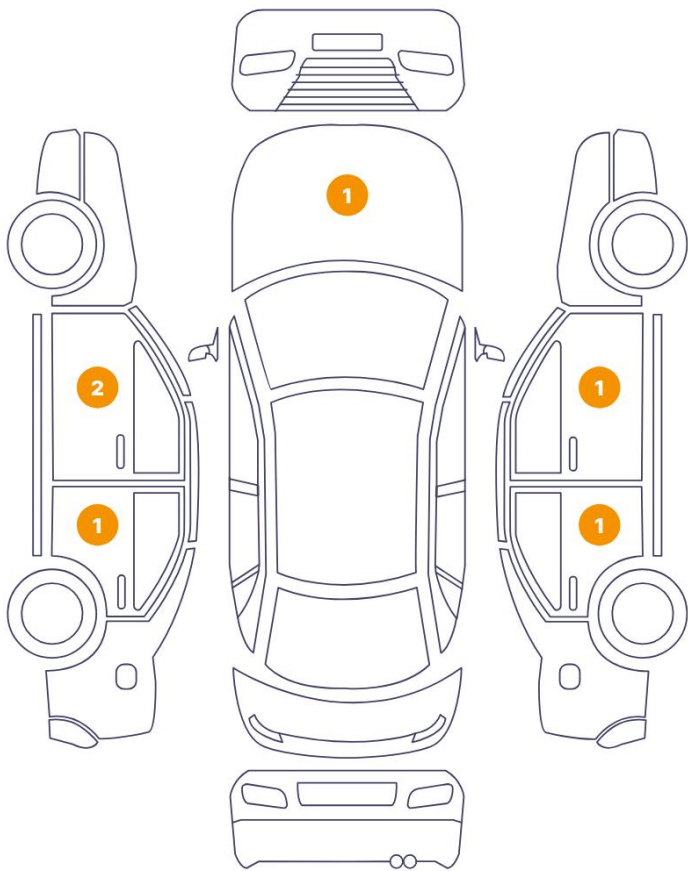
6 Dommages

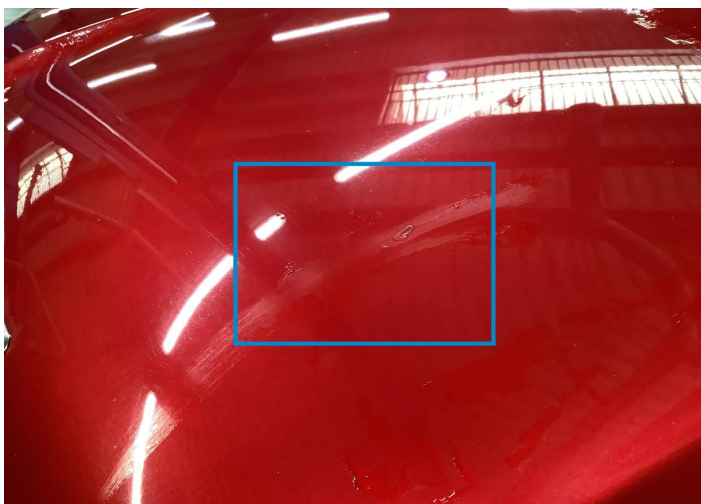
| Component | | Damage | Comments |
|---|---|---|---|
| 1 | Hood | Bodywork / Dent / Deformation | |

1. Hood  
Bodywork / Dent / Deformation -

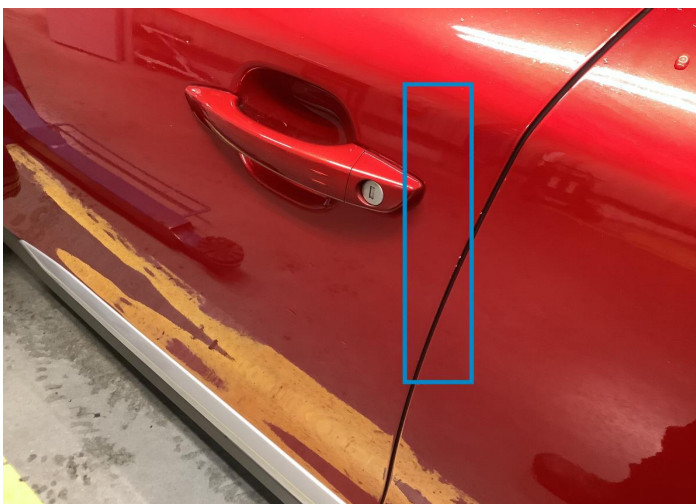
| Component | | Damage | Comments |
|---|---|---|---|
| 2 | Door / Front Left | Paint / Stone Chip | |

2. Door / Front Left  
Paint / Stone Chip -

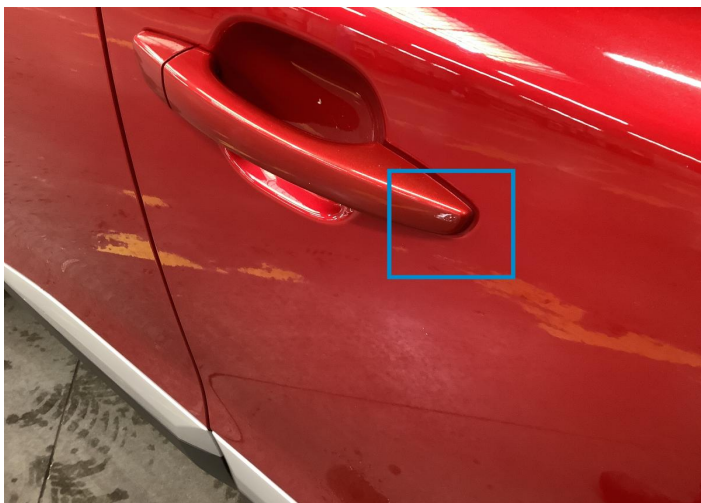
| Component | | Damage | Comments |
|---|---|---|---|
| 3 | Door Handle / Front Right | Paint / Scratch / Line | |

3. Door Handle / Front Right  
Paint / Scratch / Line -

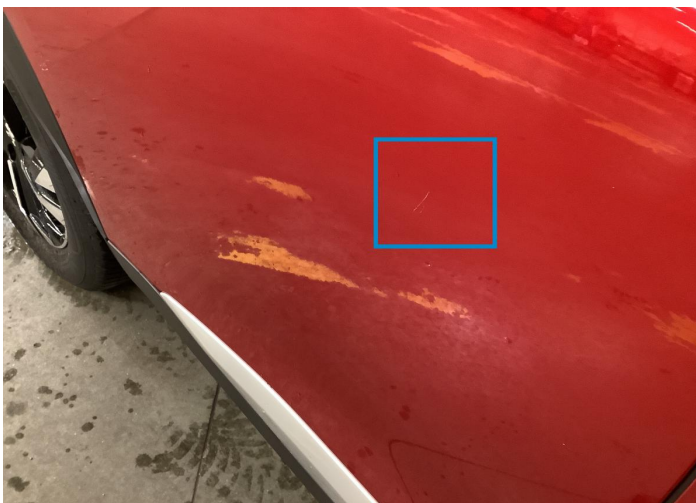
| Component | | Damage | Comments |
|---|---|---|---|
| 4 | Door / Back Right | Paint / Scratch / Line | |

4. Door / Back Right  
Paint / Scratch / Line -

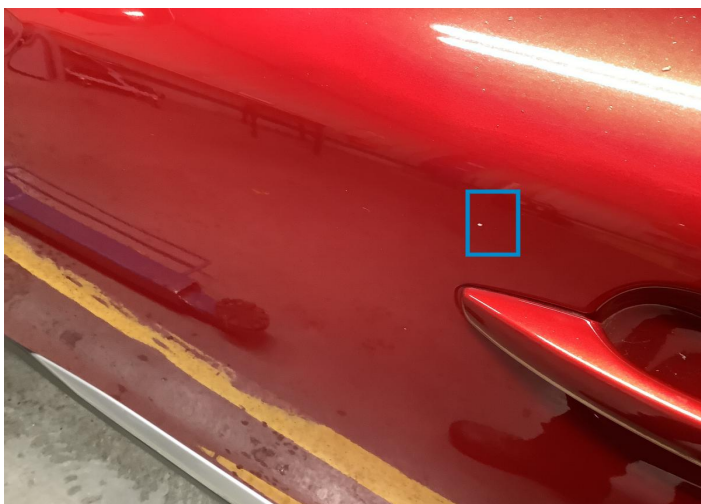
| Component | | Damage | Comments |
|---|---|---|---|
| 5 | Door / Front Left | Paint / Stone Chip | |

5. Door / Front Left  
Paint / Stone Chip -

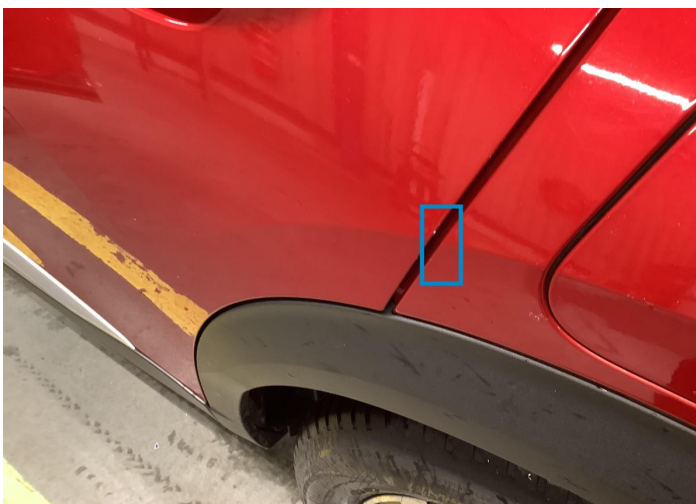
| Component | | Damage | Comments |
|---|---|---|---|
| 6 | Door / Back Left | Paint / Chipping | |

6. Door / Back Left  
Paint / Chipping -
