# RENAULT ESPACE

## Espace dCi 160 Energy Twin Turbo Intens EDC

VIN NO VF1RFC00455383361  
Registration Number EC735LJ

### Inspection Report Summary

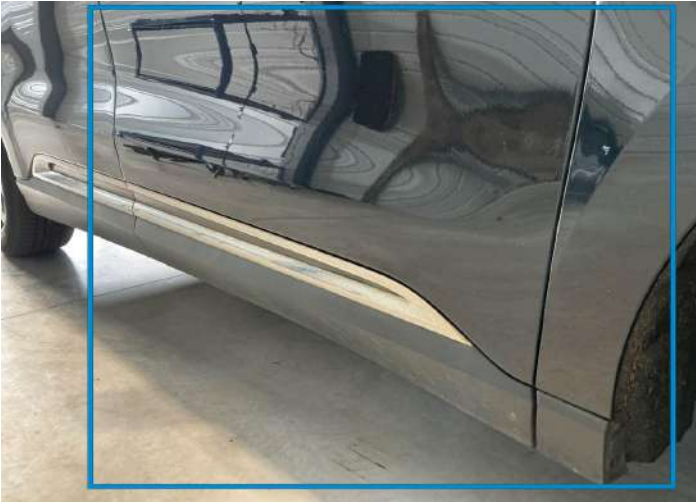
1. Door / Front Right  
Paint / Stone Chip -

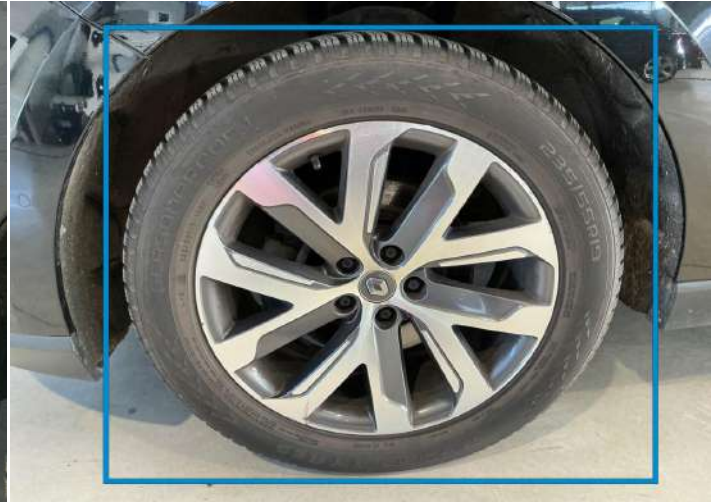
2. Rim / Front Left  
Out of Bodywork / Scratch -

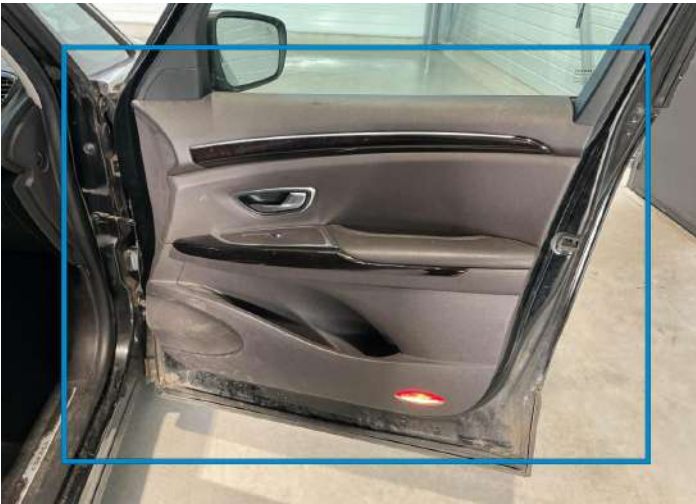
3. Panel Filling / Front Right  
Interior / Worn - out -

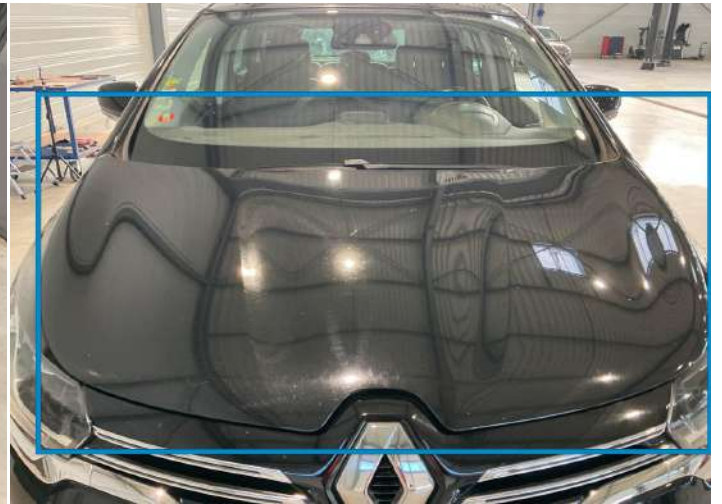
4. Hood  
Paint / Scratch / Line -

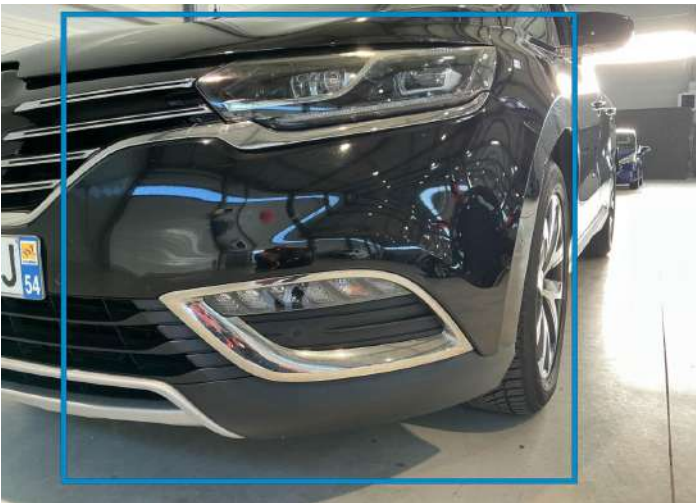
5. Corner Bumper / Front Left  
Paint / Scratch / Line -

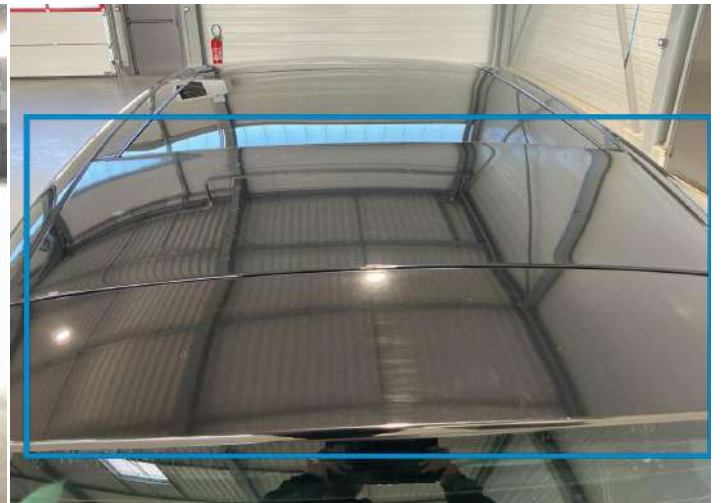
6. Roof  
Paint / Scratch / Line -

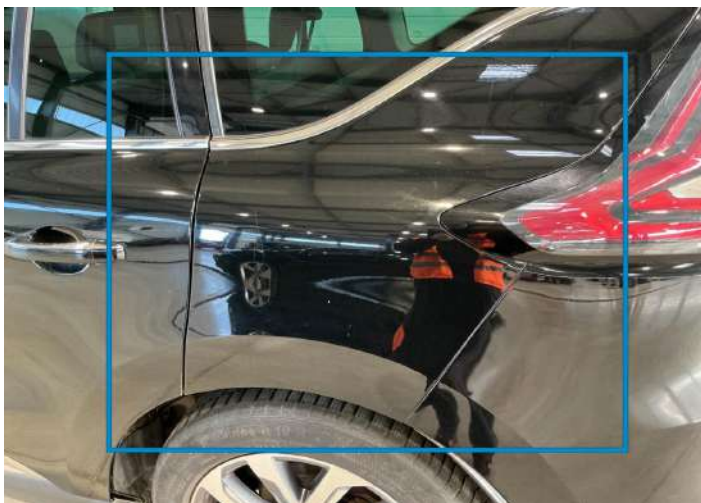
9. Fender / Back Left Paint / Scratch / Line -

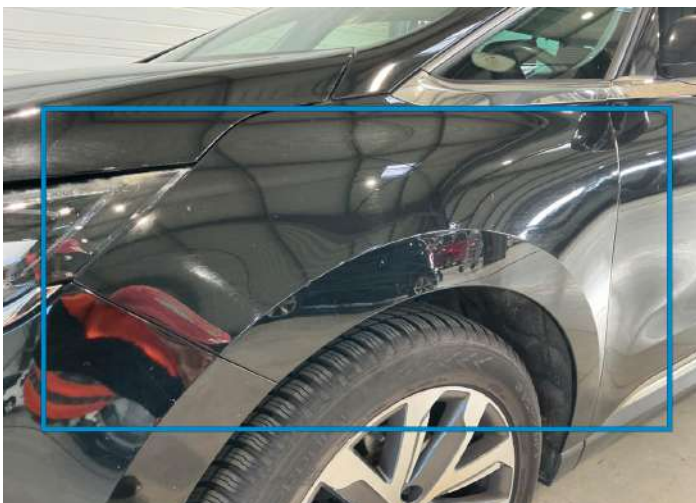
10. Fender / Front Left Paint / Scratch / Line -

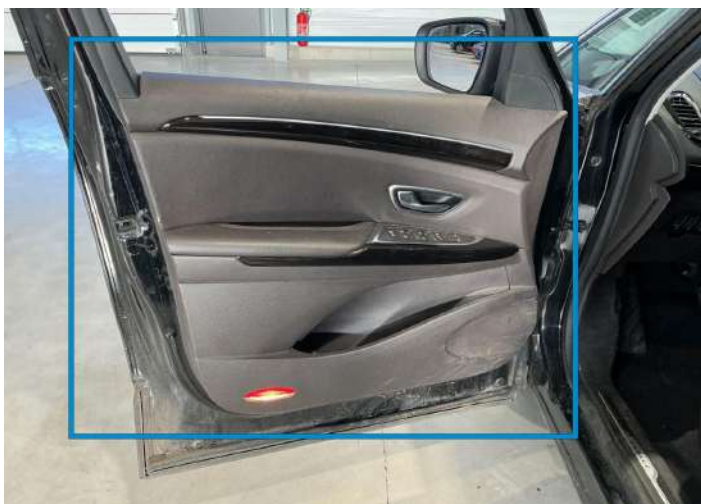
11. Panel Filling / Front Left Interior / Worn - out -

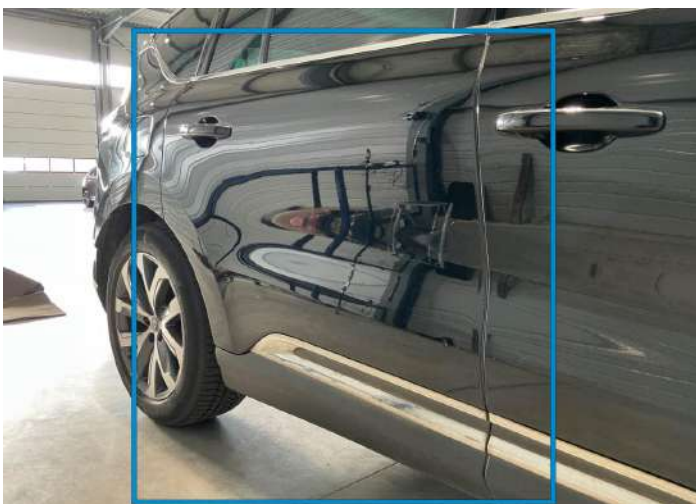
12	Door / Back Right	Bodywork / Dent / Dent	Plus éclats zone gravillonnées sur l'ensemble du bas de la porte.
13	Panel Filling / Back Right	Interior / Worn - out	
14	Panel Filling / Back Left	Interior / Worn - out	
15	Seat Cushion / Front Left	Interior / Worn - out	
16	Trunk Upholstery / Back	Interior / Worn - out	
17	Rocker Panel / Center Left	Paint / Stone Chip	
18	Rim / Back Left	Out of Bodywork / Scratch	
19	Rim / Front Right	Out of Bodywork / Scratch	
20	Seat Cushion / Front Right	Interior / Worn - out	
21	Door / Front Left	Paint / Scratch / Line	
22	Rim / Back Right	Out of Bodywork / Scratch	
23	Glovebox	Interior / Worn - out	
24	Bumper / Back	Paint / Scratch / Line	
25	Mirror Shell / Front Right	Paint / Scratch / Line	
26	Corner Bumper / Back Left	Paint / Scratch / Line	
27	Steering Wheel / Front	Interior / Worn - out	
28	Corner Bumper / Front Right	Paint / Scratch / Line	
29	Door / Back Left	Paint / Scratch / Line

12. Door / Back Right Bodywork / Dent / Dent -  
Plus éclats zone gravillonnées sur l'ensemble du bas de la porte.

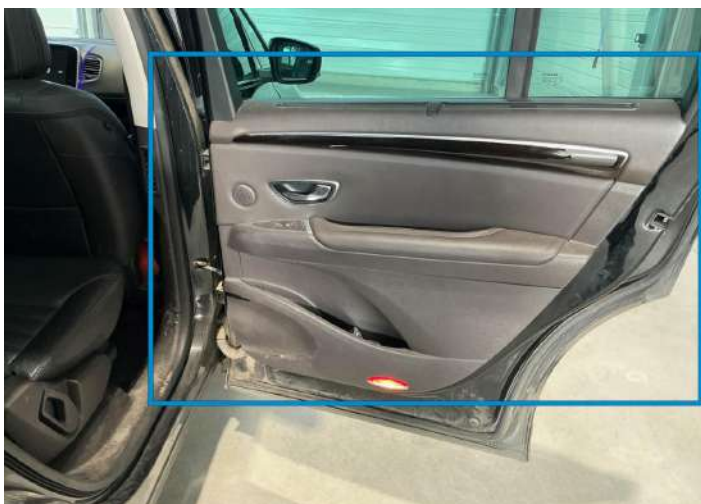
13. Panel Filling / Back Right Interior / Worn - out -

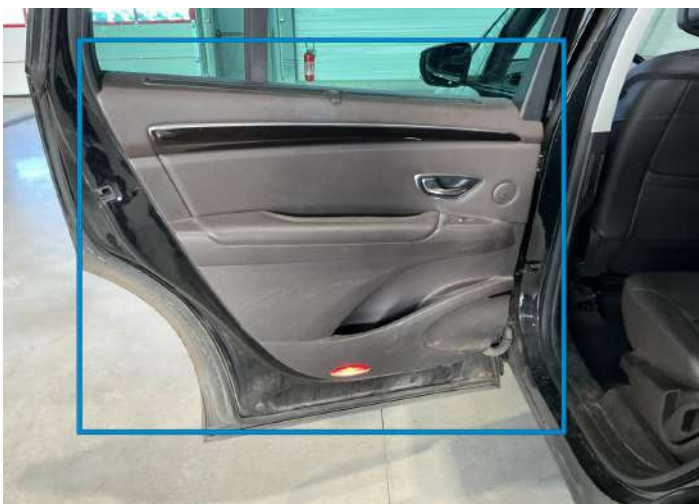
14. Panel Filling / Back Left Interior / Worn - out -

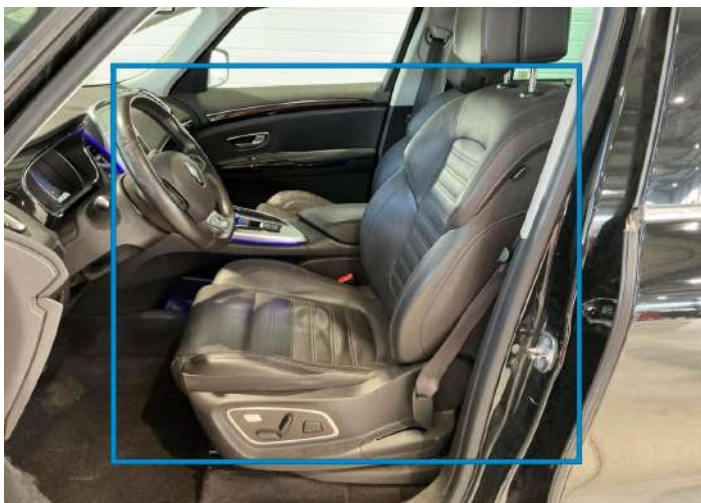
15. Seat Cushion / Front Left Interior / Worn - out -

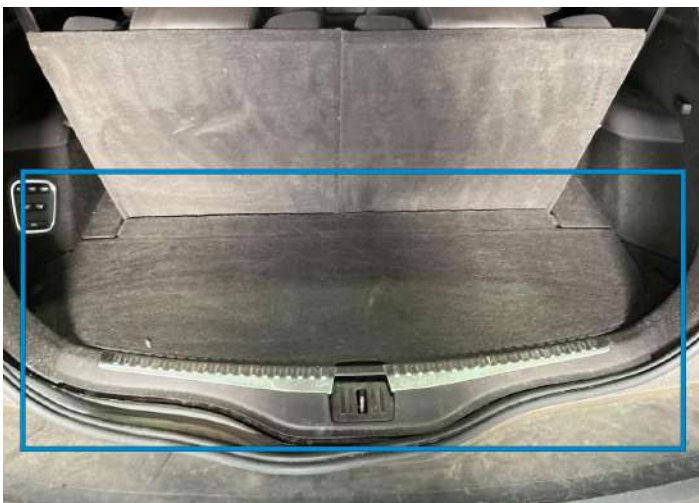
16. Trunk Upholstery / Back Interior / Worn - out -

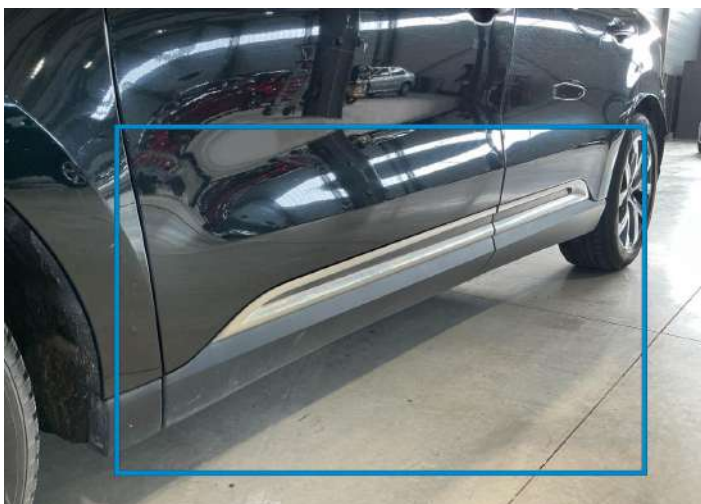
17. Rocker Panel / Center Left Paint / Stone Chip -

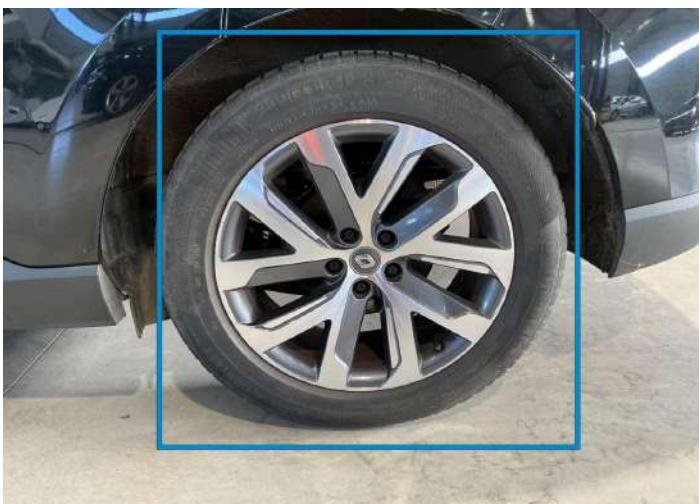
18. Rim / Back Left Out of Bodywork / Scratch -

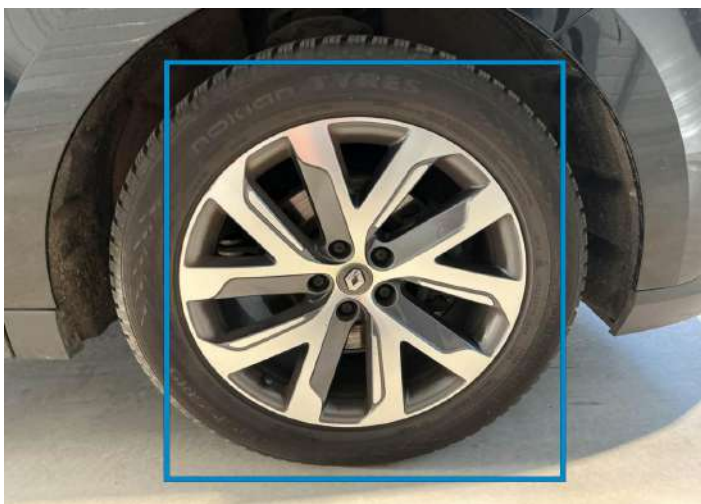
19. Rim / Front Right  
Out of Bodywork / Scratch -

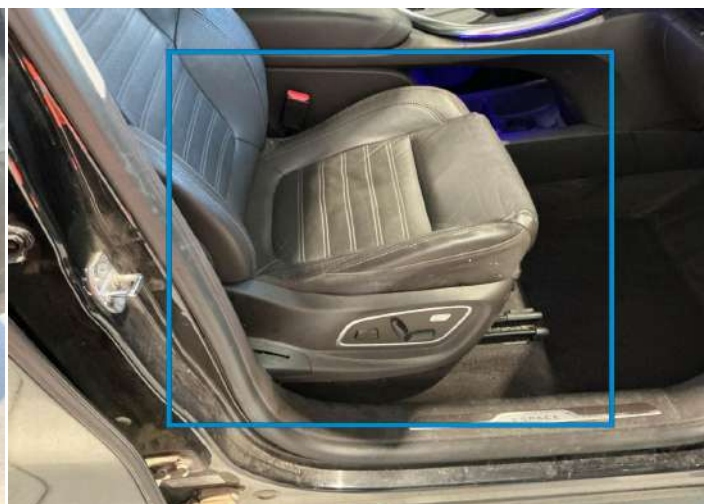
20. Seat Cushion / Front Right  
Interior / Worn - out -

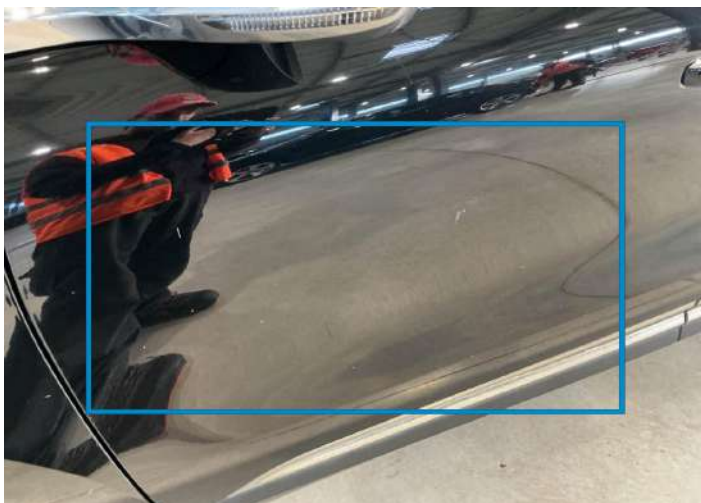
21. Door / Front Left  
Paint / Scratch / Line -

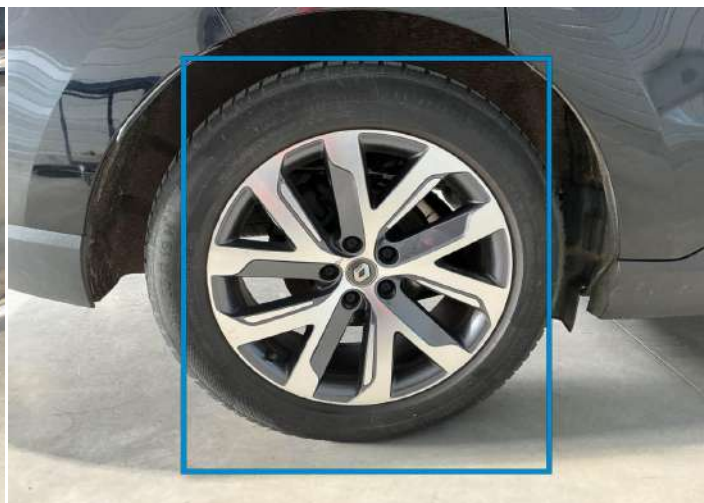
22. Rim / Back Right  
Out of Bodywork / Scratch -

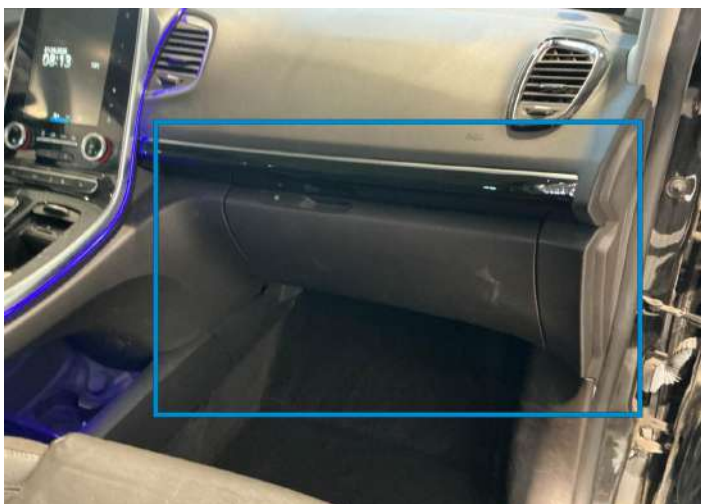
23. Glovebox  
Interior / Worn - out -

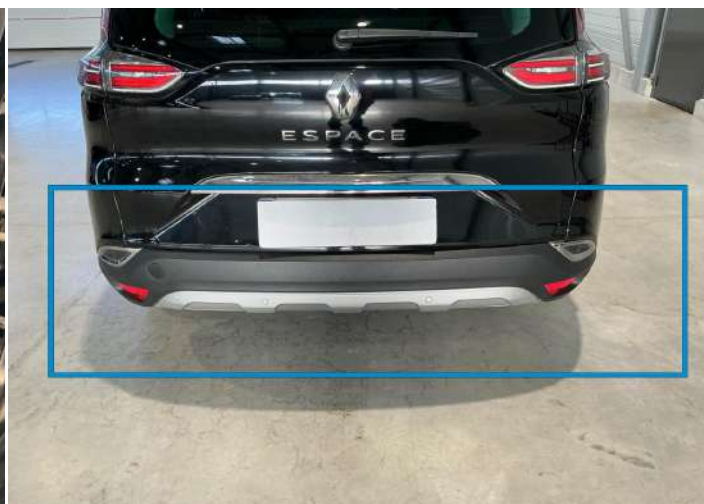
24. Bumper / Back  
Paint / Scratch / Line -

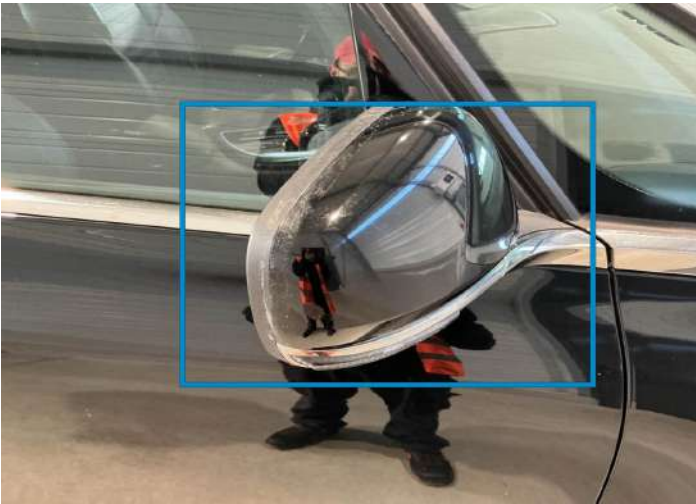
25. Mirror Shell / Front Right  
Paint / Scratch / Line -

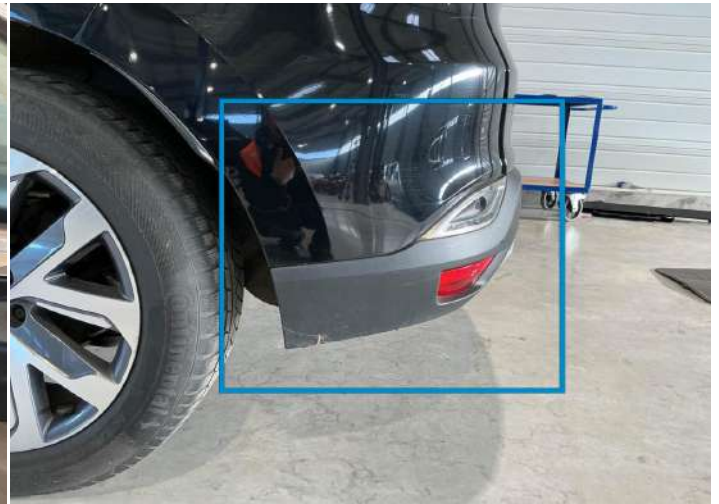
26. Corner Bumper / Back Left  
Paint / Scratch / Line -

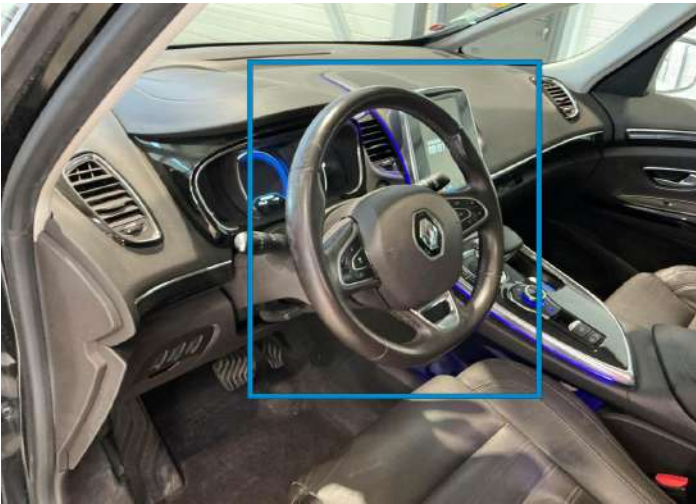
27. Steering Wheel / Front  
Interior / Worn - out -

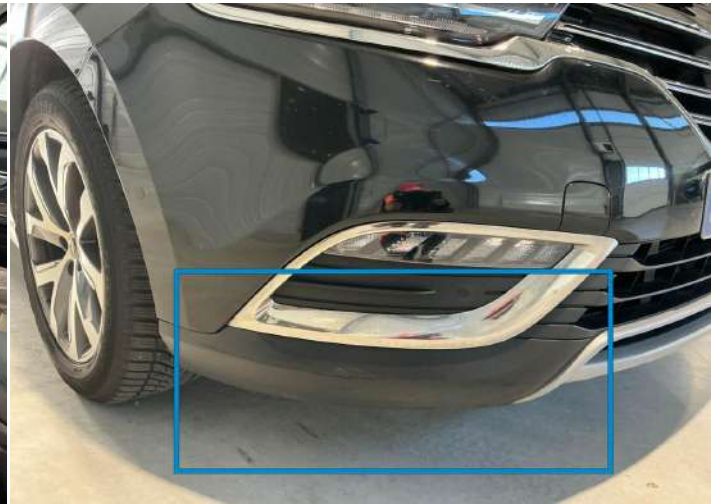
28. Corner Bumper / Front Right  
Paint / Scratch / Line -

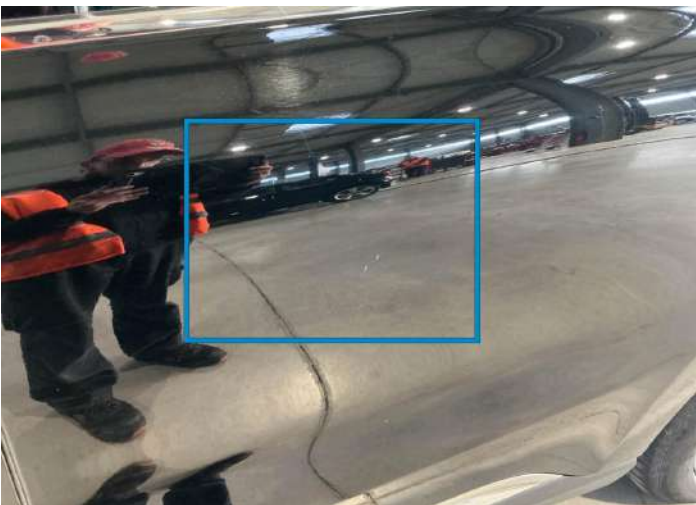
29. Door / Back Left  
Paint / Scratch / Line -

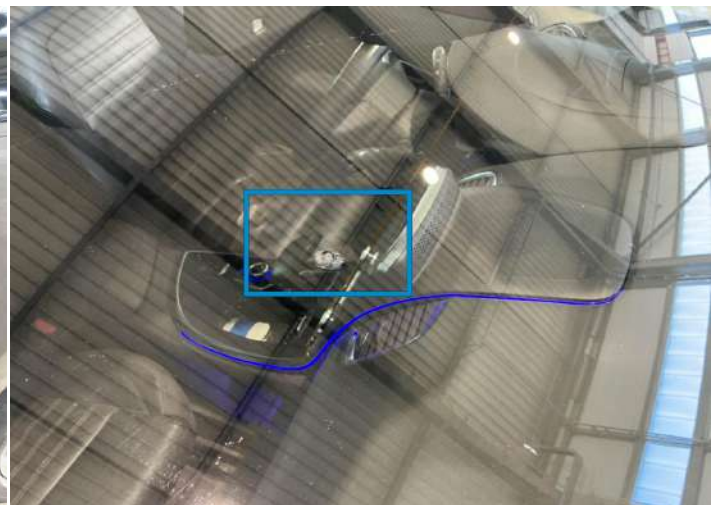
30. Windshield / Front  
Glass Break / Impact -
