CITROEN C3 ENTREPRISE

C3 SOCIETE PURE TECH 82 S&S FEEL

VIN NO VF7SXHMRPKT568517
Registration Number FH063XH

Inspection Report Summary

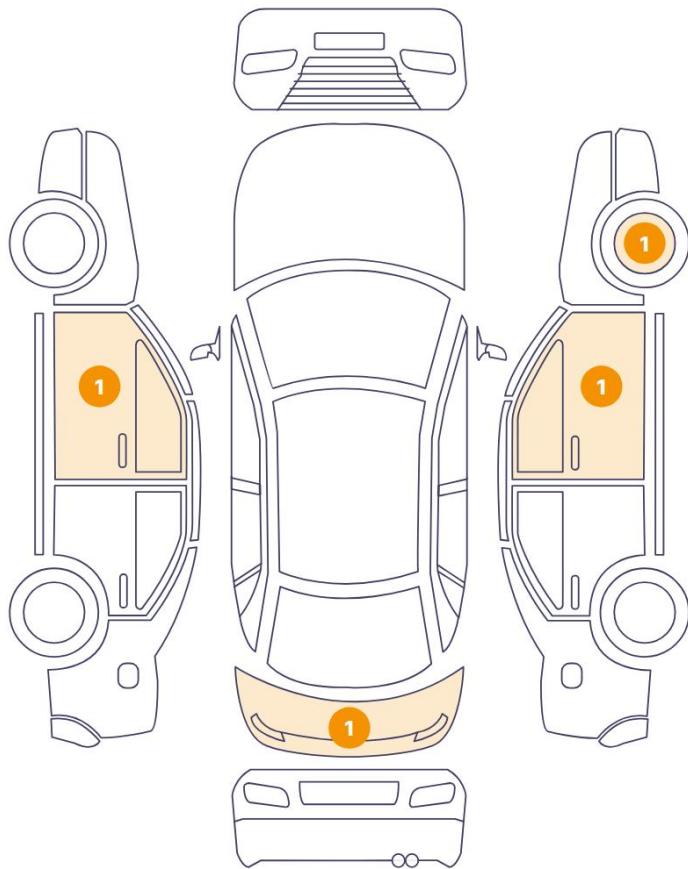
4 Dommages

Component	Damage	Comments
1 Floor Carpet	Interior / Dirty	
2 Panel Filling / Front Left	Interior / Stained	
3 Floor Carpet	Interior / Dirty	
4 Tailgate Upholstery / Back	Interior / Dirty	
5 Trunk Carpet	Interior / Dirty	
6 Hubcap / Front Right	Out of Bodywork / Scratch	
7 Mirror Shell / Front Right	Paint / Scratch / Line	
8 Mirror Shell / Front Left	Paint / Scratch / Line	
9 Tailgate	Paint / Scratch / Line

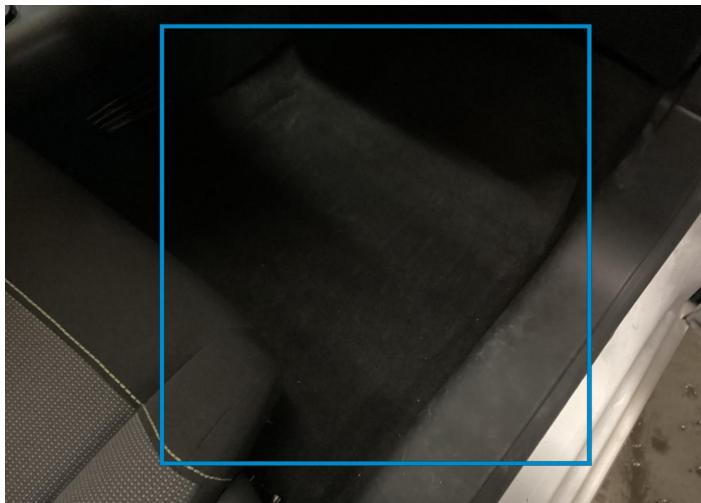
1. Floor Carpet
Interior / Dirty -

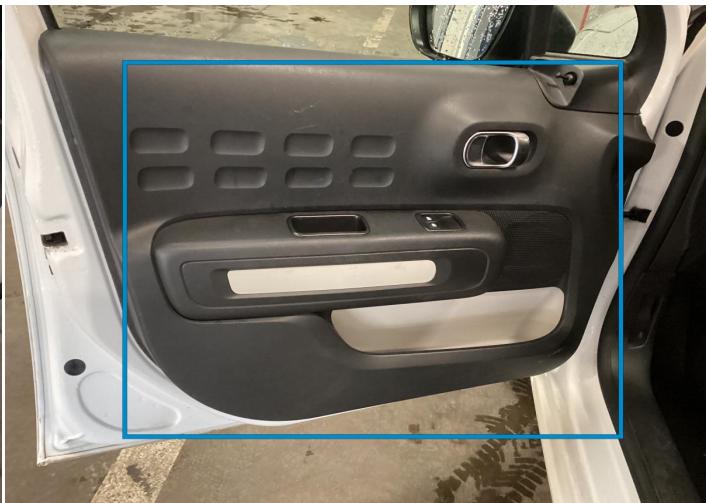
2. Panel Filling / Front Left
Interior / Stained -

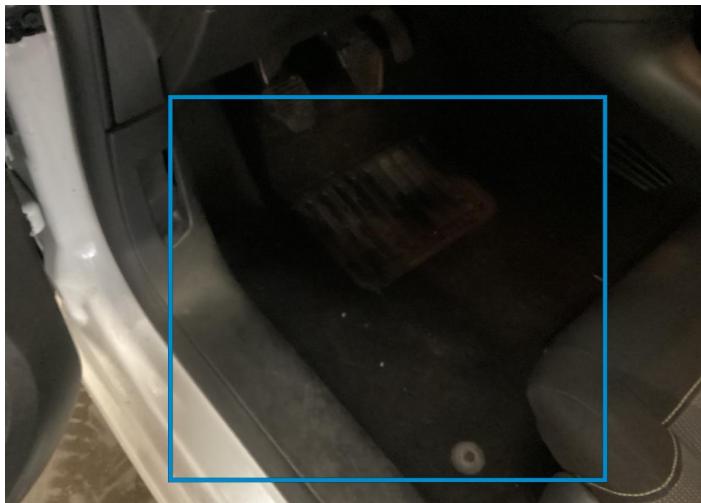
3. Floor Carpet
Interior / Dirty -

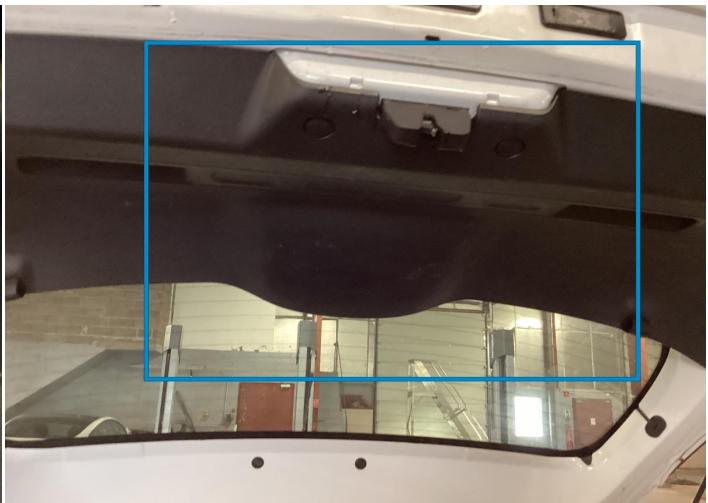
4. Tailgate Upholstery / Back
Interior / Dirty -

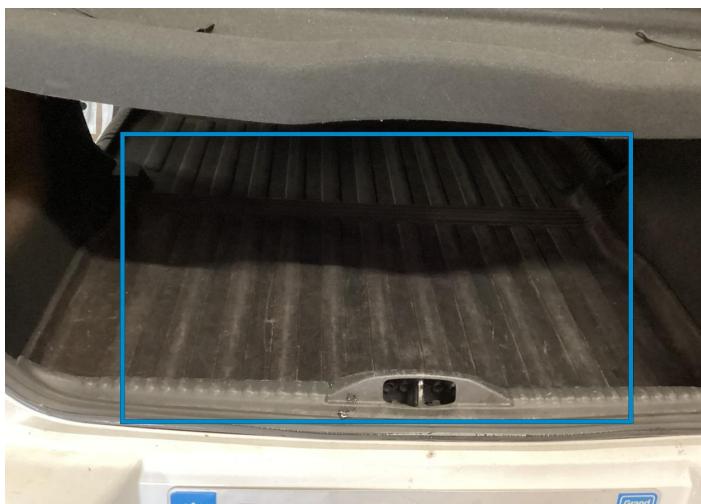
5. Trunk Carpet
Interior / Dirty -

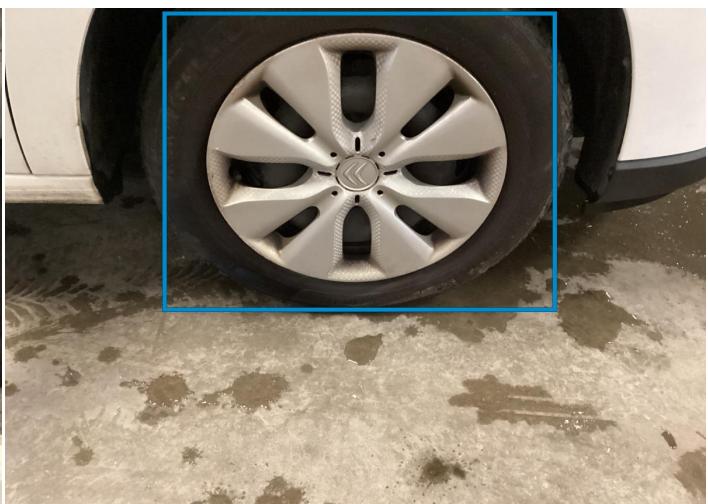
6. Hubcap / Front Right
Out of Bodywork / Scratch -

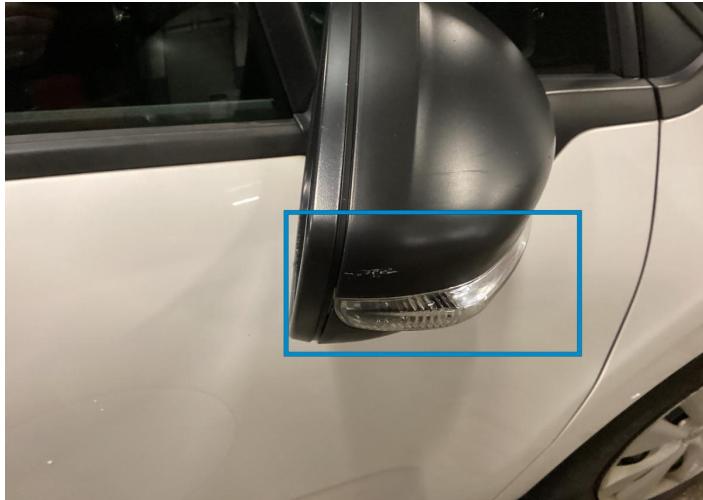
7. Mirror Shell / Front Right
Paint / Scratch / Line -

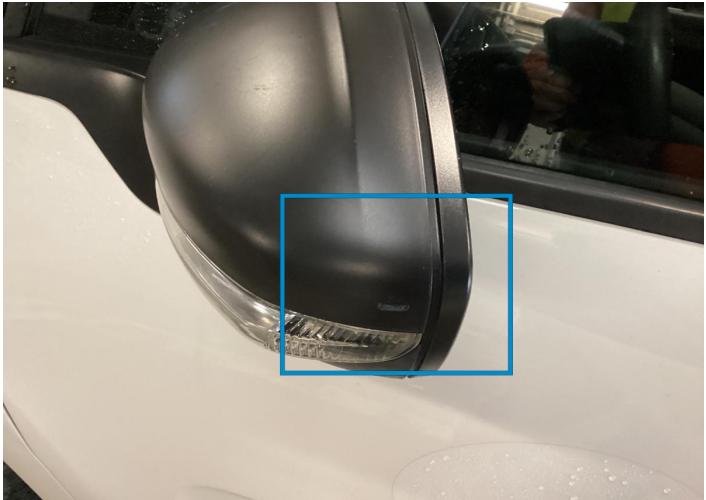
8. Mirror Shell / Front Left
Paint / Scratch / Line -

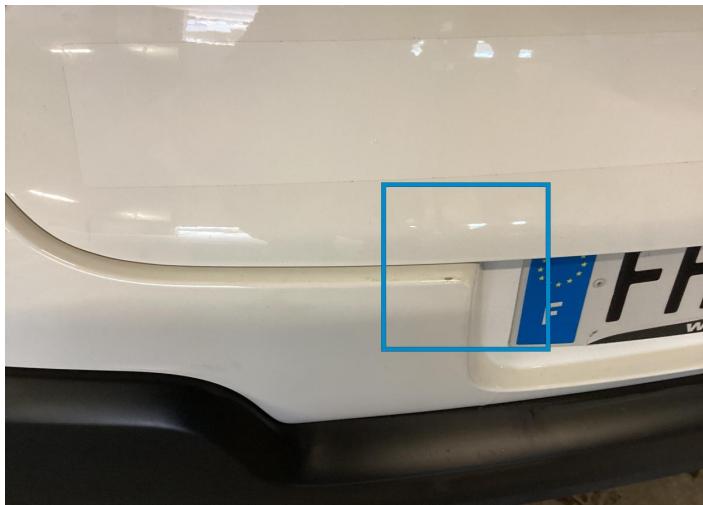
9. Tailgate
Paint / Scratch / Line -
