# HYUNDAI KONA Kona Electrique 64 kWh - 204 ch Creative

VIN NO TMAK381GFNJ056394 Registration Number GF425TS

Customer	BCAuto Encheres	Report Number	P20250919104319
Inspection Date / Place	2025-09-19 / BCA AUNAY	Cosmetic Grade	3

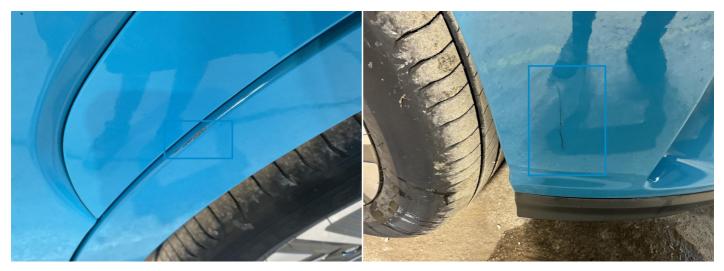
1. Mud Flap / Back Left Paint / Chipping -

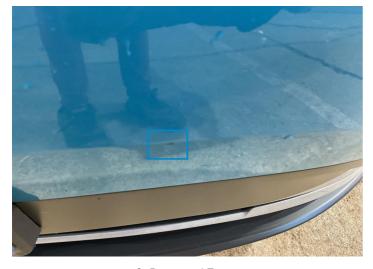
3. Bumper / Front Paint / Chipping -
