HYUNDAI KONA Kona Electrique 39 kWh - 136 ch Intuitive

VIN NO TMAK281HFNJ054814 Registration Number GF836QB

Inspection Report Summary

Customer	BCAuto Encheres	Report Number	P20250725071950
Inspection Date / Place	2025-07-28 / BCA	Cosmetic Grade	1

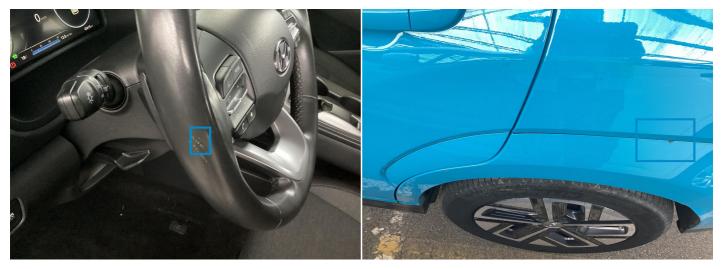
1. Steering Wheel / Front Interior / Scratched -

2. Fender / Back Left Paint / Chipping -

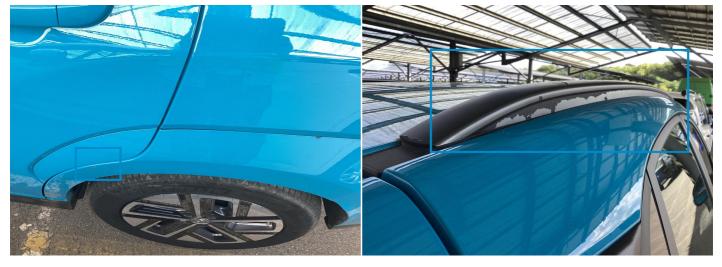
3. Fender / Back Left Paint / Chipping -

4. Roof Molding / Left Paint / Poor Previous Repair -
