FT584WY

The primary vehicle description

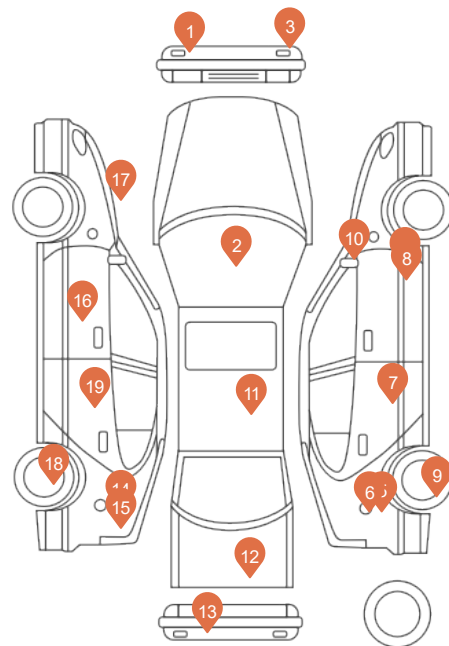
1. Bumper Front; Cracked; UpTo 25mm
2. Screen Front; Cracked; Replace
3. Bumper Front; Scratched; Over 100mm Thru Paint

4. Door osf; Dented; Over 30% Of Panel
5. Qtr Panel osr; Dented; Over 30mm
6. Qtr Panel osr; Scratched; Over 25mm Thru Paint
7. Door osr; Scratched; Over 25mm Thru Paint
8. Door osf; Scratched; Over 25mm Thru Paint
9. Wheel osr; Scratched; Up To 50mm
10. Door Mirror Assy osf; Scratched (Painted); UpTo 25mm Thru Paint

11. Roof; Chipped; Over 5mm

12. Tailgate; Dented; Over 30% Of Panel
13. Bumper Rear; Cracked; UpTo 25mm

14. Qtr Panel nsr; Dented; Hail - Severe
15. Qtr Panel nsr; Scratched; Over 25mm Thru Paint
16. Door nsf; Scratched; Over 25mm Thru Paint
17. Wing nsf; Scratched; UpTo 25mm Thru Paint
18. Wheel nsr; Scratched; Over 50mm
19. Door nsr; Scratched; UpTo 25mm Thru Paint

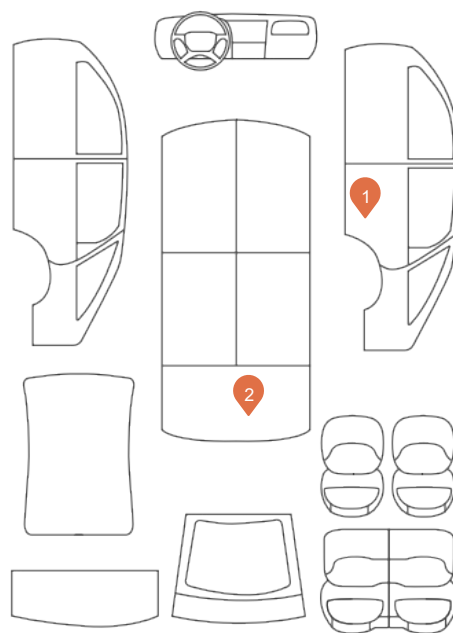
1. Door Pad osr; Scuffed; UpTo 25mm

2. Shelfload Cover Rear; Missing; Replace

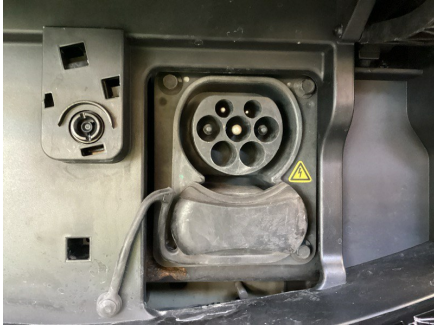
BUYER ADVISORY
General Exterior; Buyer Advisory; Report Only

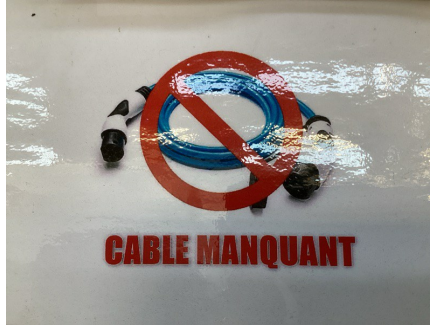
BUYER ADVISORY
General Exterior; Buyer Advisory; Report Only

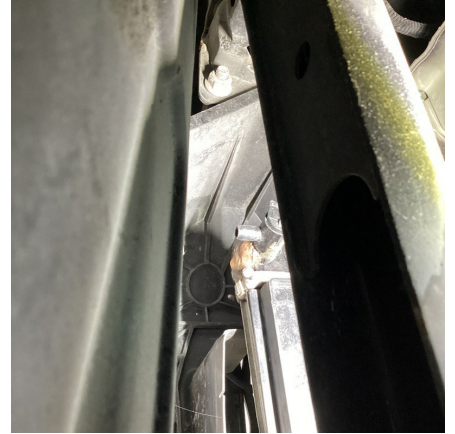
BUYER ADVISORY
General Exterior; Buyer Advisory; Report Only

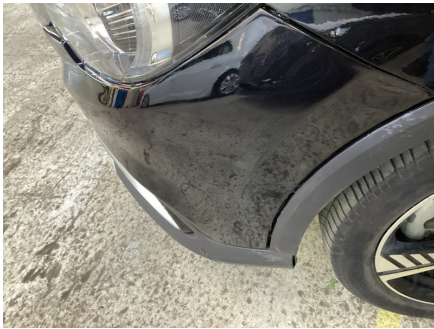
EXTERIOR - FRONT
Bumper Front; Cracked; UpTo 25mm

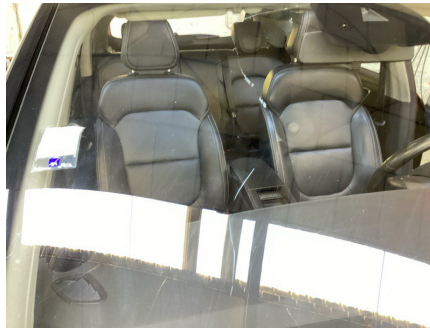
EXTERIOR - FRONT
Screen Front; Cracked; Replace

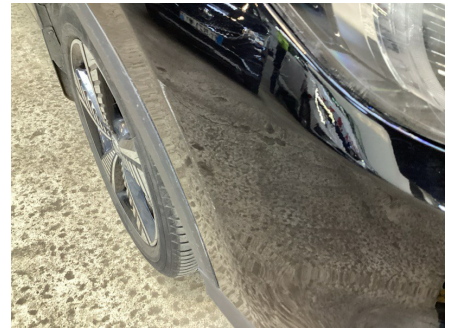
EXTERIOR - FRONT
Bumper Front; Scratched; Over 100mm Thru Paint

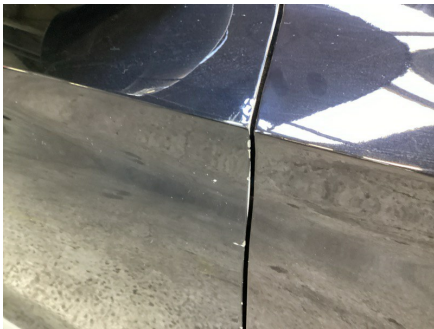
EXTERIOR - PASSENGER SIDE
Door osf; Dented; Over 30% Of Panel

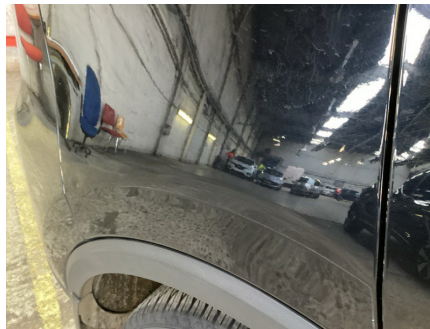
EXTERIOR - PASSENGER SIDE
Qtr Panel osf; Dented; Over 30mm

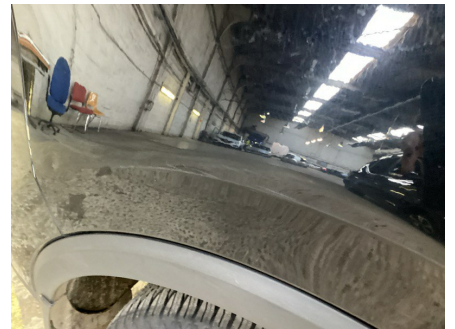
EXTERIOR - PASSENGER SIDE
Qtr Panel osf; Scratched; Over 25mm Thru Paint

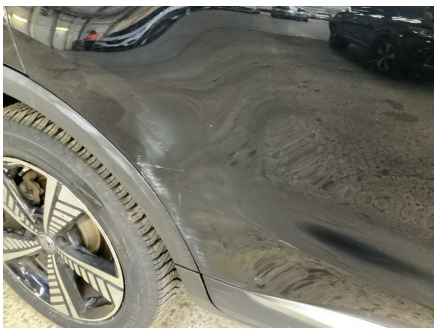
EXTERIOR - PASSENGER SIDE
Door osf; Scratched; Over 25mm Thru Paint

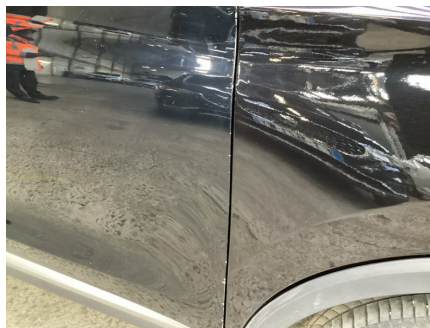
EXTERIOR - PASSENGER SIDE
Door osf; Scratched; Over 25mm Thru Paint

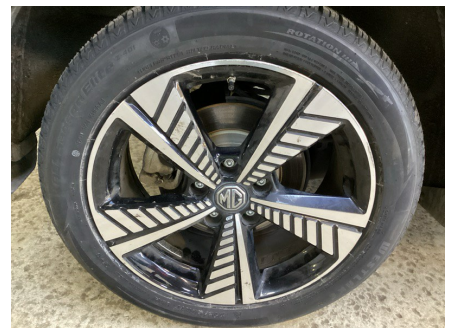
EXTERIOR - PASSENGER SIDE
Wheel osf; Scratched; Up To 50mm

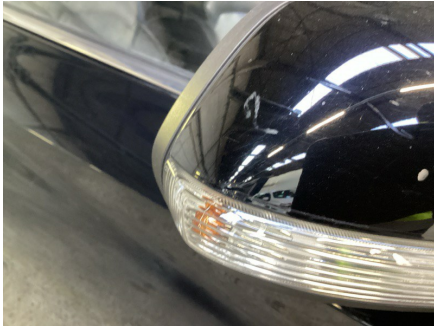
EXTERIOR - PASSENGER SIDE
Door Mirror Assy osf; Scratched (Painted); UpTo 25mm Thru Paint

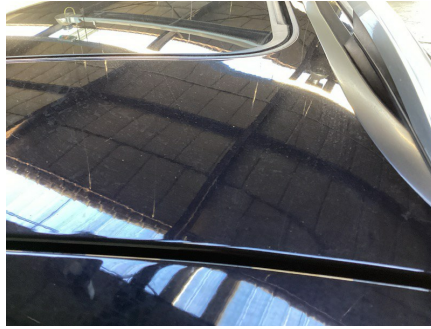
EXTERIOR - ROOF
Roof; Chipped; Over 5mm

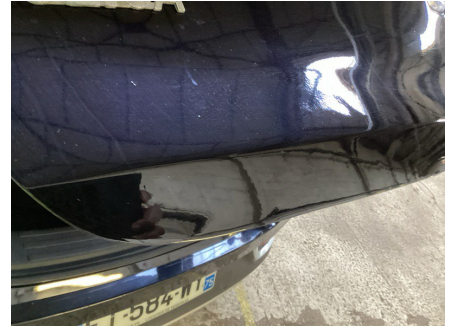
EXTERIOR - REAR
Tailgate; Dented; Over 30% Of Panel

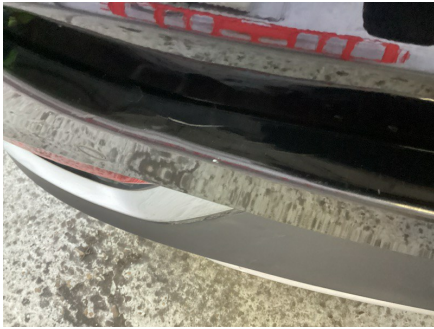
EXTERIOR - REAR
Bumper Rear; Cracked; UpTo 25mm

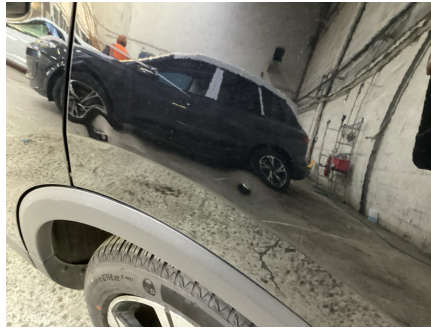
EXTERIOR - DRIVERS SIDE
Qtr Panel nsr; Dented; Hail - Severe

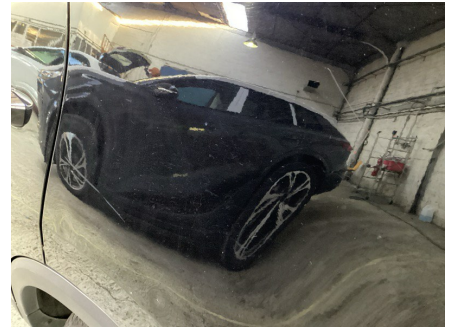
EXTERIOR - DRIVERS SIDE
Qtr Panel nsr; Scratched; Over 25mm Thru Paint

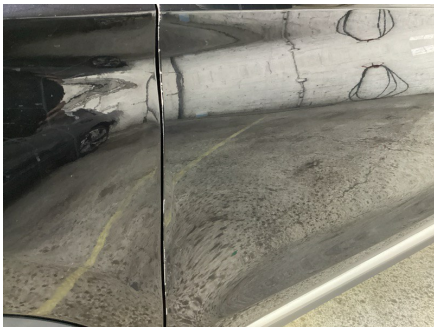
EXTERIOR - DRIVERS SIDE
Door nsf; Scratched; Over 25mm Thru Paint

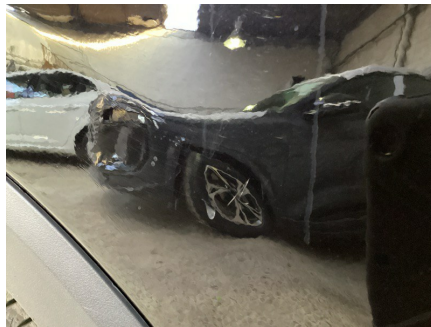
EXTERIOR - DRIVERS SIDE
Wing nsf; Scratched; UpTo 25mm Thru Paint

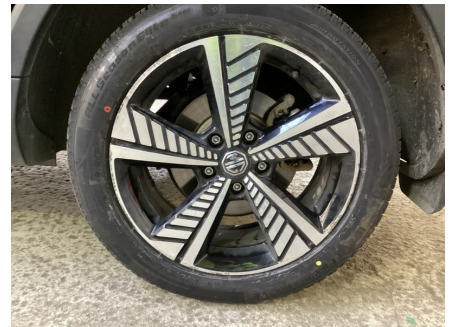
EXTERIOR - DRIVERS SIDE
Wheel nsr; Scratched; Over 50mm

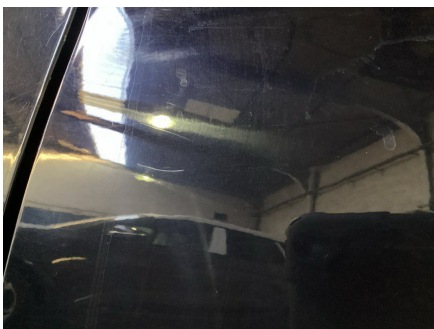
EXTERIOR - DRIVERS SIDE
Door nsr; Scratched; UpTo 25mm Thru Paint

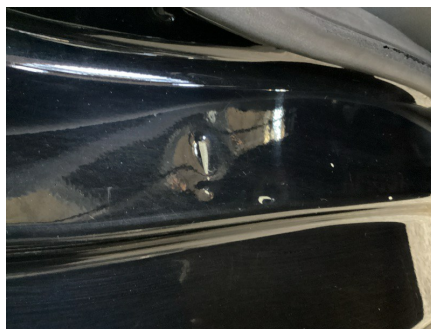
INTERIOR - REAR
Door Pad osr; Scuffed; UpTo 25mm

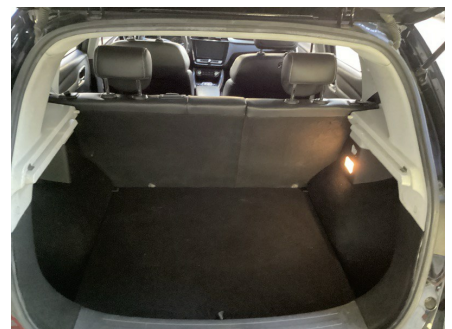
INTERIOR - LOAD AREA
Shelfload Cover Rear; Missing; Replace
