# RENAULT Kangoo Combi Z.E. Kangoo Z.E. Maxi 5pl.

VIN NO VF1FWFZTC60695566

Registration Number 1387KPD

## Inspection Report Summary

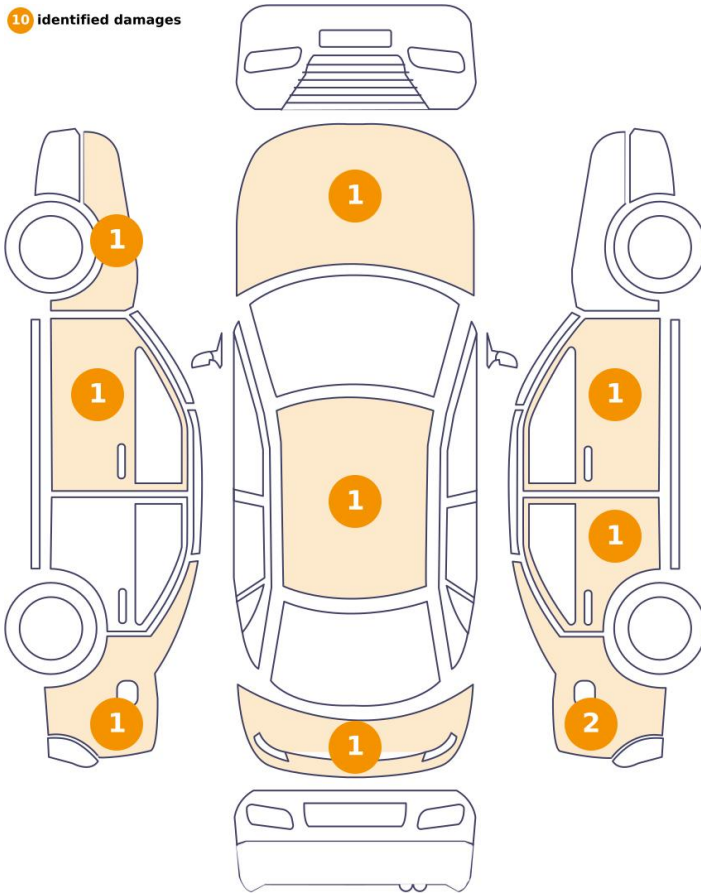
10 identified damages

Component	Damage	Comments
1 Fender / Back Right	Bodywork / Dent / Deformation	
2 Side Panel / Back Left	Bodywork / Dent / Deformation	
3 Pillar / Back Right	Paint / Scratch / Line	
4 Fender / Back Right	Missing Part	
5 Roof	Bodywork / Dent / Hail Area	
6 Other	Bodywork / Breakage	
7 Door / Front Right	Paint / Scratch / Line	
8 Other	Interior / Broken	
9 Fender / Front Left	Paint / Scratch / Line	
10 Door / Front Left	Bodywork / Dent / Dent	
11 Swing Door / Back Left	Paint / Scratch / Line

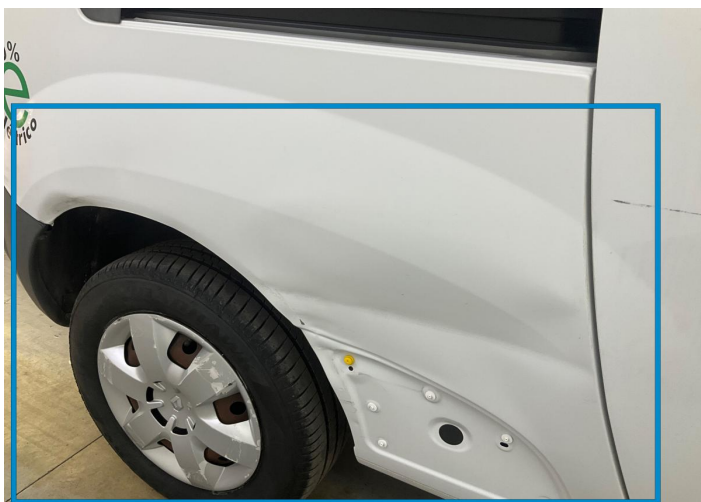
1. Fender / Back Right  
Bodywork / Dent / Deformation -

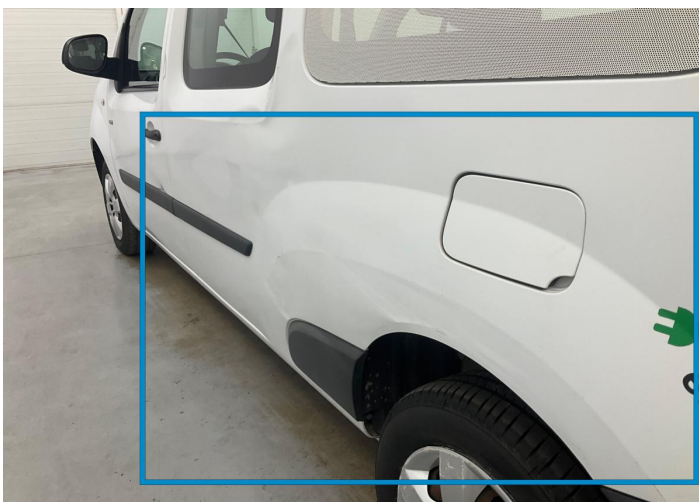
2. Side Panel / Back Left  
Bodywork / Dent / Deformation -

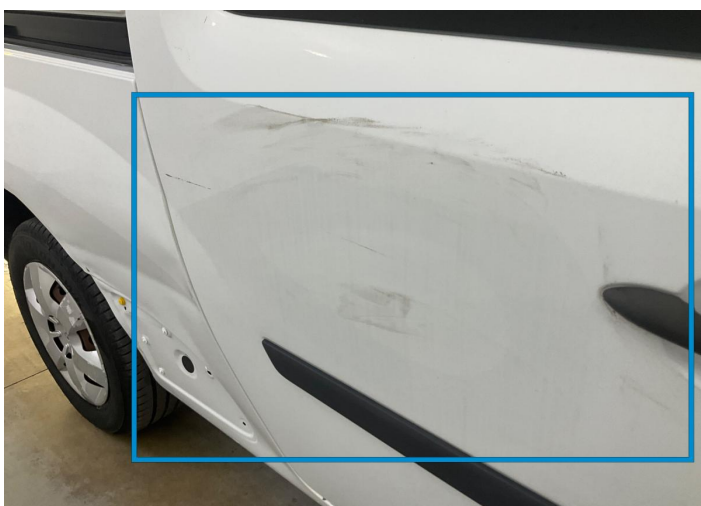
3. Pillar / Back Right  
Paint / Scratch / Line -

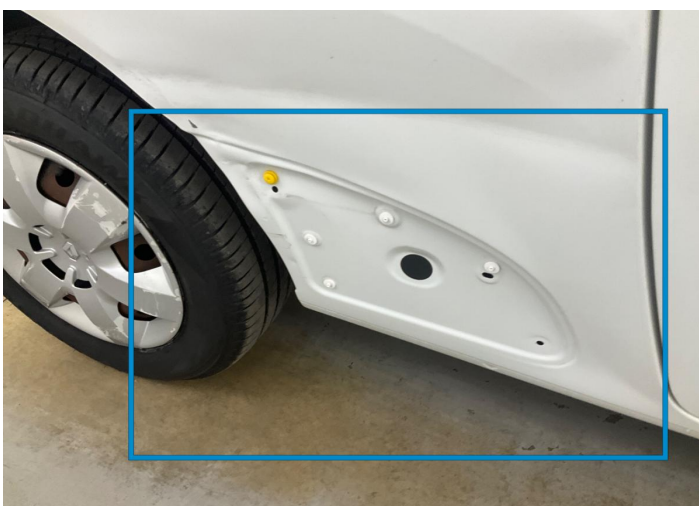
4. Fender / Back Right  
Missing Part -

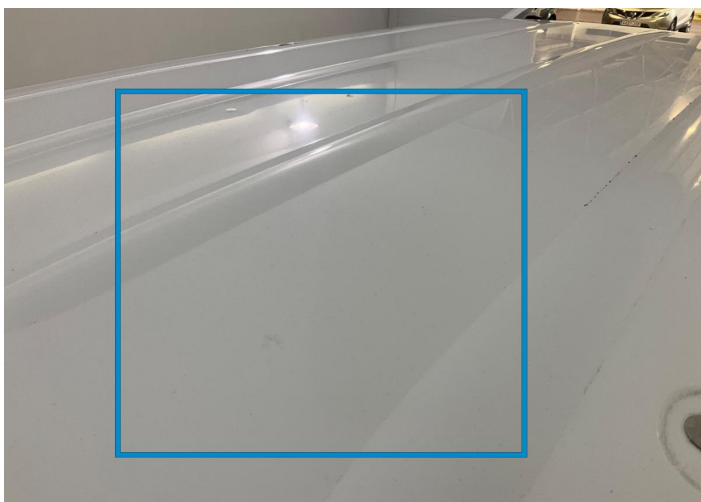
5. Roof  
Bodywork / Dent / Hail Area -

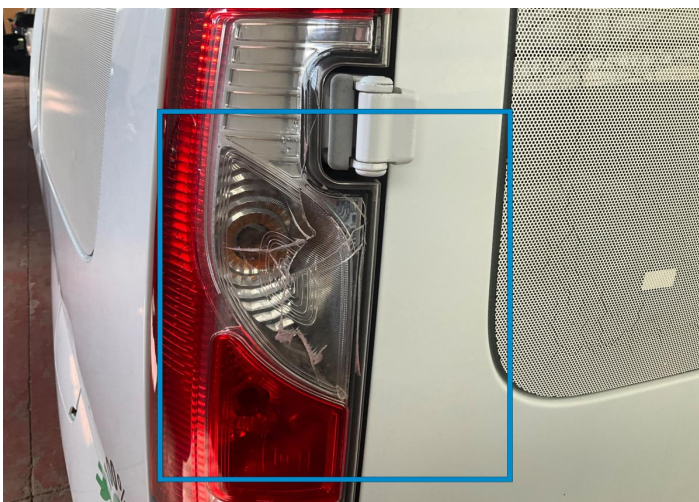
6.  
Bodywork / Breakage -

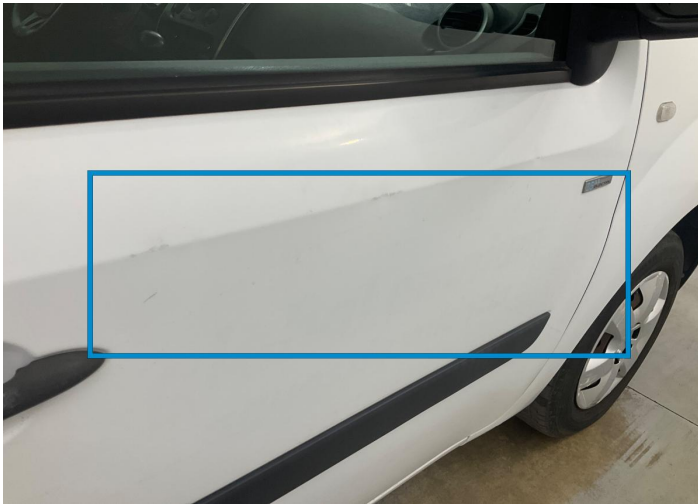
7. Door / Front Right  
Paint / Scratch / Line -

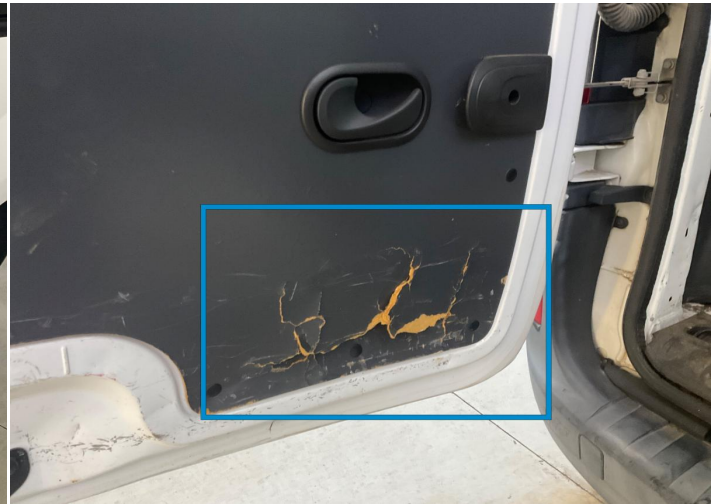
8.  
Interior / Broken -

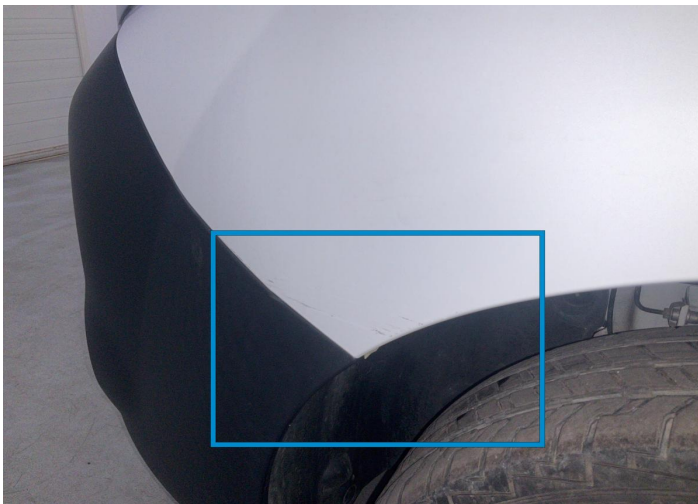
9. Fender / Front Left  
Paint / Scratch / Line -

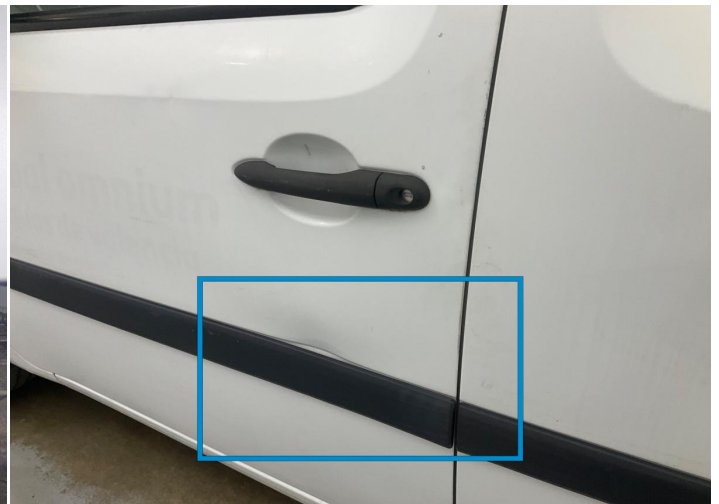
10. Door / Front Left  
Bodywork / Dent / Dent -

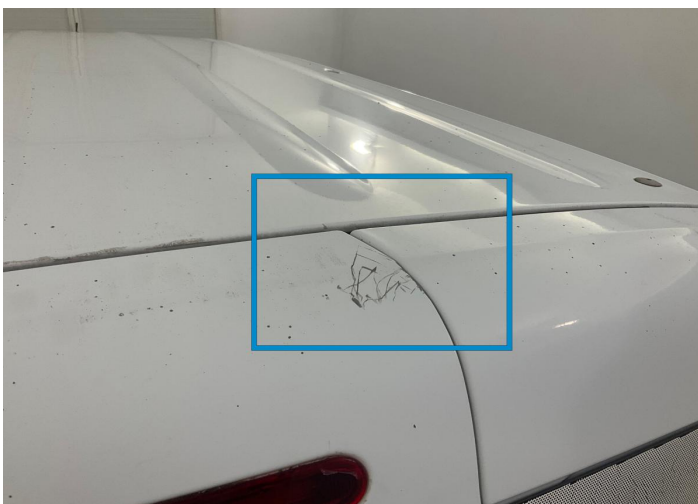
11. Swing Door / Back Left  
Paint / Scratch / Line -

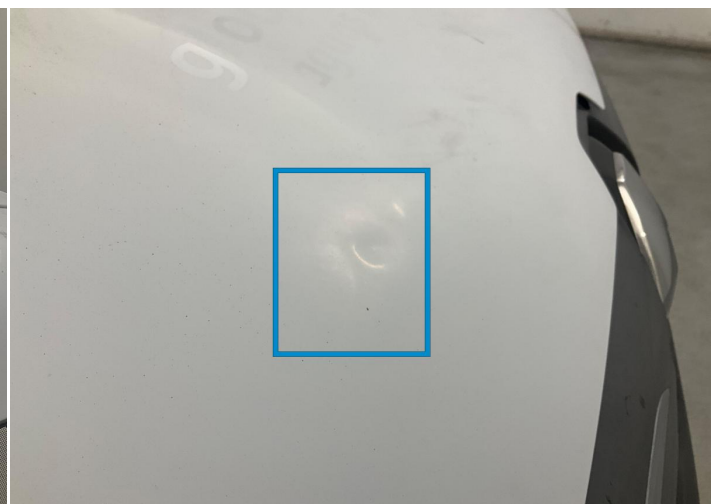
12. Hood  
Bodywork / Dent / Dent -
