Expertise

Protocol number: 40743812
Order No. / Reference: 24991269
Inspection date: 24 Jul 2025

Manufacturer: Kia	Model: e-Soul Spirit EV 204
VIN: KNAJ3811FL7011641

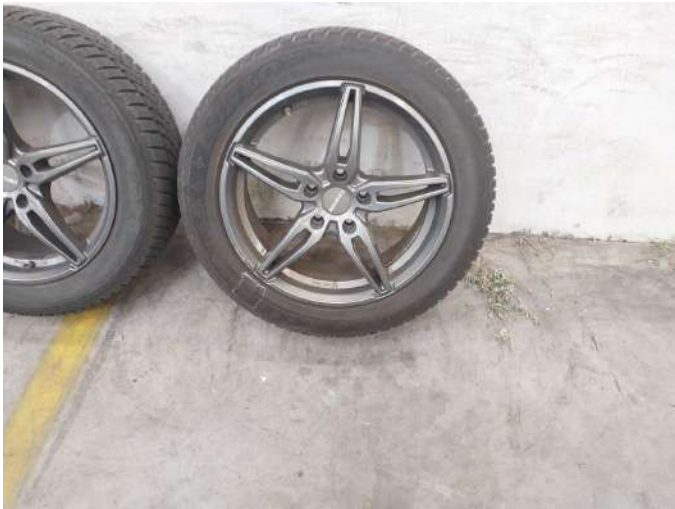
Damage 1: 2nd wheel set: 1 alloy rim - Scratch(es) - No deduction

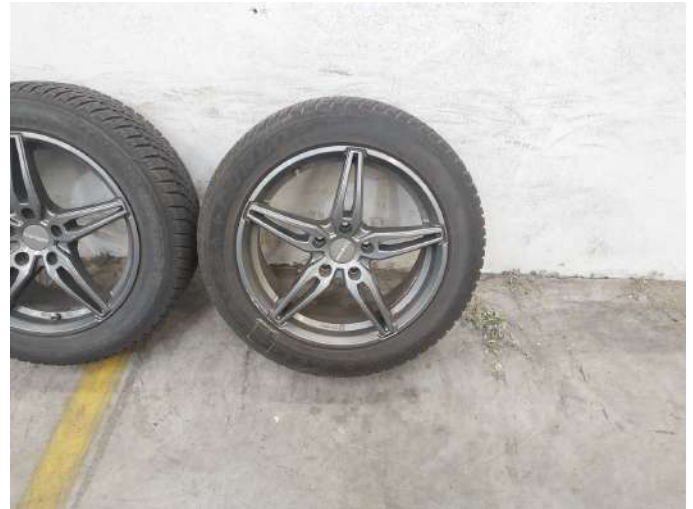
Damage 2: 2nd wheel set: 1 tyre - Damaged - No deduction

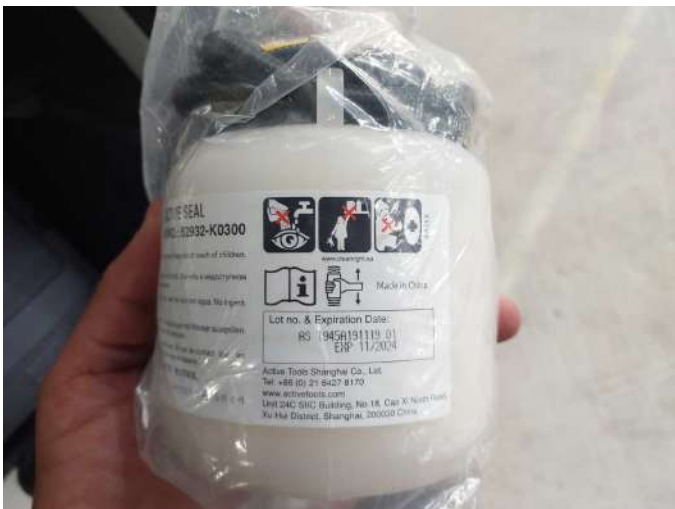
Damage 3: Equipment: Tirefit filler - Expired - Replace

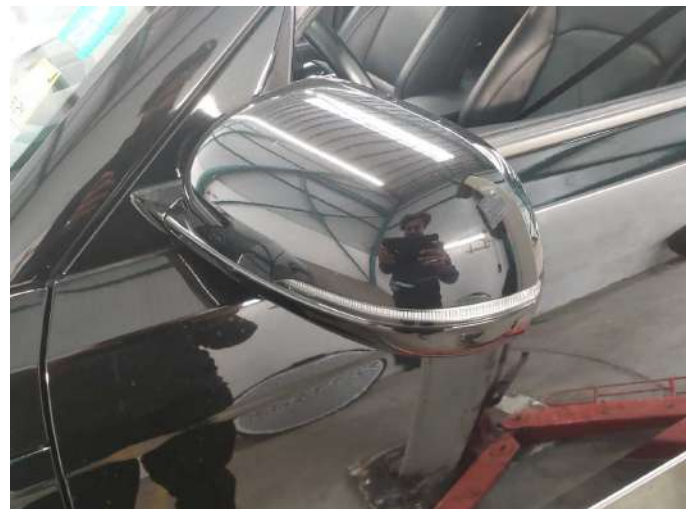
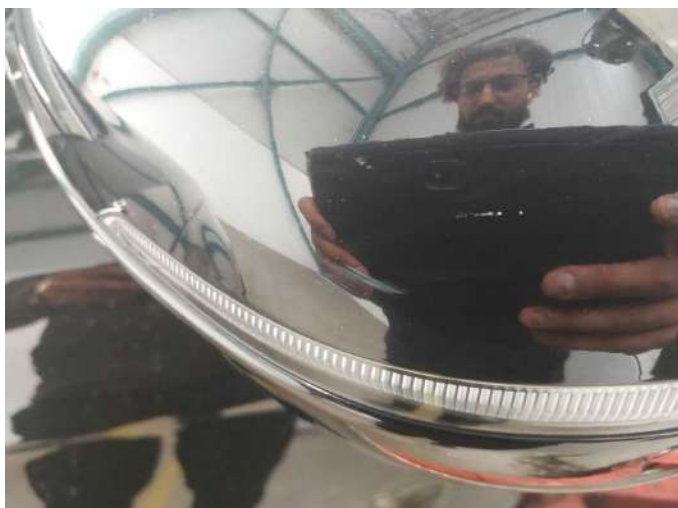
Damage 4: Wing mirror - left side: Cap - Scratch(es) - Smart repair

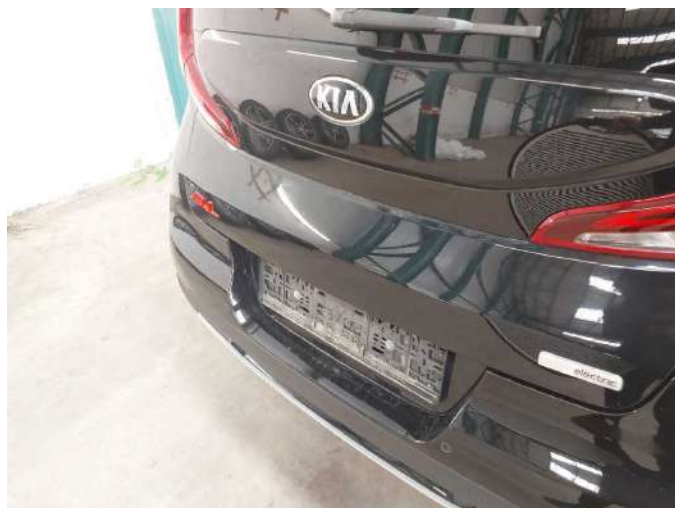
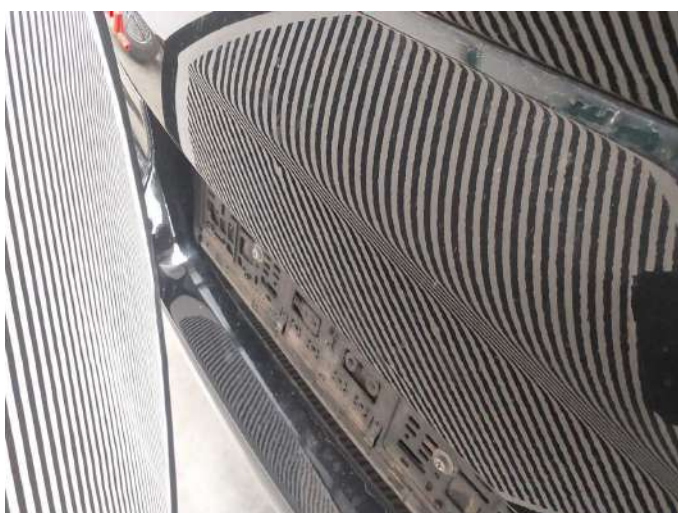
Damage 5: Boot lid / rear door: Boot lid - dent(s) - Smart repair

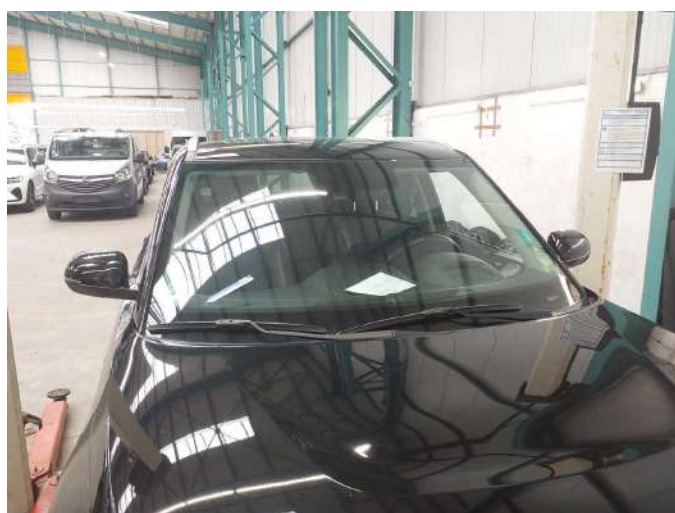
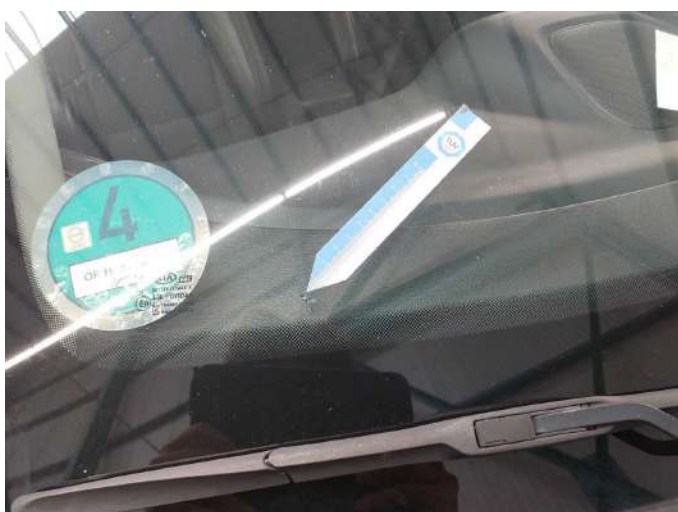
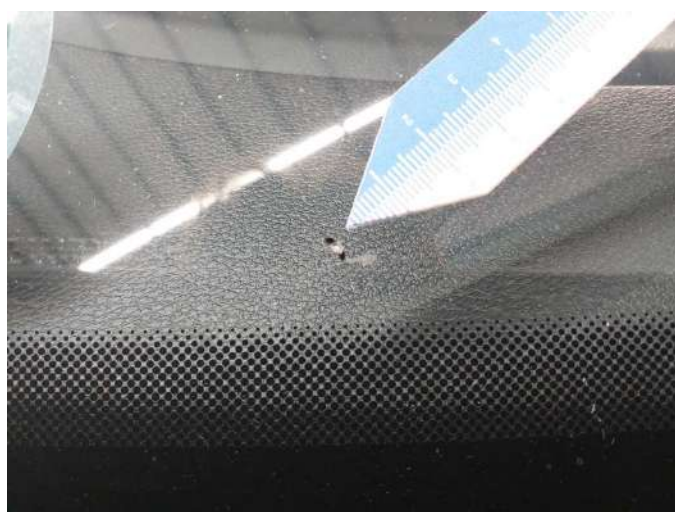
Damage 6: Vehicle glazing: Windscreen with rain sensor - Stone chips - Smart repair

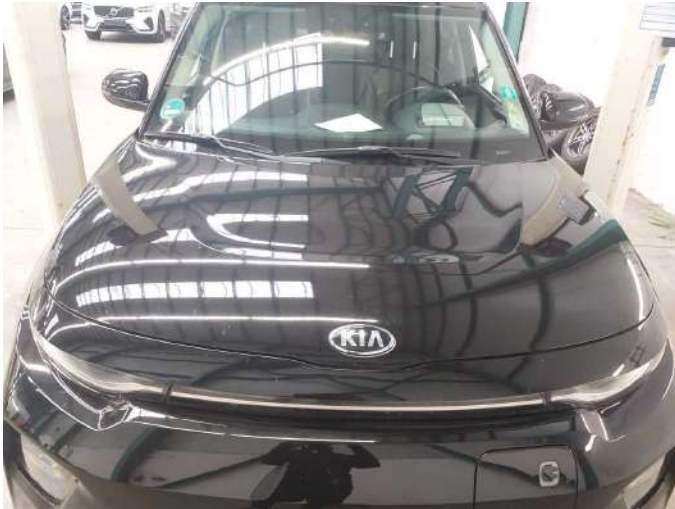
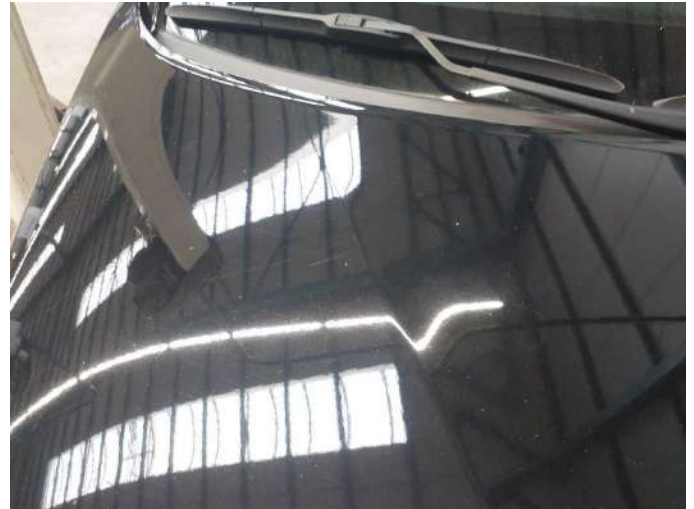
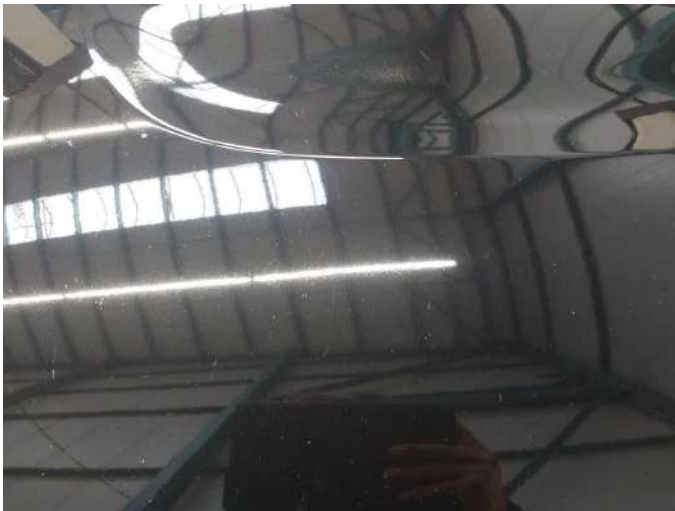
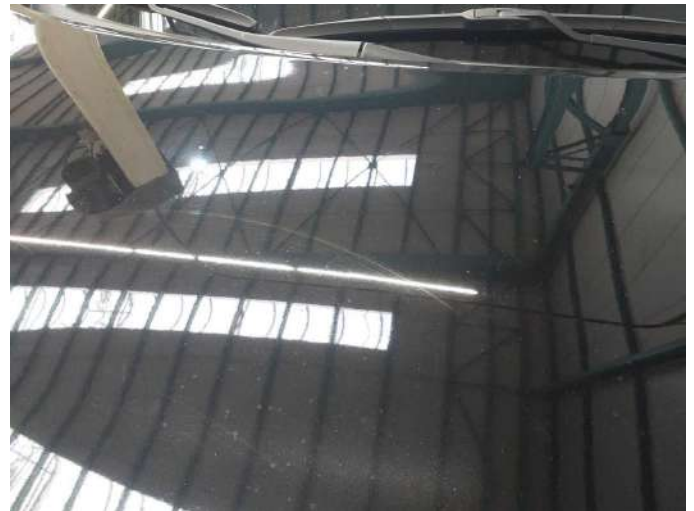
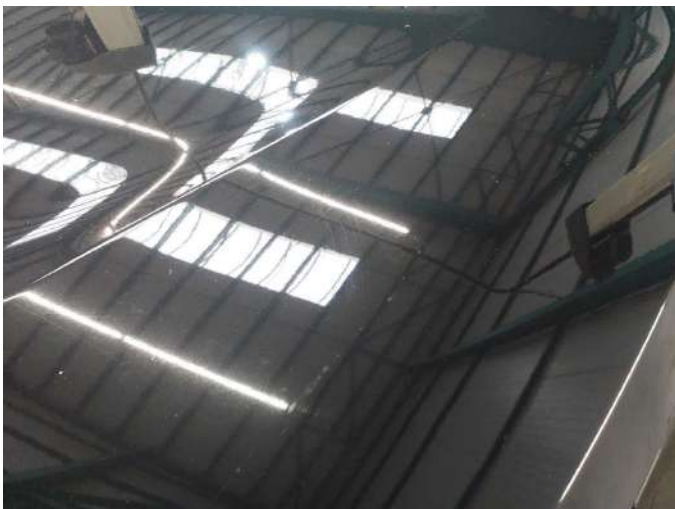
Damage 7: Bonnet: Bonnet - Scratch(es) - Cover / polish

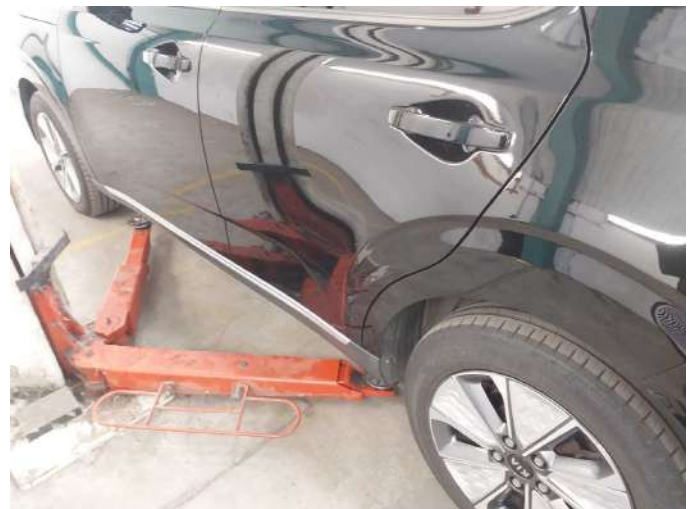
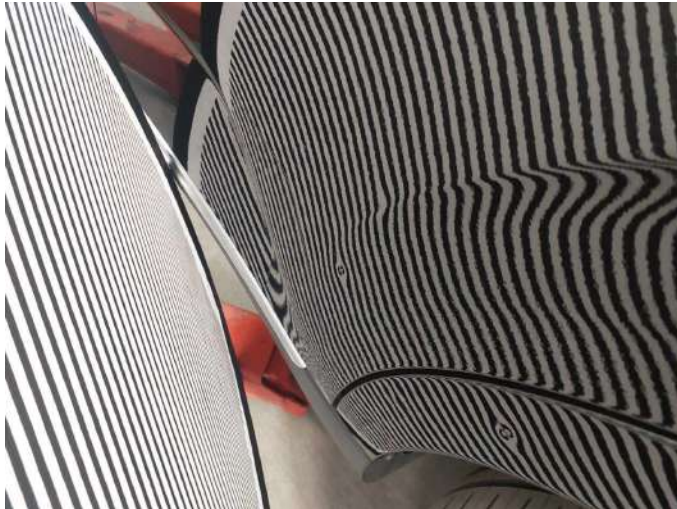
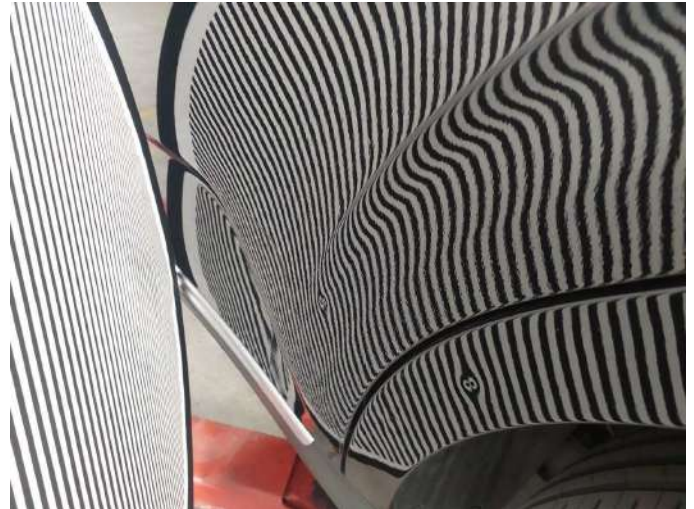
Damage 8: Door - rear left side: Door - dent(s) - Smart repair

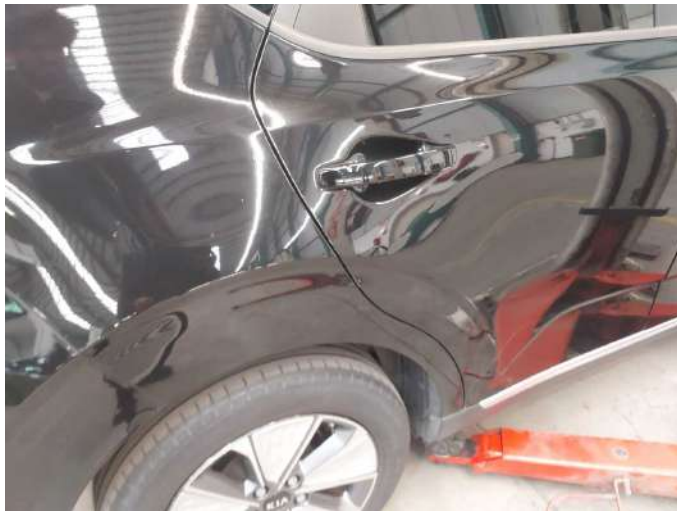
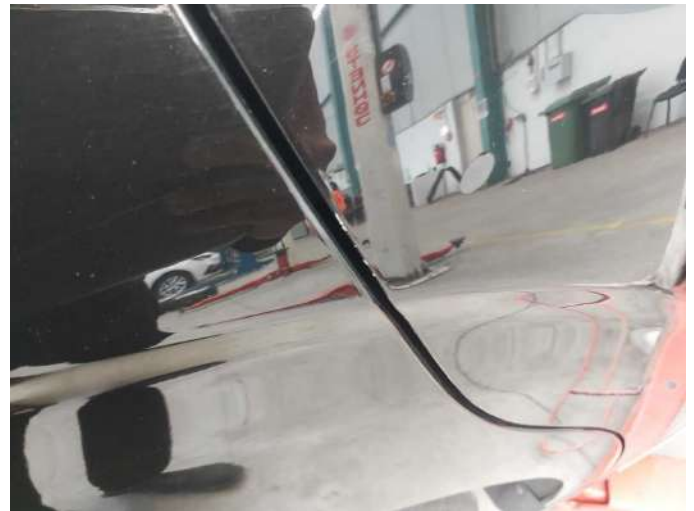
Damage 9: Door - rear right side: Door - Scratch(es) - Smart repair

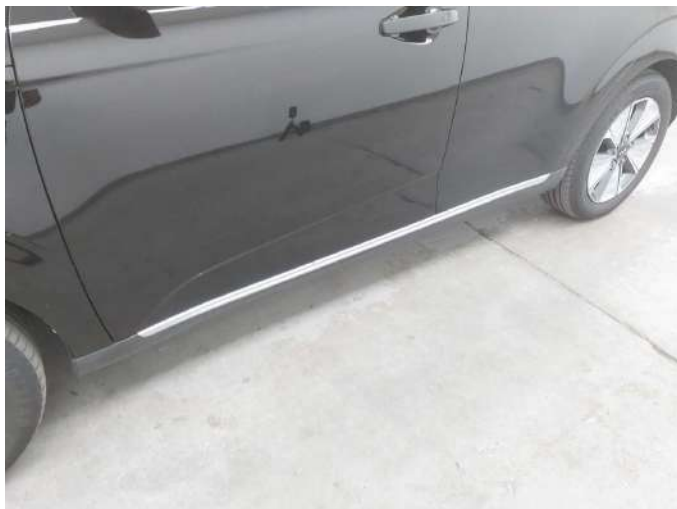
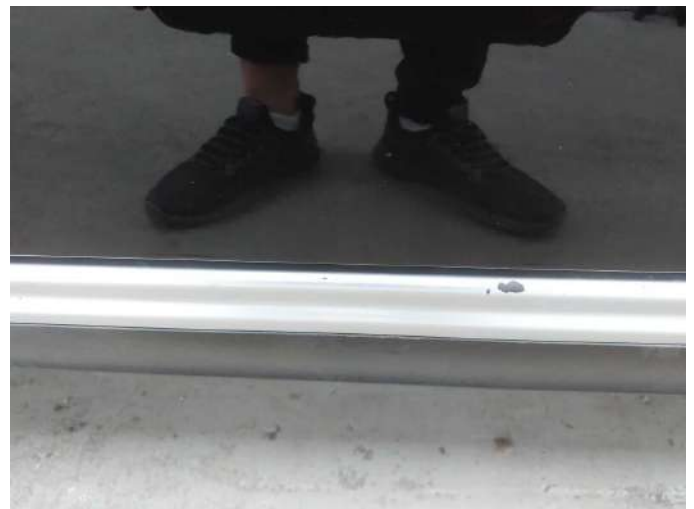
Damage 10: Sill - left side: Sill - Scratch(es) - Smart repair

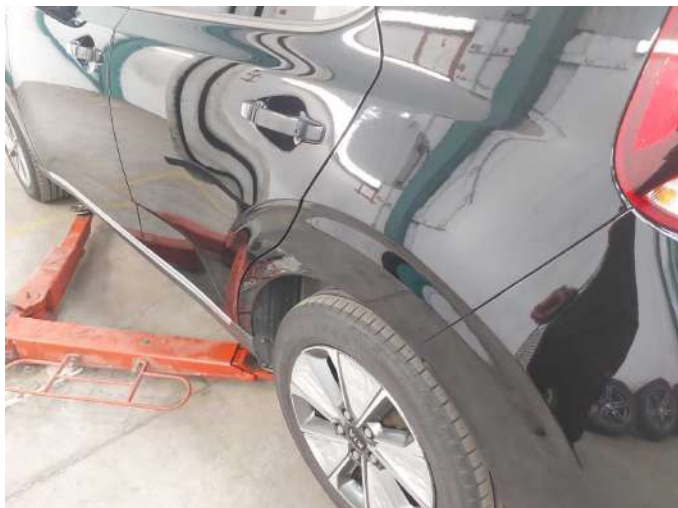
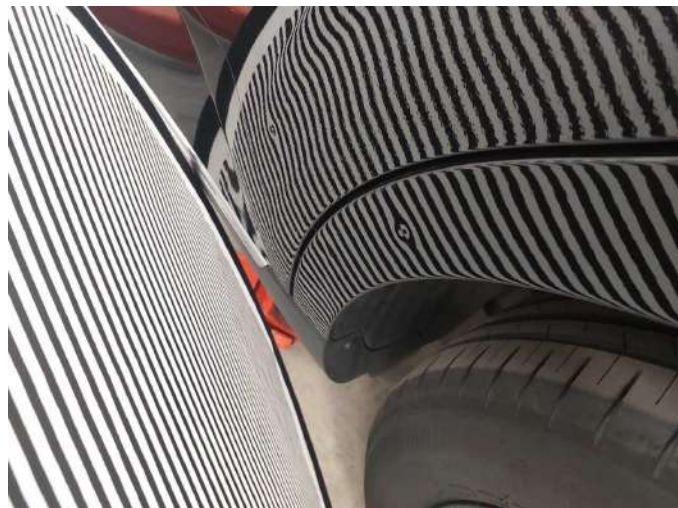
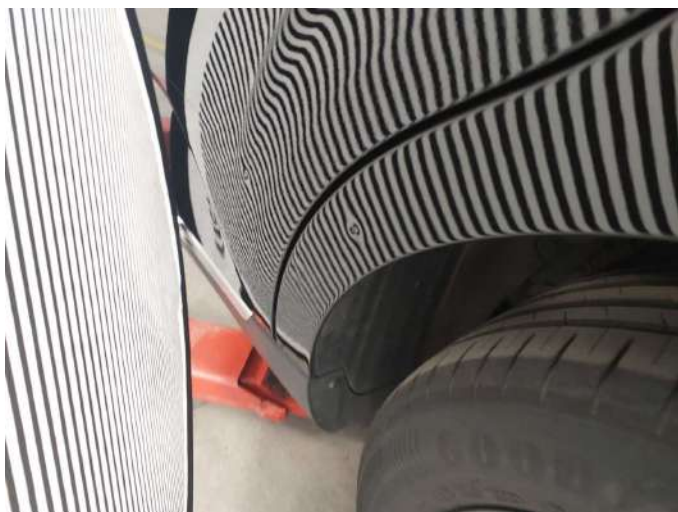
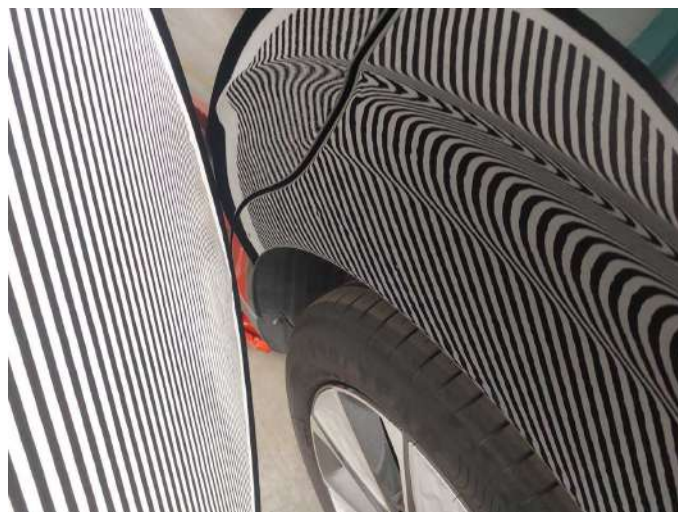
Damage 12: Side panel - rear left side: Side panel - Dent / paintcoat damage - Repair and paint

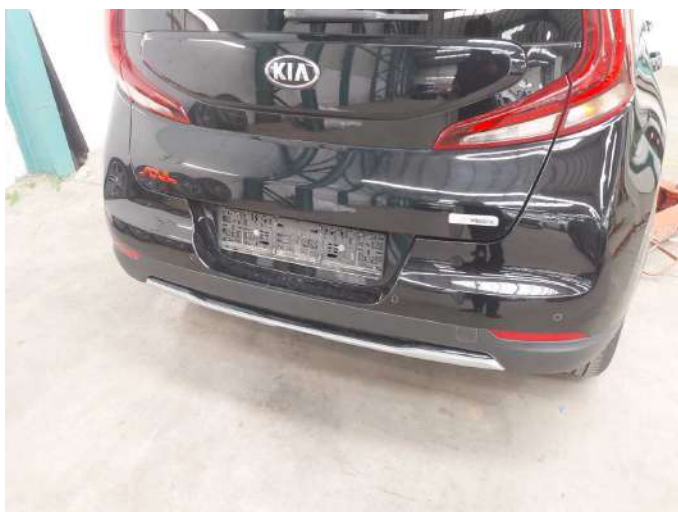
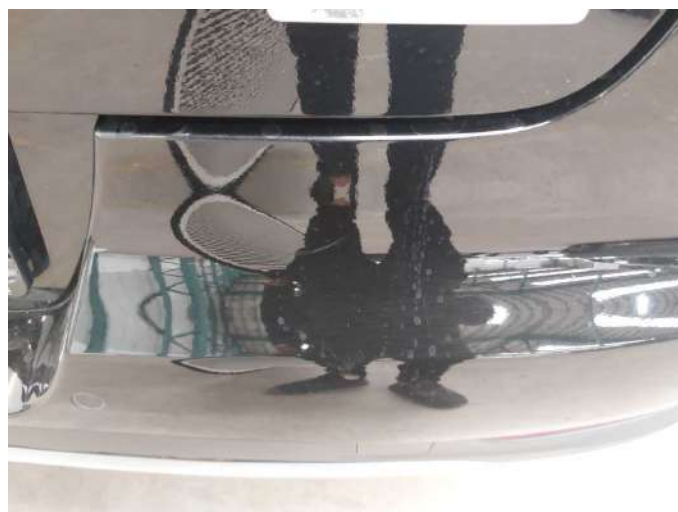
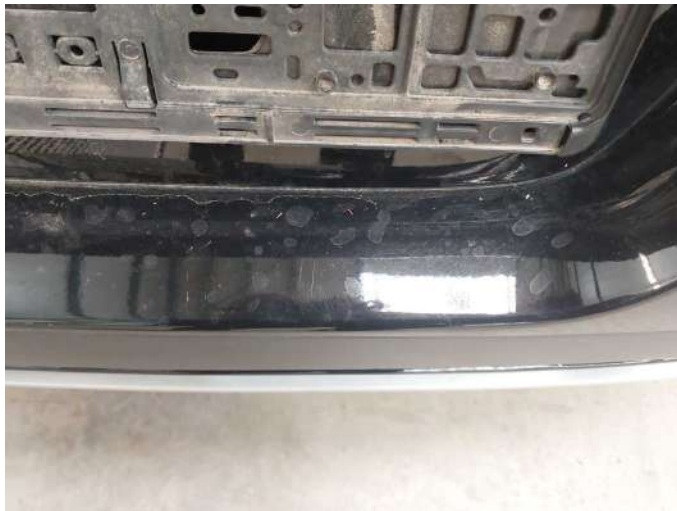
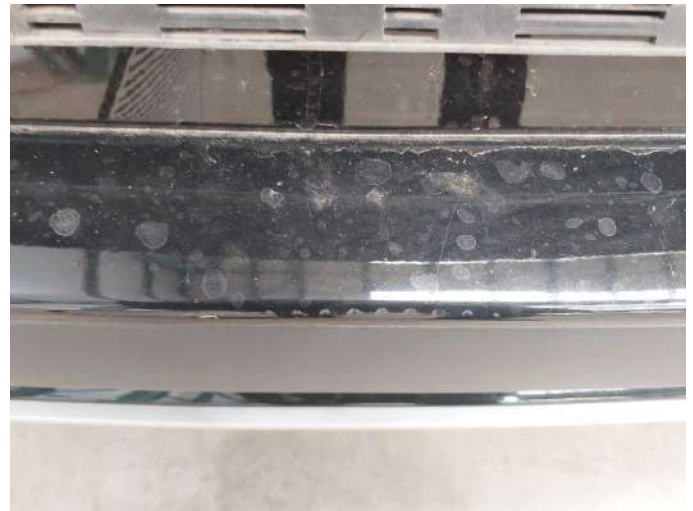
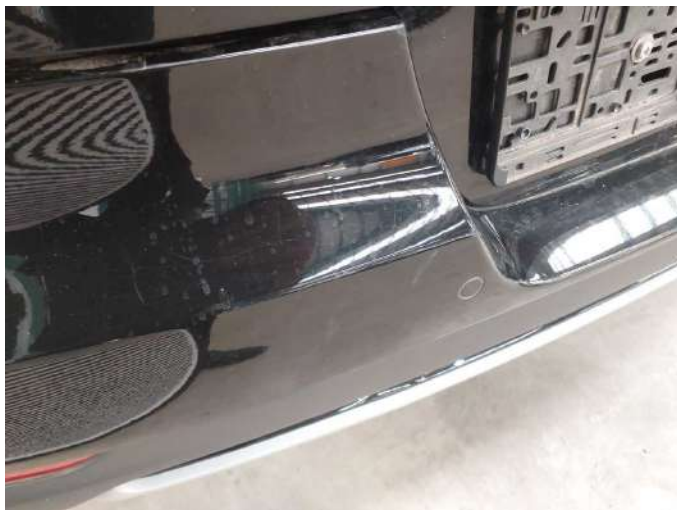
Damage 13: Rear bumper: Rear bumper - Scratch(es) - Paint

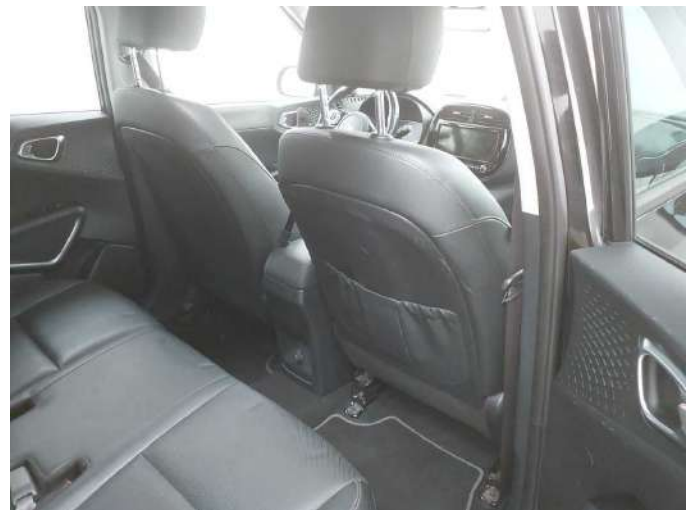
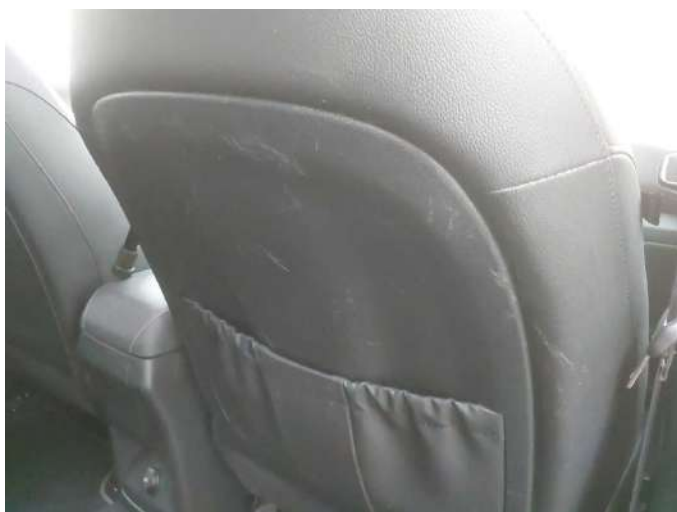
Wear and tear 1: Seat - front: Seat - right side - Abrasion - No deduction

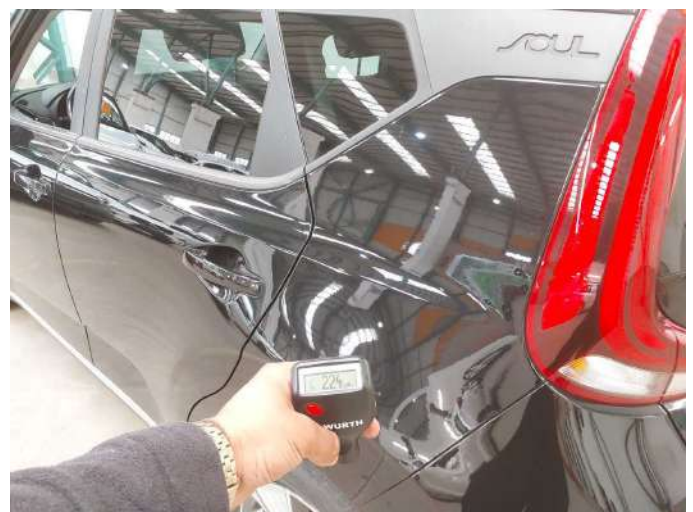
Repainting 1: Side panel - rear left side

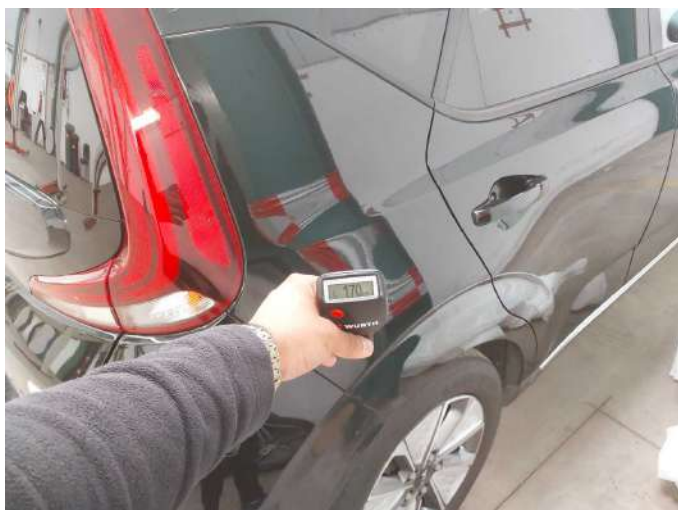
Repainting 2: Side panel - rear right side

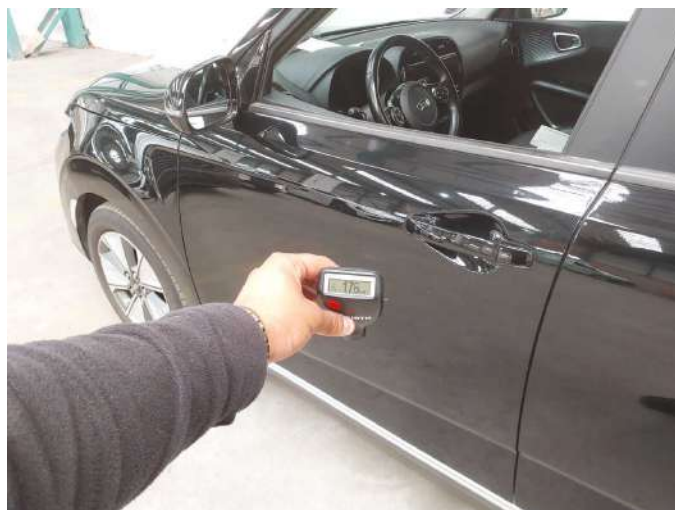
Repainting 3: Door - front left side

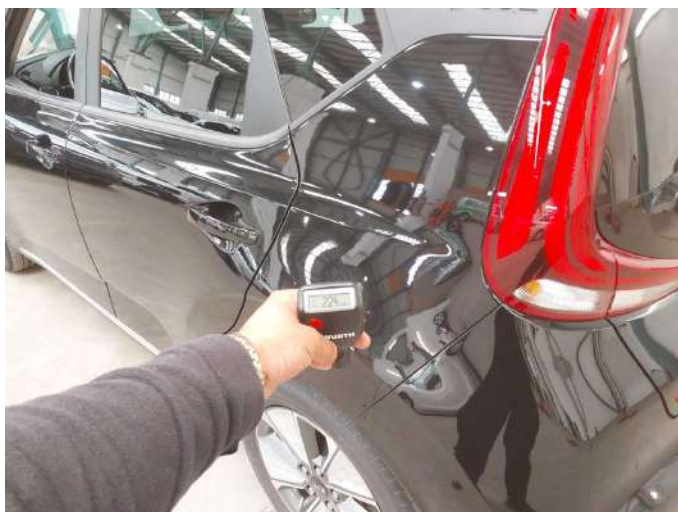
Side panel - rear left side: 224 μm

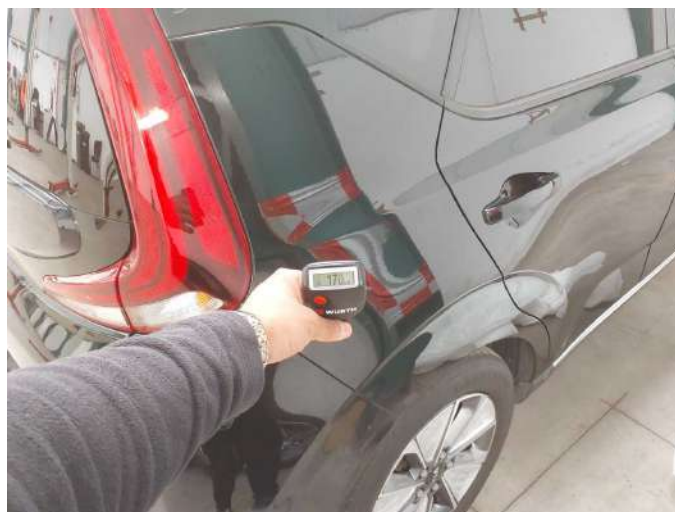
Side panel - rear right side: 170 μm

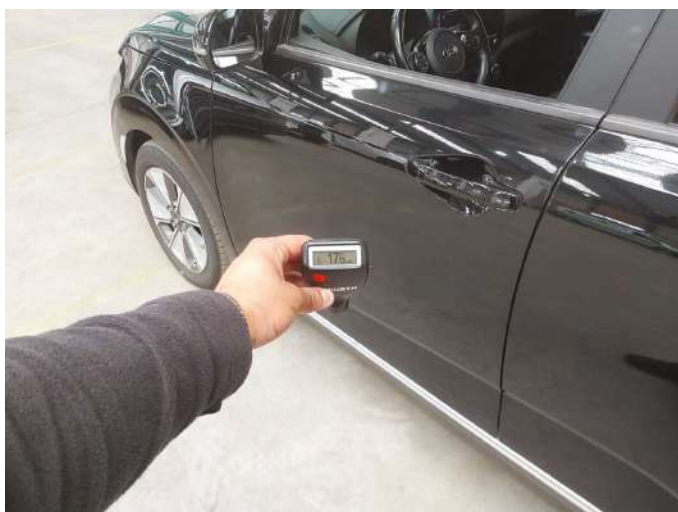
Door - front left side: 176 μm
