# CITROEN C3

## C3 PureTech 82 S&S BVM5 Live

VIN NO VF7SXHMRVKT720282  
Registration Number FN998CQ

### Inspection Report Summary

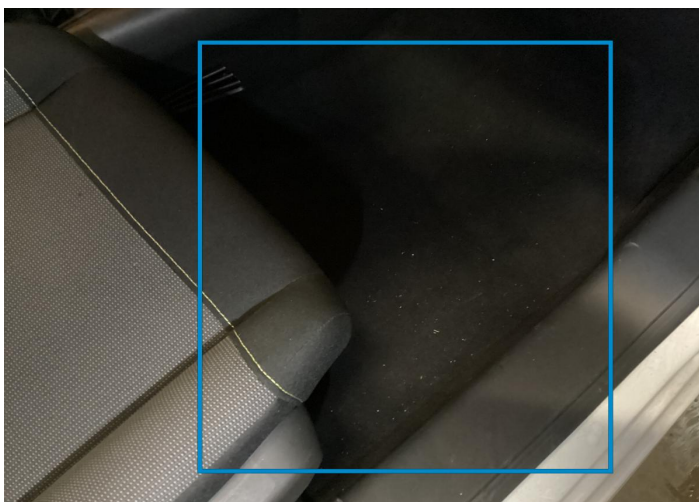
| Component | | Damage | Comments |
|---|---|---|---|
| 1 | Floor Carpet | Interior / Dirty | |

1. Floor Carpet  
Interior / Dirty -

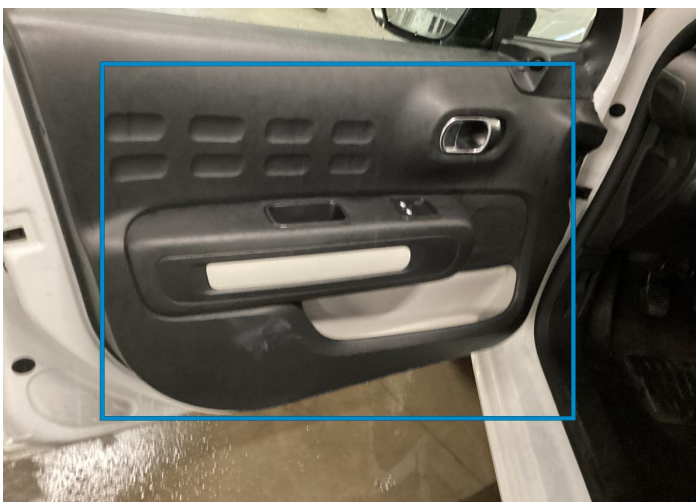
| Component | | Damage | Comments |
|---|---|---|---|
| 2 | Panel Filling / Front Left | Interior / Stained | |

2. Panel Filling / Front Left  
Interior / Stained -

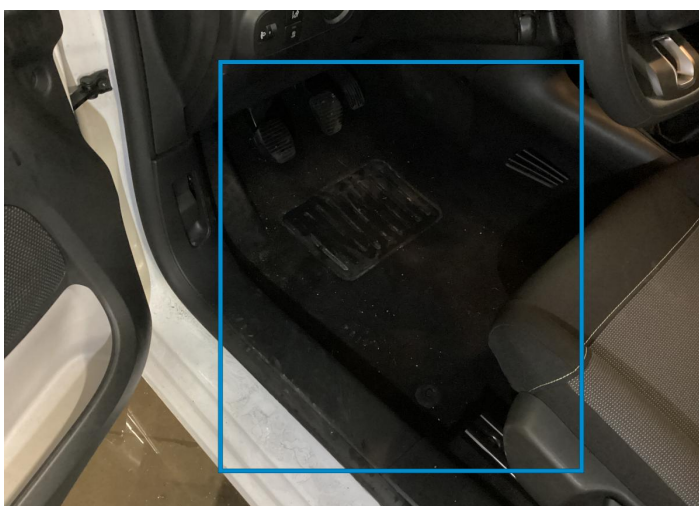
| Component | | Damage | Comments |
|---|---|---|---|
| 3 | Floor Carpet | Interior / Dirty | |

3. Floor Carpet  
Interior / Dirty -

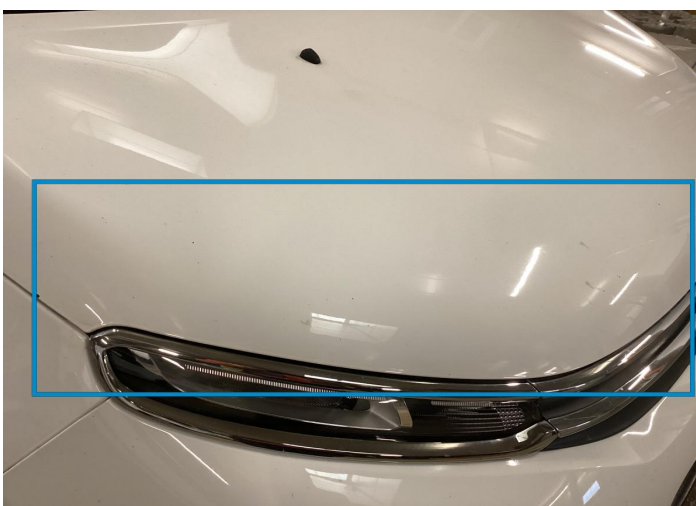
| Component | | Damage | Comments |
|---|---|---|---|
| 4 | Hood | Paint / Stone Chip | |

4. Hood  
Paint / Stone Chip -

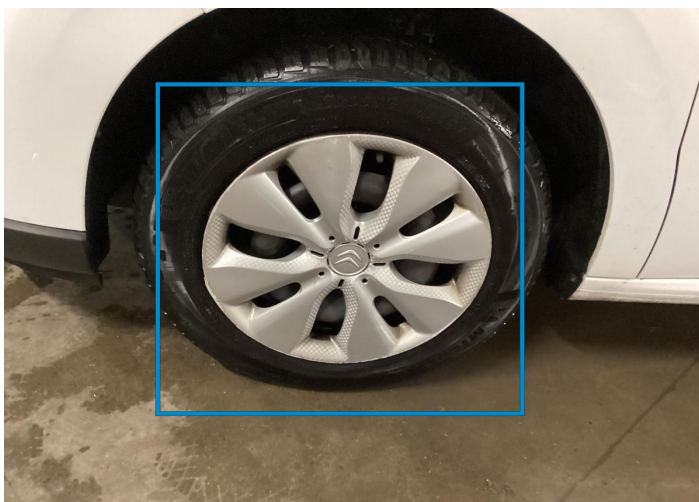
| Component | | Damage | Comments |
|---|---|---|---|
| 5 | Hubcap / Front Left | Out of Bodywork / Scratch | |

5. Hubcap / Front Left  
Out of Bodywork / Scratch -

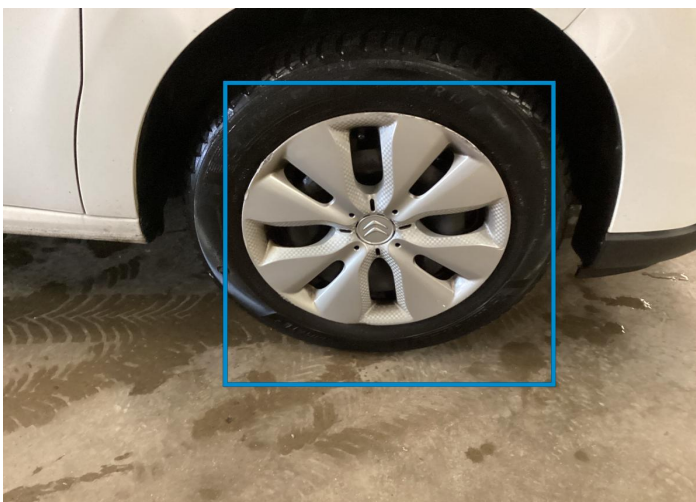
| Component | | Damage | Comments |
|---|---|---|---|
| 6 | Hubcap / Front Right | Out of Bodywork / Scratch | |

6. Hubcap / Front Right  
Out of Bodywork / Scratch -

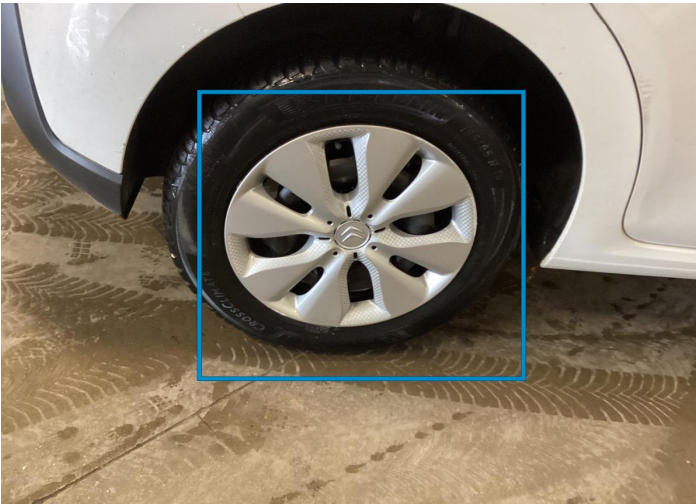
| Component | | Damage | Comments |
|---|---|---|---|
| 7 | Rim / Back Right | Out of Bodywork / Scratch | |

7. Rim / Back Right  
Out of Bodywork / Scratch -

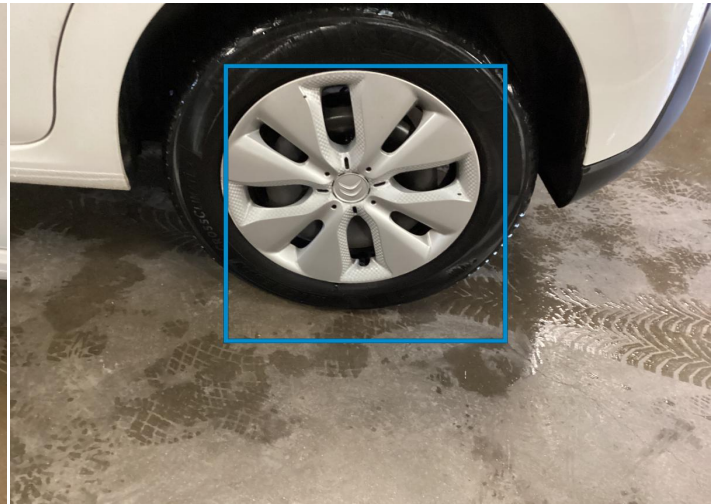
| Component | | Damage | Comments |
|---|---|---|---|
| 8 | Hubcap / Back Left | Out of Bodywork / Scratch | |

8. Hubcap / Back Left  
Out of Bodywork / Scratch -

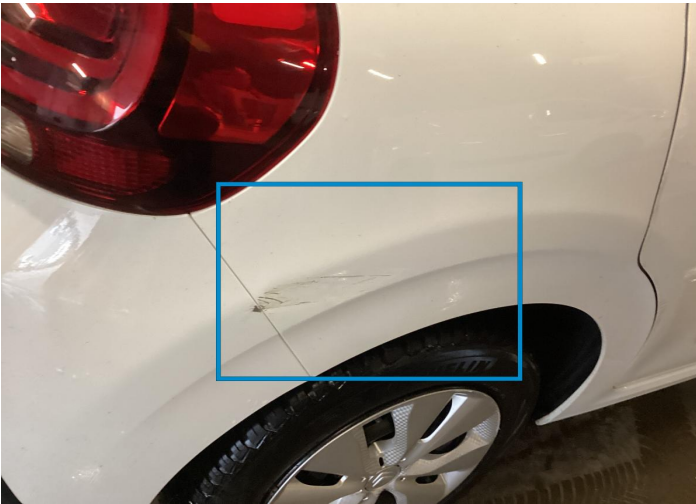
| Component | | Damage | Comments |
|---|---|---|---|
| 9 | Side Panel / Back Right | Paint / Scratch / Line | |

9. Side Panel / Back Right  
Paint / Scratch / Line -

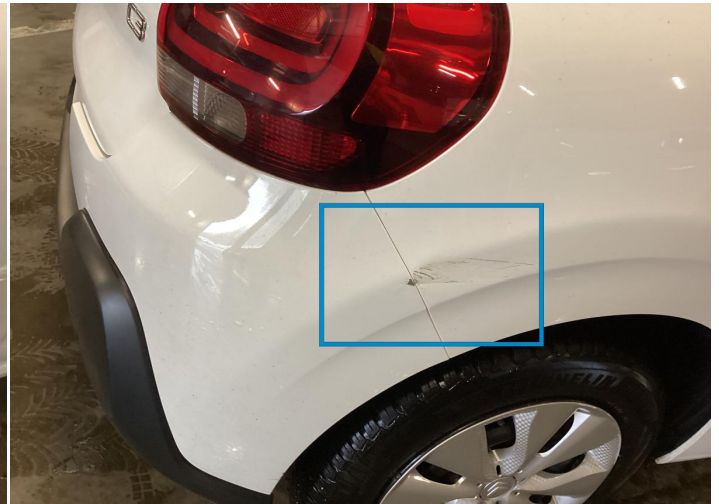
| Component | | Damage | Comments |
|---|---|---|---|
| 10 | Corner Bumper / Back Right | Paint / Scratch / Line | |

10. Corner Bumper / Back Right  
Paint / Scratch / Line -
