## status report

| Report number: | 0000000804148-EN968 | | |

#### Hyundai Kona (OS)(2017->) Trend Elektro 2WD

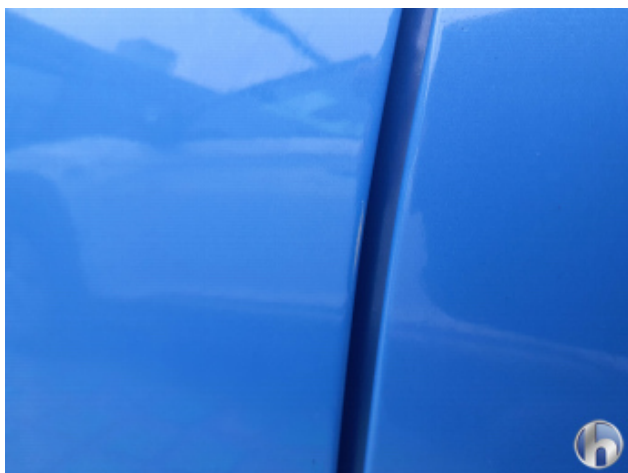
| 1. | Front door - left | Wear and tear | Without repair |

1. Front door - left  
**Wear and tear - Without repair**

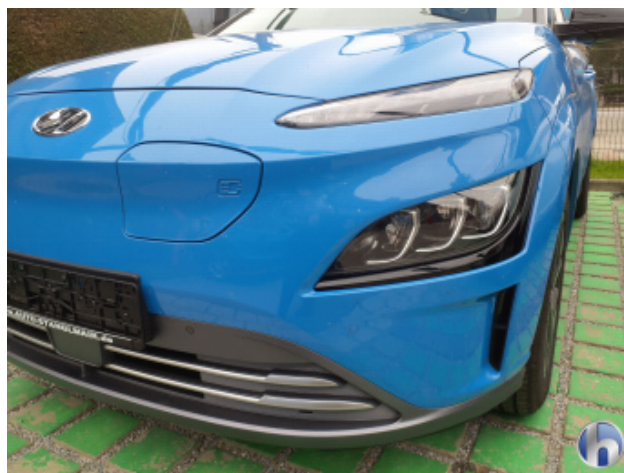
| 2. | Front bumper | Chipping from stones | Paint |

2. Front bumper  
**Chipping from stones - Paint**
