NISSAN LEAF Leaf Electrique 40kWh N-Connecta

VIN NO SJNFAAZE1U0044479 Registration Number FD213CC

Inspection Report Summary

| Customer | BCAuto Encheres | Report Number | P20250703114740 |

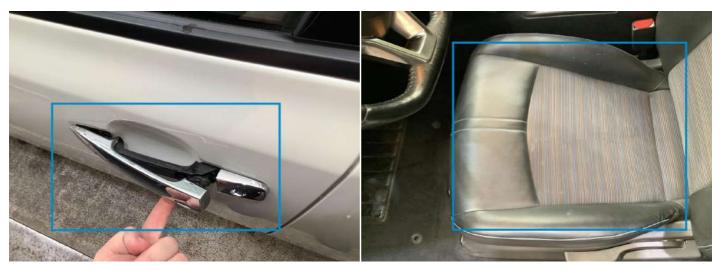
1. Door Handle / Front Left Bodywork / Assembly -

2. Seat Cushion / Front Left Interior / Stained -

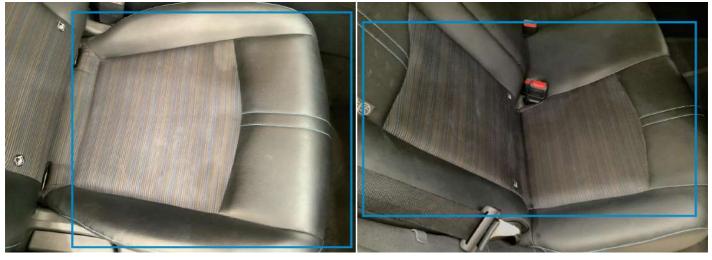
3. Seat Cushion / Front Right Interior / Stained -

4. Seat / Back Right Interior / Stained -

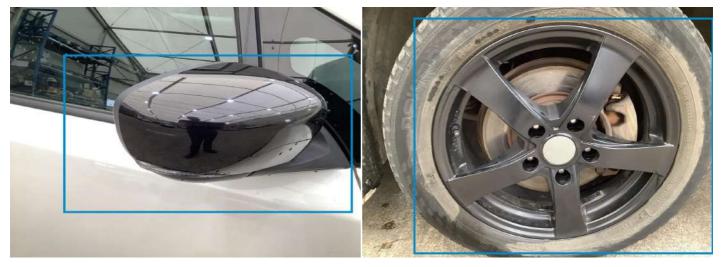
5. Mirror Shell / Front Right Paint / Scratch / Line -

6. Rim / Front Right
Out of Bodywork / Scratch -

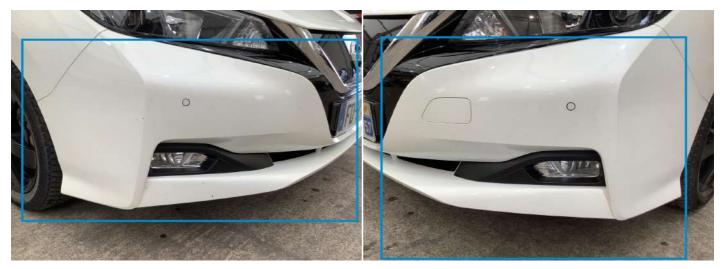
7. Corner Bumper / Front Right Paint / Chipping -

8. Corner Bumper / Front Left Paint / Chipping -

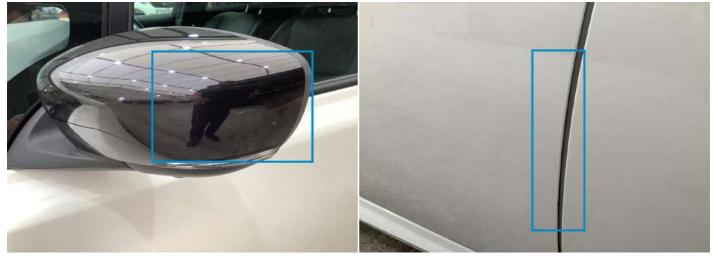
9. Mirror Shell / Front Left Paint / Scratch / Line -

10. Door / Front Left Paint / Chipping -

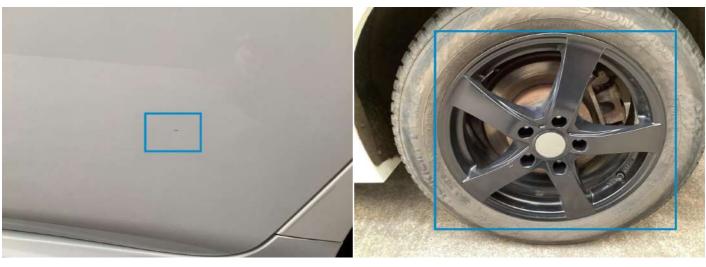
11. Door / Back Left Paint / Chipping -

12. Rim / Back Left Out of Bodywork / Scratch -

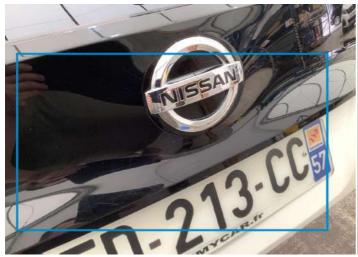
13. Tailgate Paint / Scratch / Line -

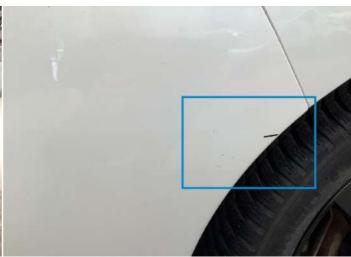
| 14 | Corner Bumper / Back Right | Paint / Scratch / Line |

14. Corner Bumper / Back Right Paint / Scratch / Line -

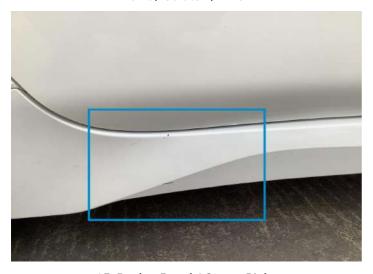
| 14 | Corner Bumper / Back Right | Paint / Scratch / Line |
|---|---|---|
| 15 | Rocker Panel / Center Right | Paint / Scratch / Line |

15. Rocker Panel / Center Right Paint / Scratch / Line -
