HYUNDAI KONA

Kona Electrique 39 kWh - 136 ch Intuitive

VIN NO TMAK281HFNJ046040
Registration Number GD756BX

Inspection Report Summary

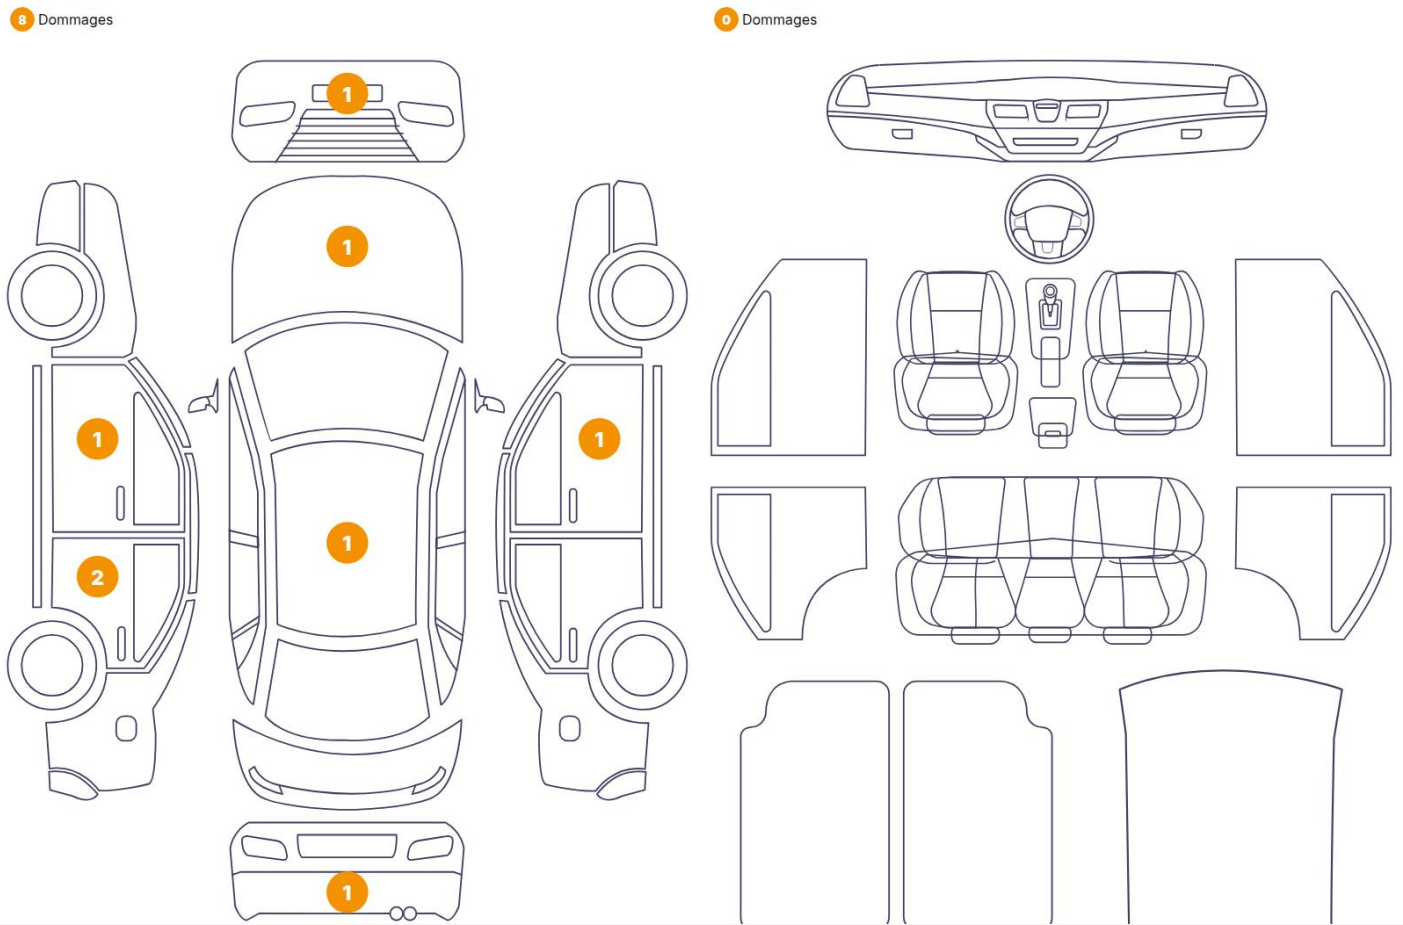
Cosmetic Damage

Component		Damage	Comments
1	Hood	Bodywork / Dent / Hail Area	
2	Corner Bumper / Front Left	Paint / Scratch / Line	
3	Door / Front Left	Paint / Scratch / Line	
4	Door / Back Left	Paint / Scratch / Line	
5	Door / Back Left	Paint / Scratch / Line	
6	Corner Bumper / Back Left	Paint / Chipping	
7	Roof	Bodywork / Dent / Hail Area	
8	Door / Front Right	Paint / Scratch / Line

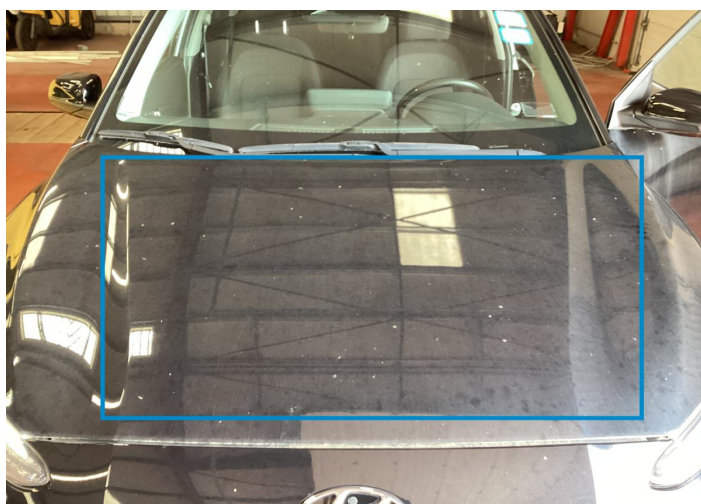
1. Hood
Bodywork / Dent / Hail Area -

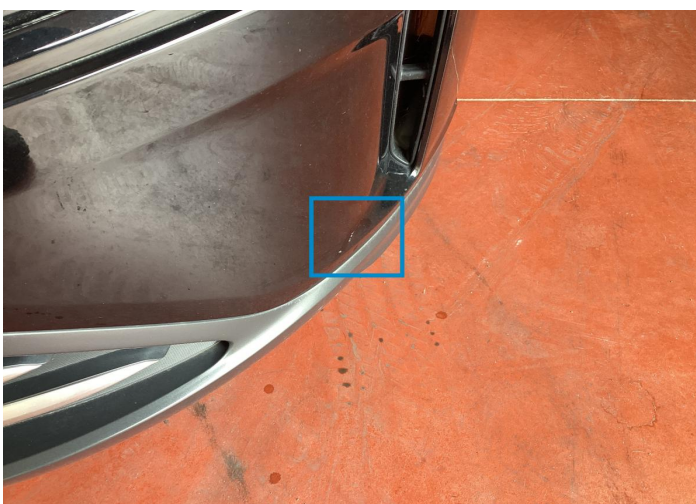
2. Corner Bumper / Front Left
Paint / Scratch / Line -

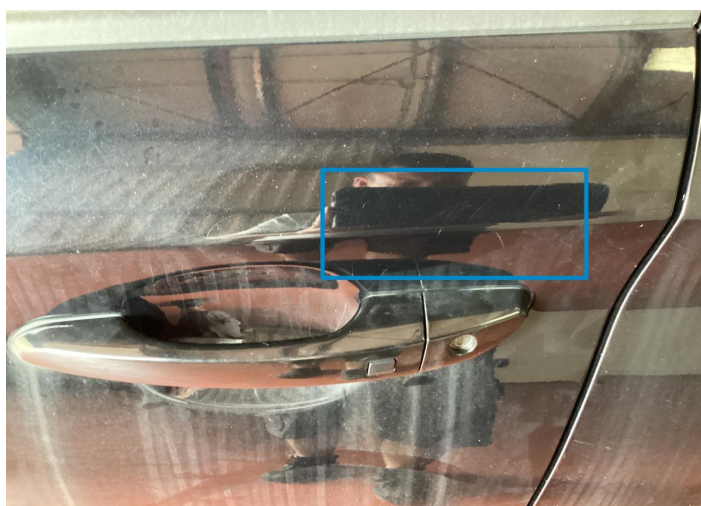
3. Door / Front Left
Paint / Scratch / Line -

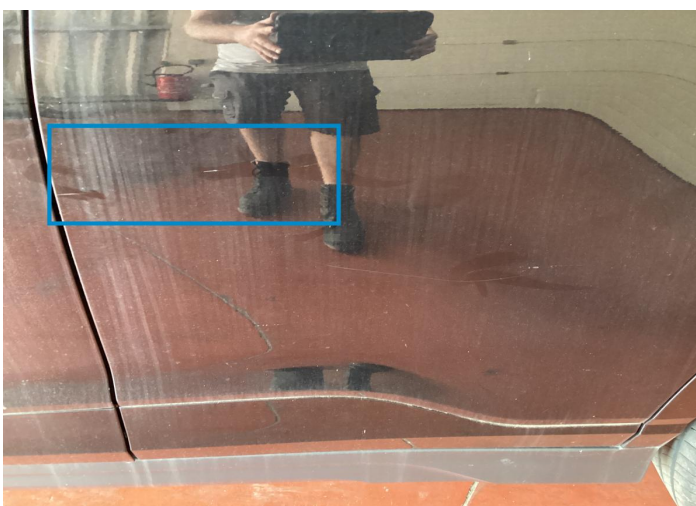
4. Door / Back Left
Paint / Scratch / Line -

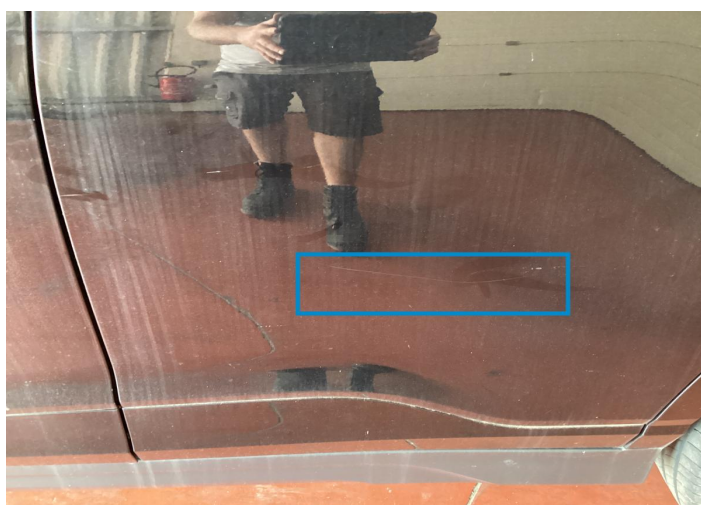
5. Door / Back Left
Paint / Scratch / Line -

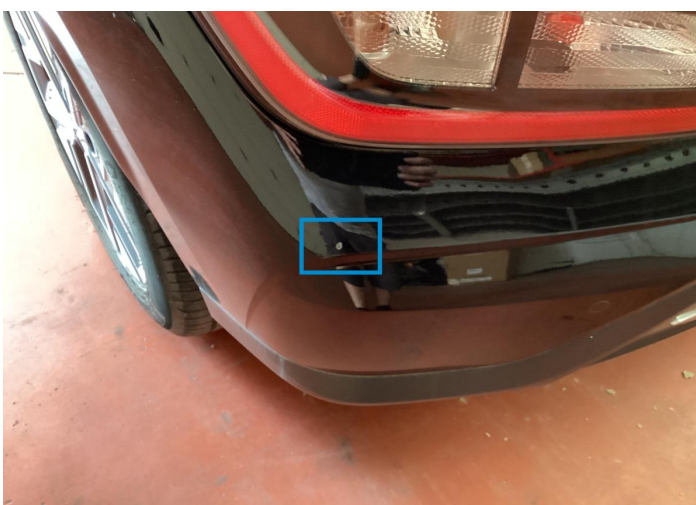
6. Corner Bumper / Back Left
Paint / Chipping -

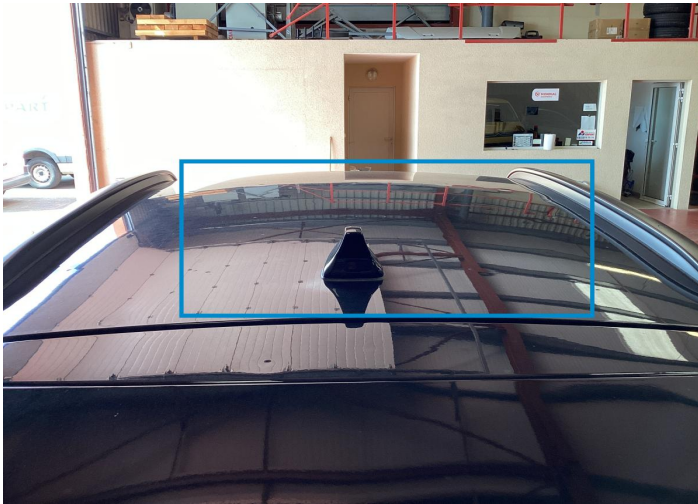
7. Roof
Bodywork / Dent / Hail Area -

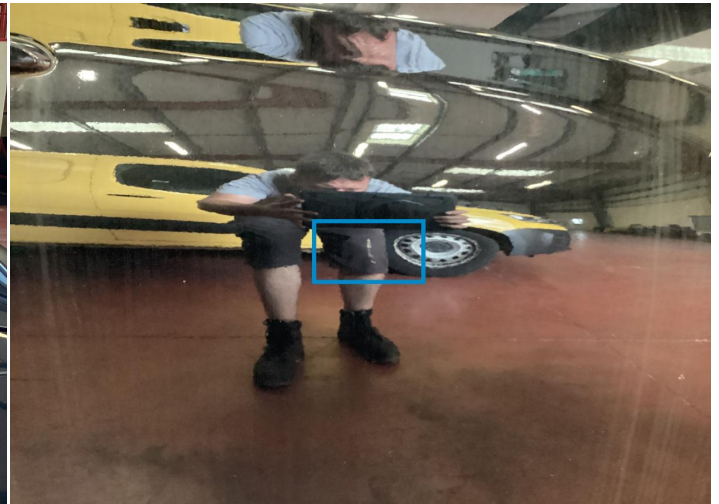
8. Door / Front Right
Paint / Scratch / Line -
