## Inspection Report

| Registration Number | WFX28D | Mechanical Grade | A |

#### Nissan Leaf Acenta 40 kWh - 2020

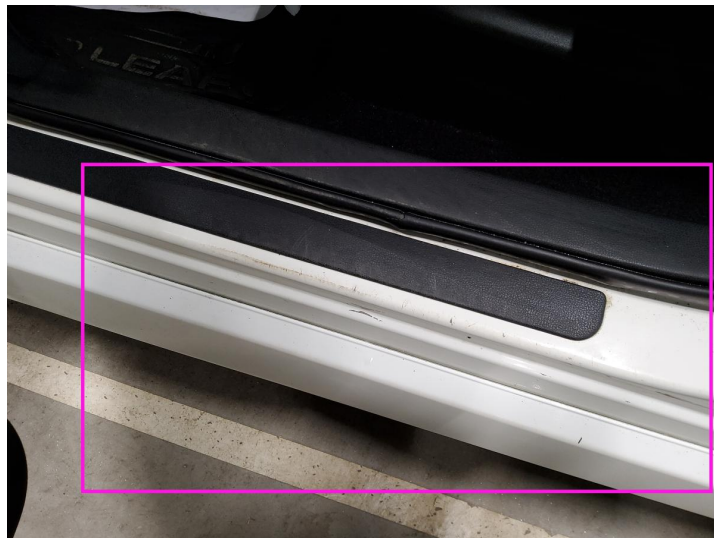
| Component | Damage |
|---|---|
| 2 Door Step / Front Left | Interior / Scratched |

2. Door Step / Front Left  
Interior / Scratched

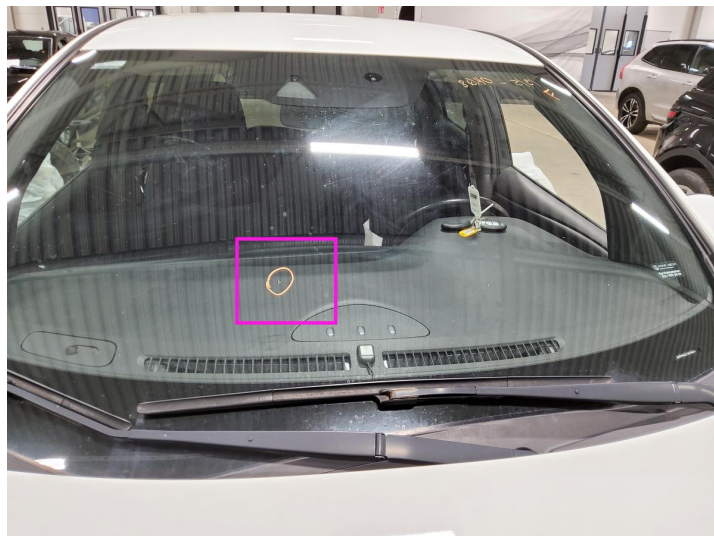
| Component | Damage |
|---|---|
| 3 Windshield / Front | Paint / Chipping |

3. Windshield / Front  
Paint / Chipping

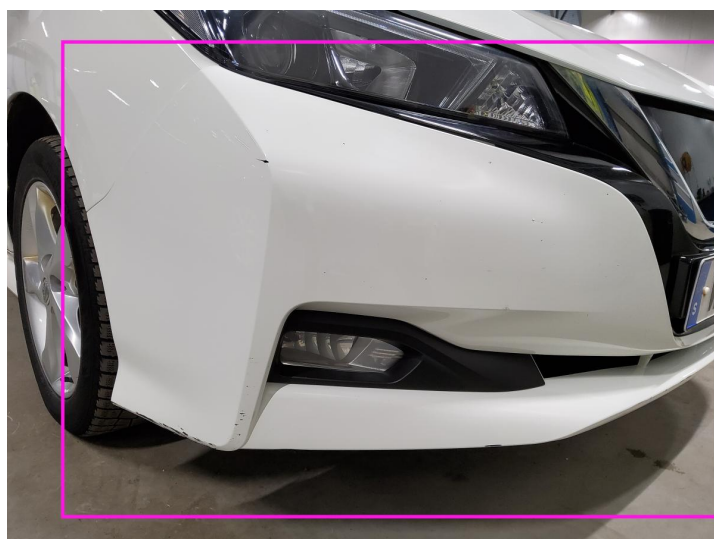
| Component | Damage |
|---|---|
| 4 Shield / Front | Paint / Scratch / Scuff |

4. Shield / Front  
Paint / Scratch / Scuff

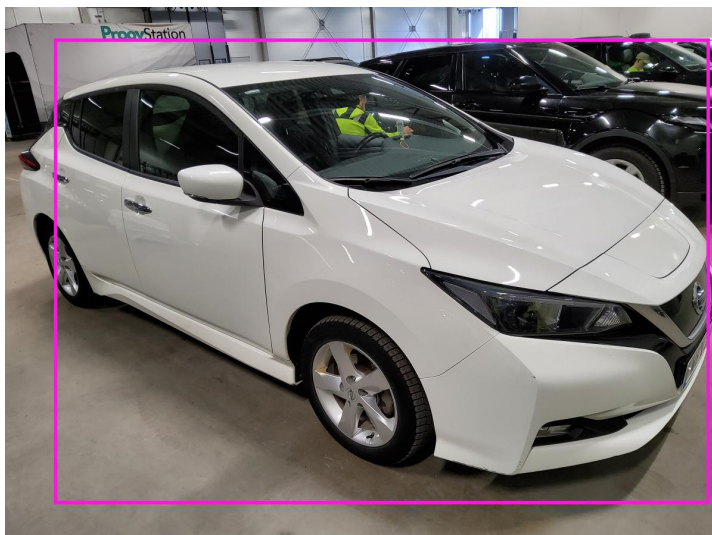
5. Färgskillnad på flera paneler, märken efter dekaler/color difference on several panels,marks after stickers

| Component | Damage |
|---|---|
| 5 Färgskillnad på flera paneler, märken efter dekalers/color difference on several panels,marks after stickers | Paint / Poor Previous Repair |

Paint / Poor Previous Repair

Färgskillnad på flera paneler, märken efter dekaler/color difference on several panels,marks after stickers

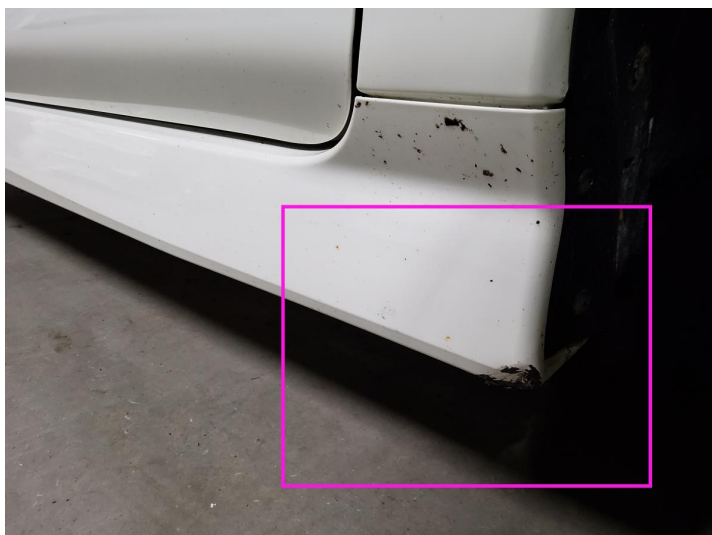
6. Rocker Panel / Center Right

| Component | Damage |
|---|---|
| 6 Rocker Panel / Center Right | Bodywork / Dent / Dent |

Bodywork / Dent / Dent

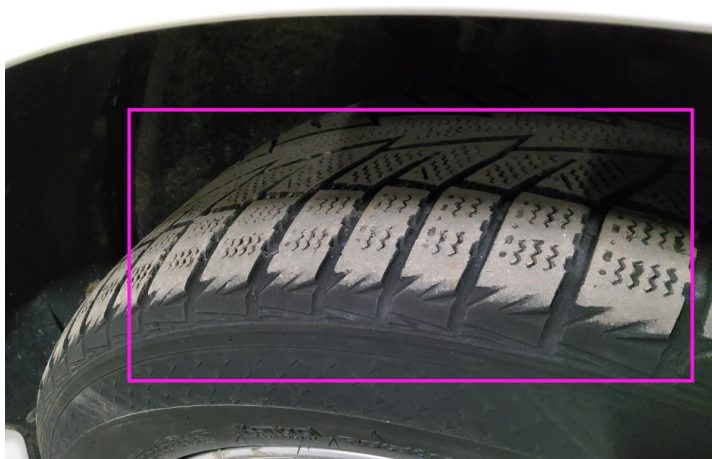
7. Set of 4 Winter Wheels

| Component | Damage |
|---|---|
| 7 Set of 4 Winter Wheels | Bodywork / Dent / Deformation |

Bodywork / Dent / Deformation

Snedslitna vinterdäck /uneven worn winter tires

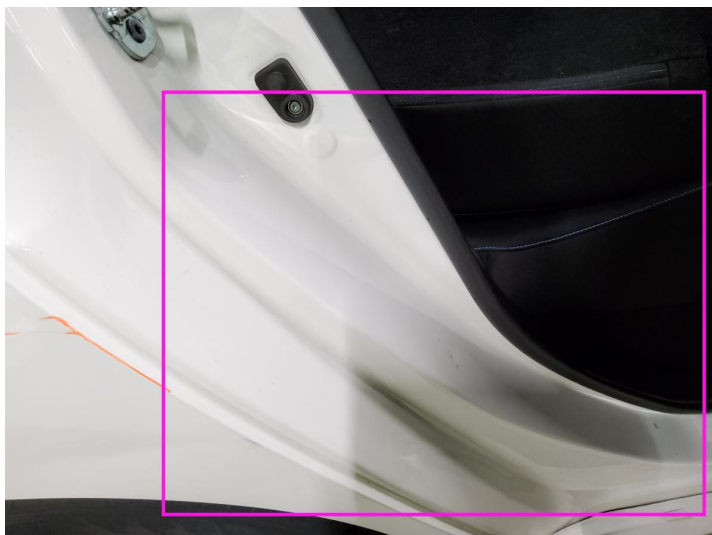
8. Pillar / Back Right

| Component | Damage |
|---|---|
| 8 Pillar / Back Right | Bodywork / Dent / Dent |

Bodywork / Dent / Dent

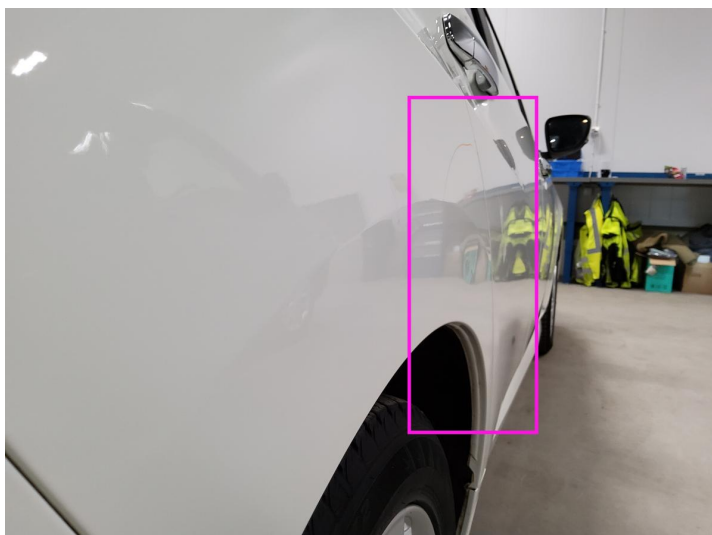
9. Fender / Back Right

| Component | Damage |
|---|---|
| 9 Fender / Back Right | Bodywork / Dent / Dent |

Bodywork / Dent / Dent

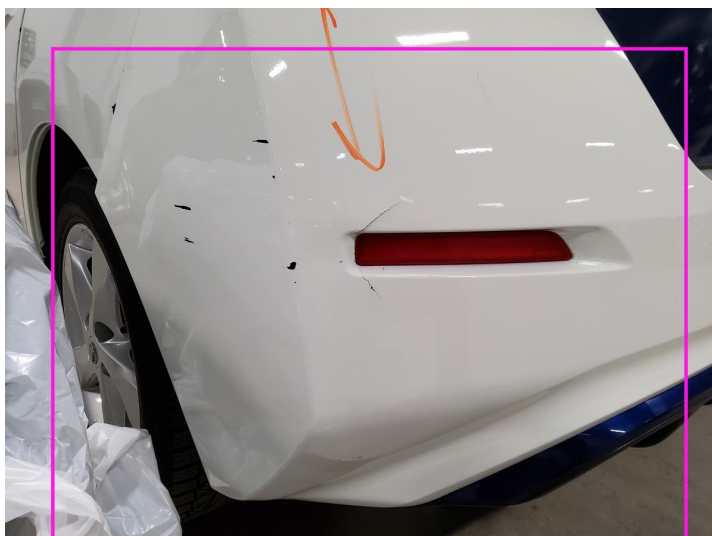
10. Shield / Back

| Component | Damage |
|---|---|
| 10 Shield / Back | Bodywork / Breakage / Crack |

Bodywork / Breakage / Crack

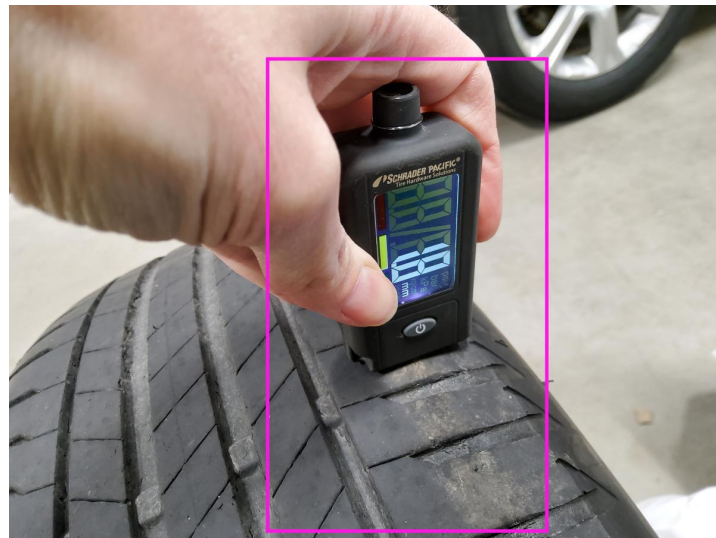
11. Tire / Front Left

Tire

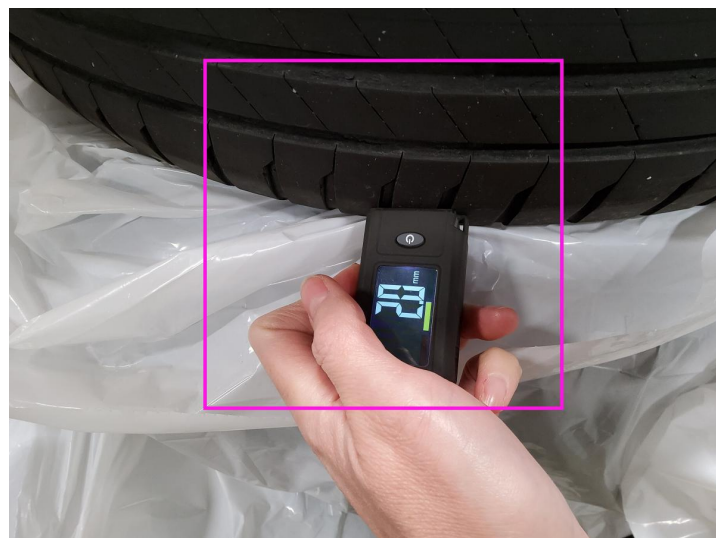
12. Tire / Front Right

Tire

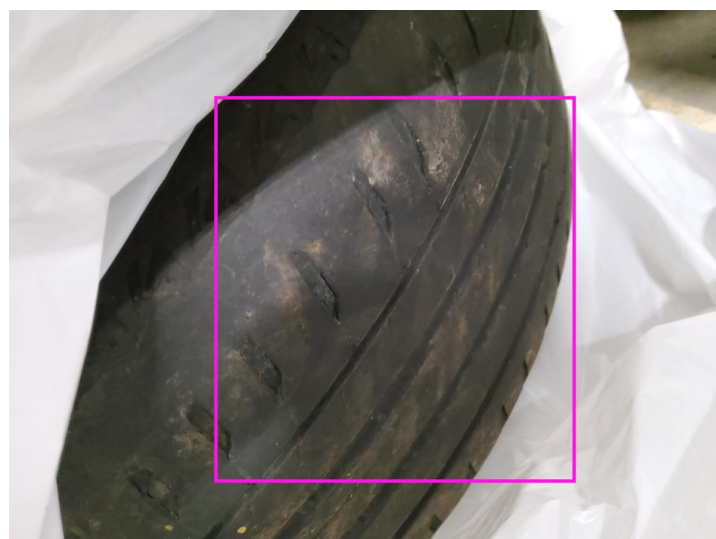
13. Tire / Back Left

Tire

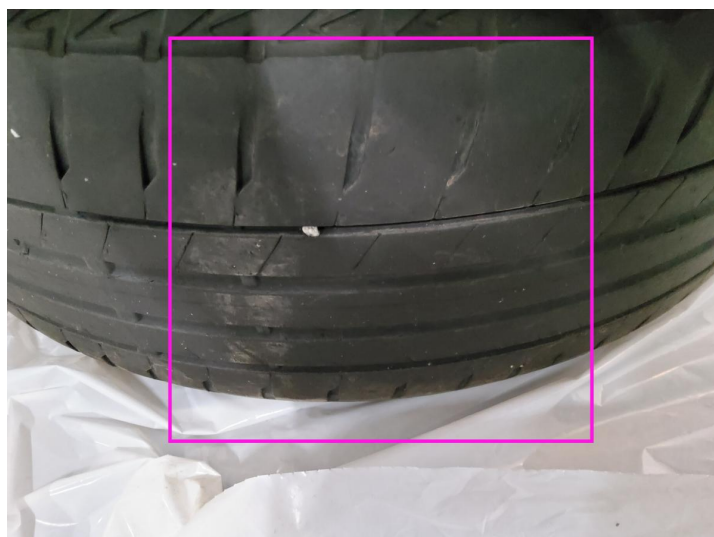
14. Tire / Back Right

Tire

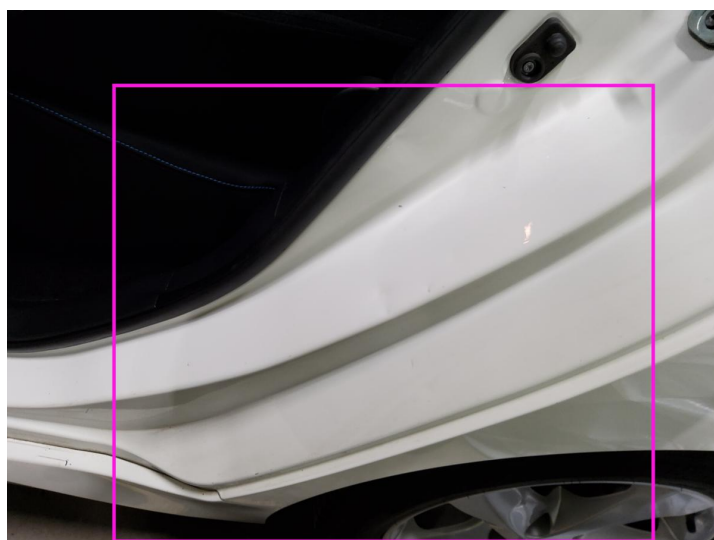
15. Pillar / Back Left

| Component | Damage |
|---|---|
| 15 Pillar / Back Left | Bodywork / Dent / Dent |

Bodywork / Dent / Dent

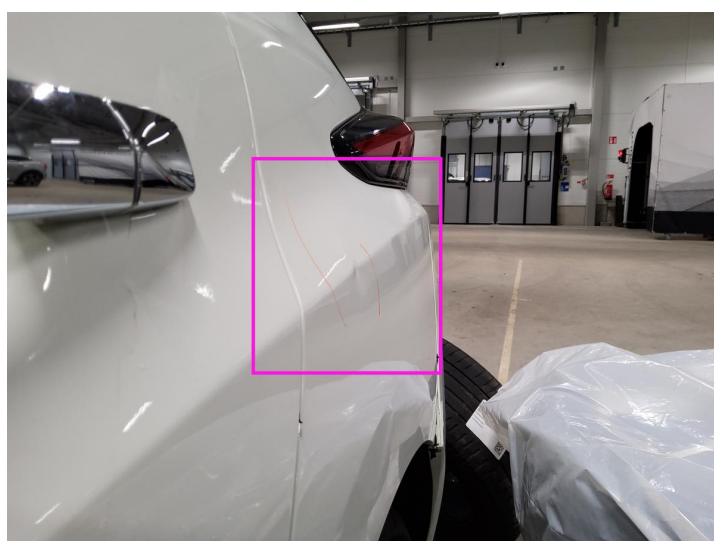
16. Fender / Back Left

| Component | Damage |
|---|---|
| 16 Fender / Back Left | Bodywork / Dent / Dent |

Bodywork / Dent / Dent

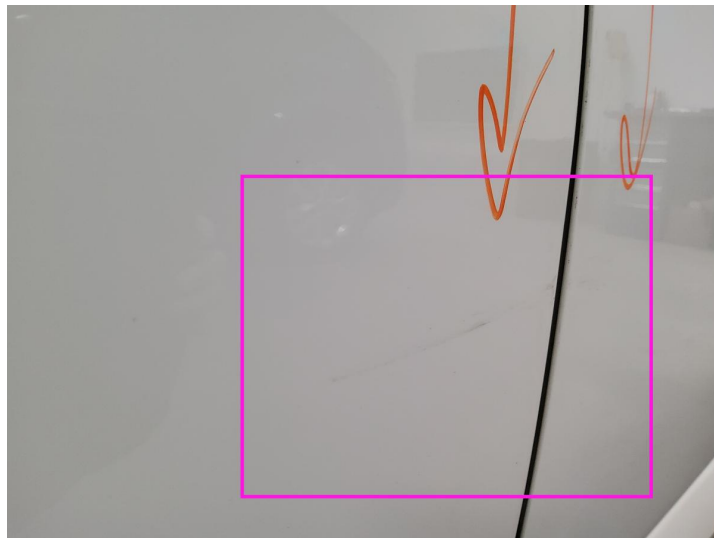
17. Door / Back Right

| Component | Damage |
|---|---|
| 17 Door / Back Right | Paint / Scratch / Scuff |

Paint / Scratch / Scuff

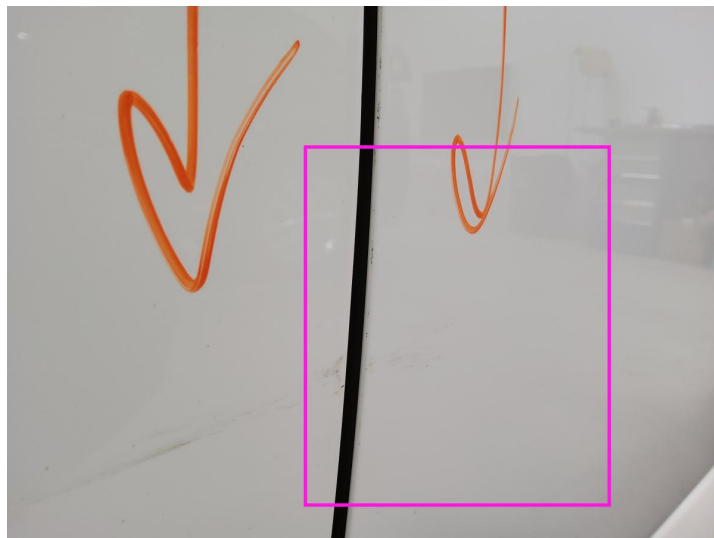
18. Door / Front Right

| Component | Damage |
|---|---|
| 18 Door / Front Right | Paint / Scratch / Scuff |

Paint / Scratch / Scuff

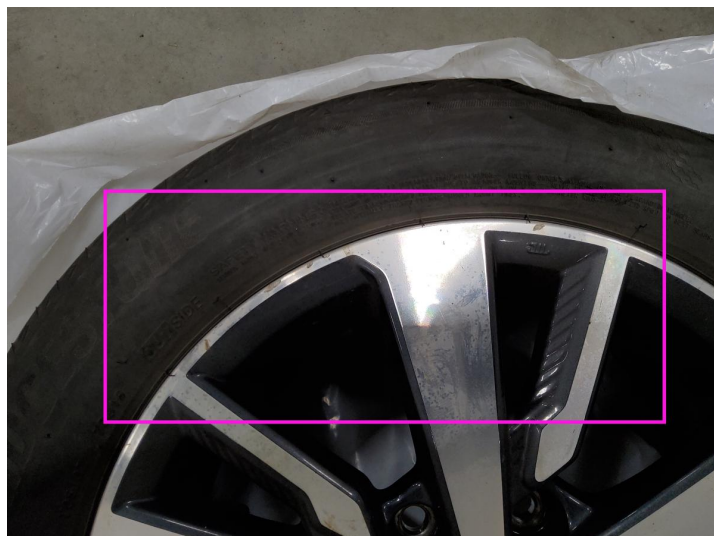
19. Rim / Back Left

| Component | Damage |
|---|---|
| 19 Rim / Back Left | Out of Bodywork / Scratch |

Out of Bodywork / Scratch

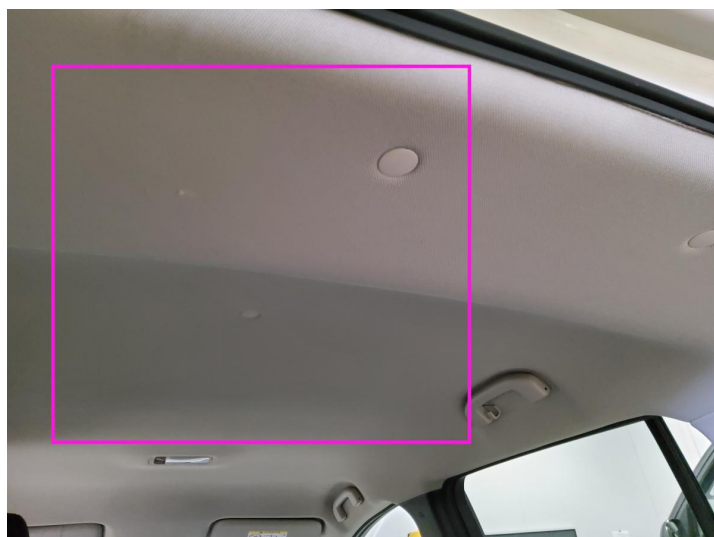
| Component | Damage |
|---|---|
| 20 Roof Upholstery | Interior / Scratched |

20. Roof Upholstery  
Interior / Scratched
