## Vehicle Inspection Report

126059731 - 0

| Model | KANGOO Z.E. (FW) (13-22) |
| Plate number | 5738LCJ |

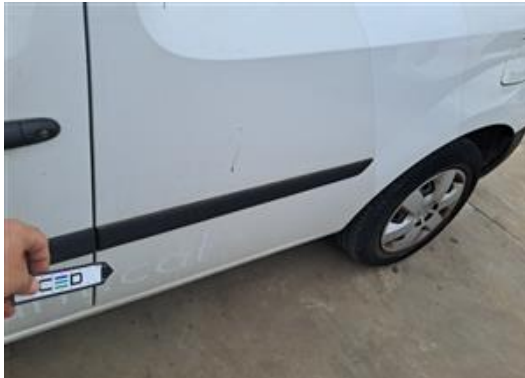
Daño Exterior

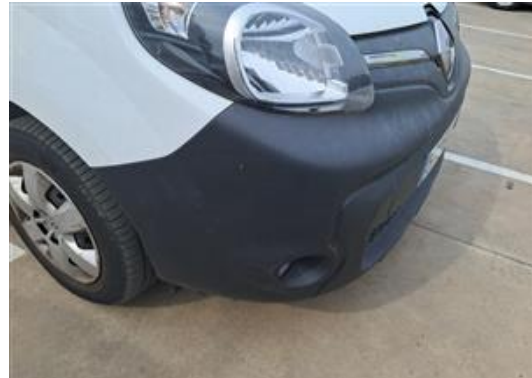
Daño Exterior

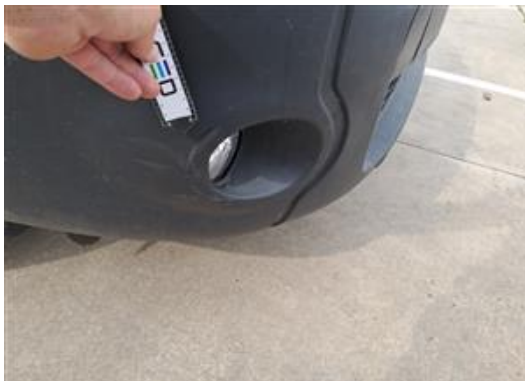
Daño Exterior

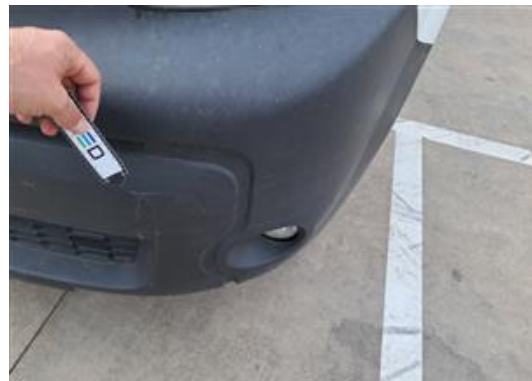
Daño Exterior

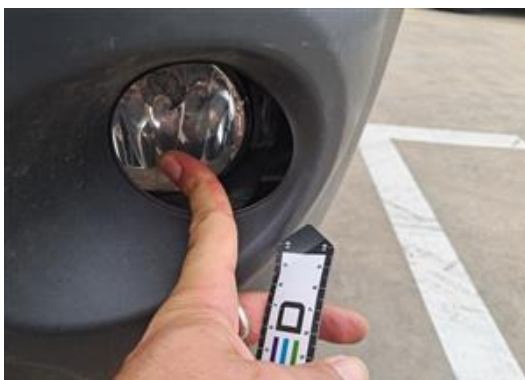
Daño Exterior

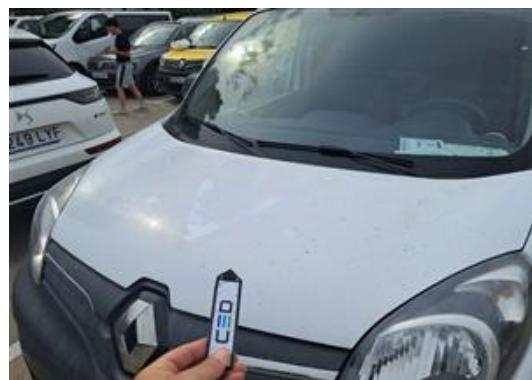
Daño Exterior

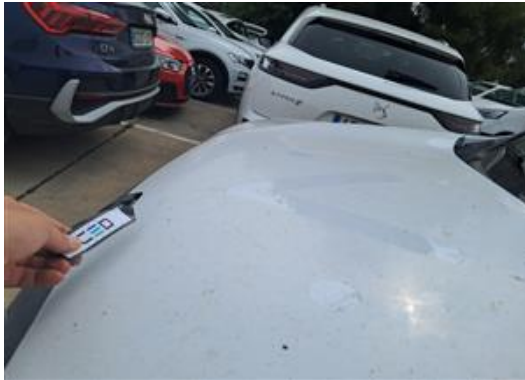
Daño Exterior

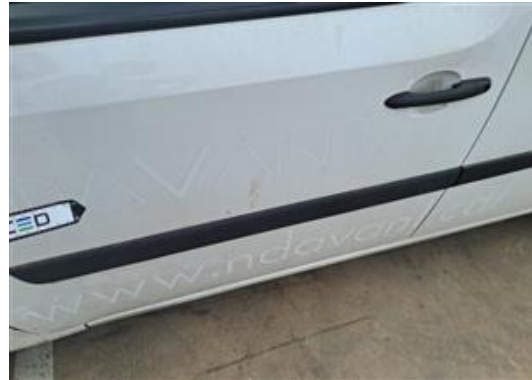
Daño Exterior

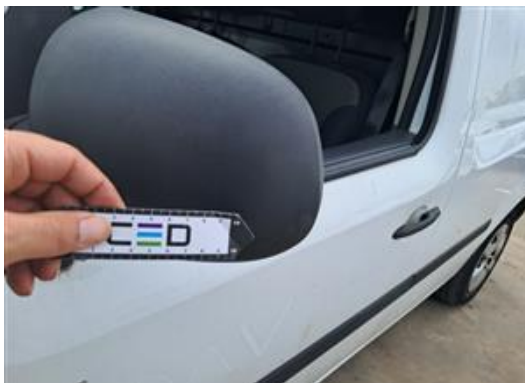
Daño Exterior

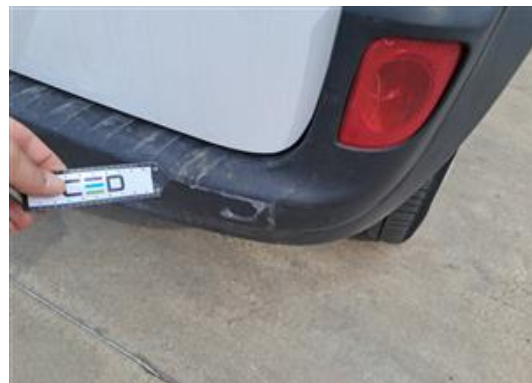
Daño Exterior

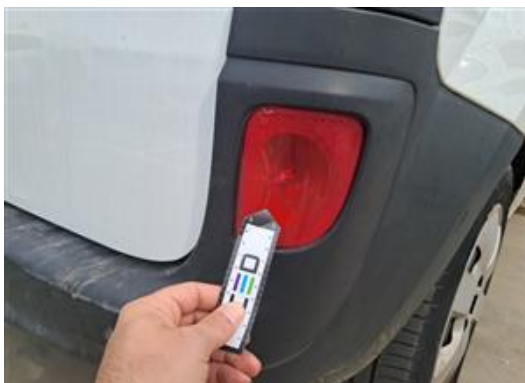
Daño Exterior

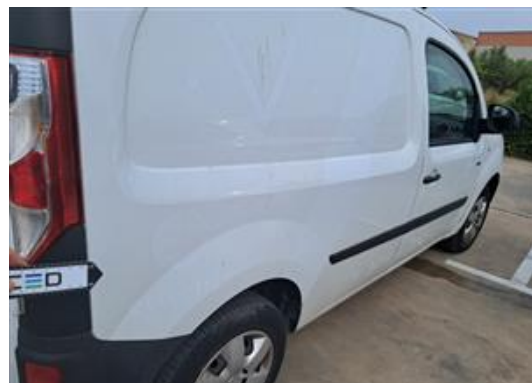
Daño Exterior

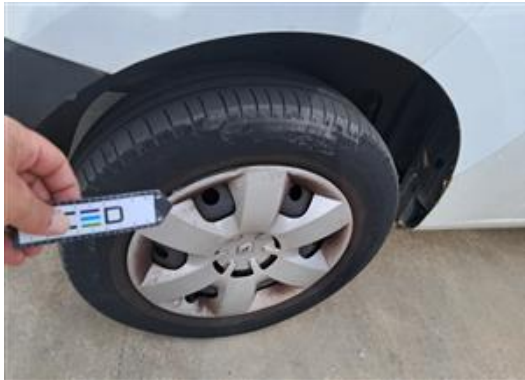
Daño Exterior

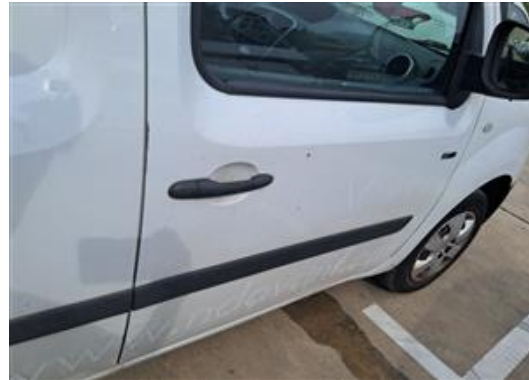
Daño Exterior

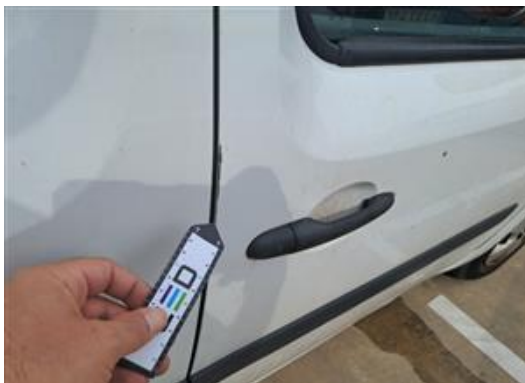
Daño Exterior

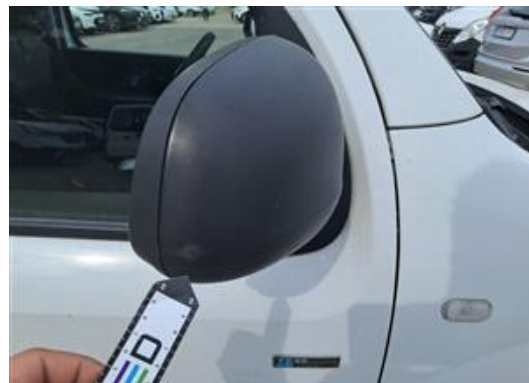
Daño Exterior

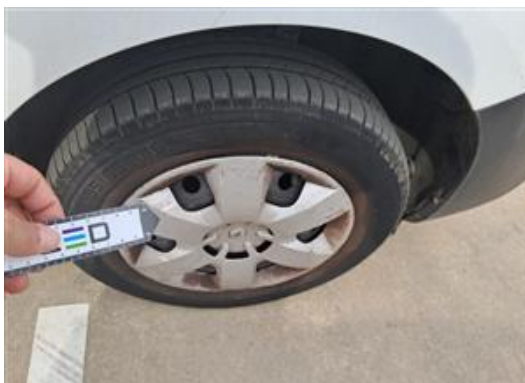
Daño Exterior

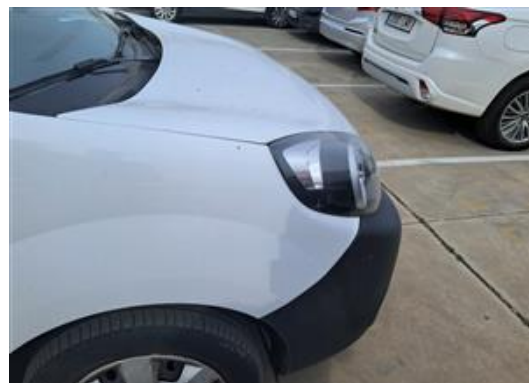
Daño Exterior

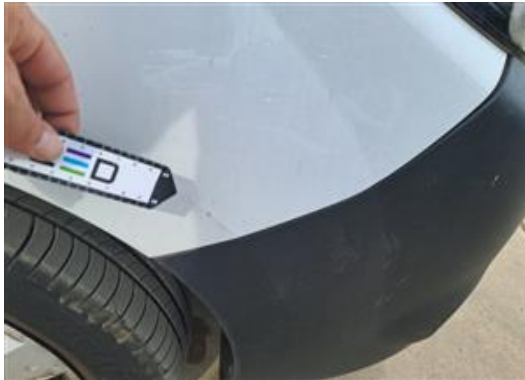
Daño Exterior

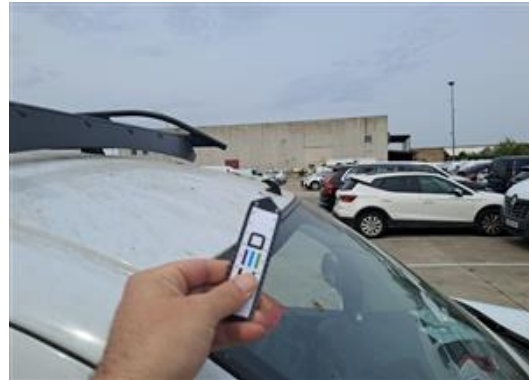
Daño Exterior

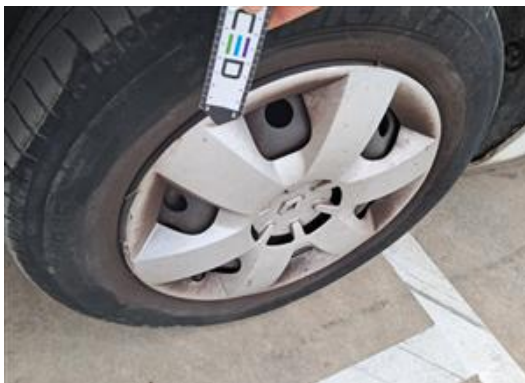
Daño Exterior

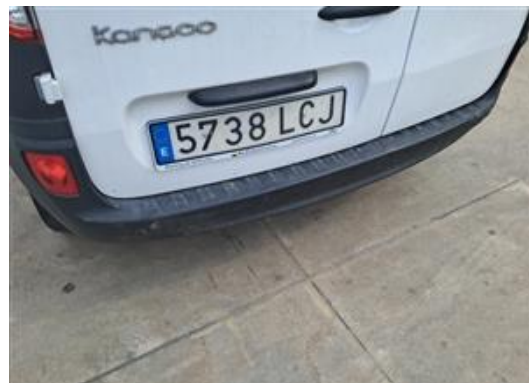
Daño Exterior

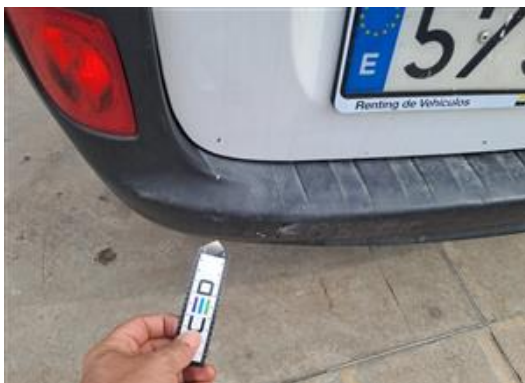
Daño Exterior

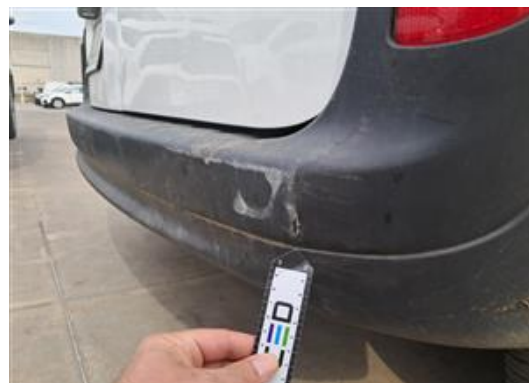
Daño Exterior

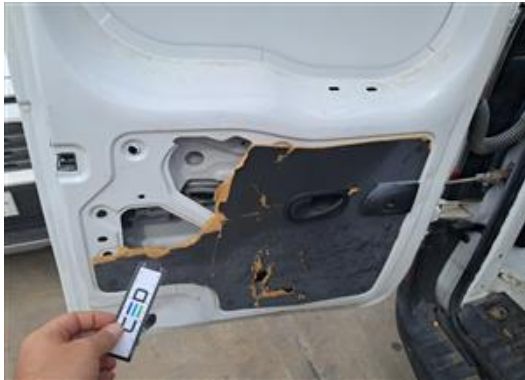
Daño Interior

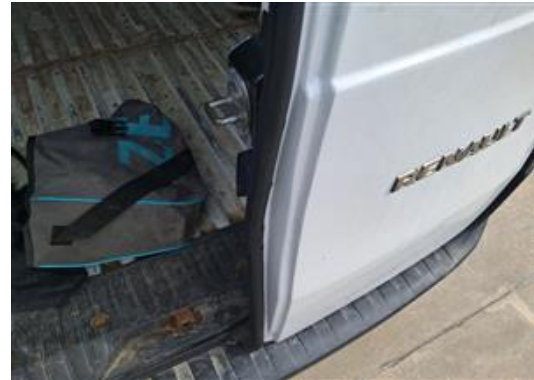
Daño Interior

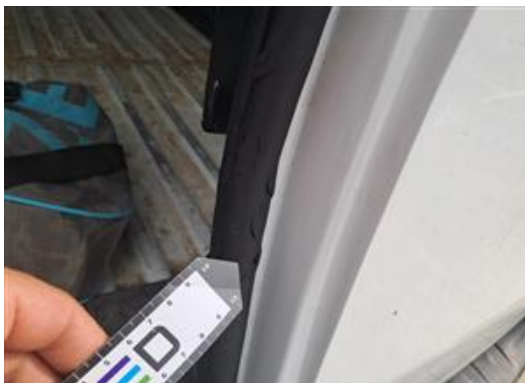
Daño Interior

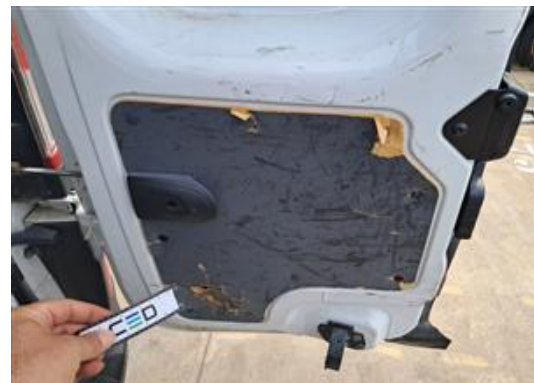
Daño Interior

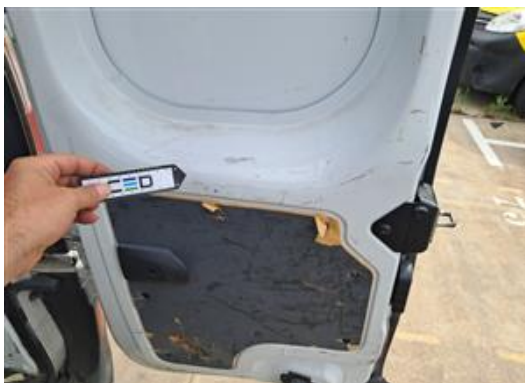
Daño Interior

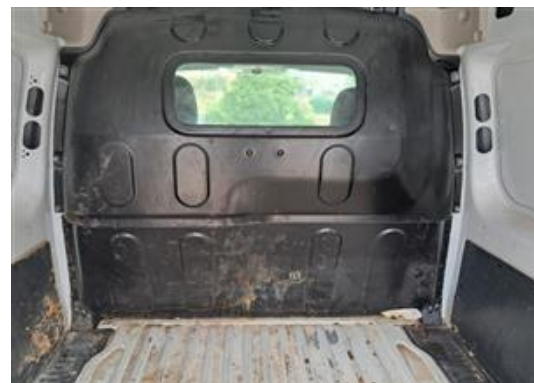
Daño Interior

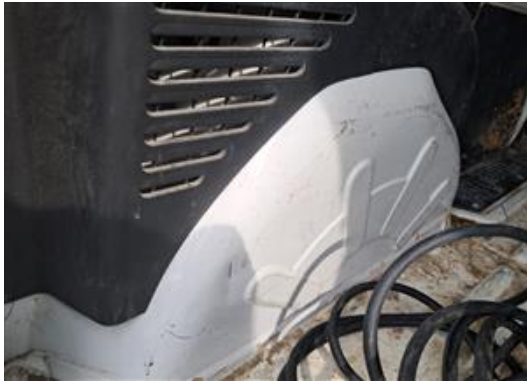
Daño Interior

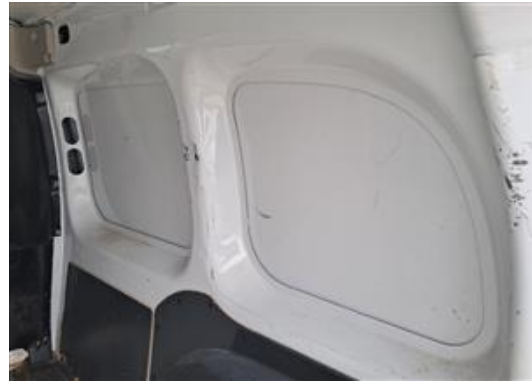
Daño Interior

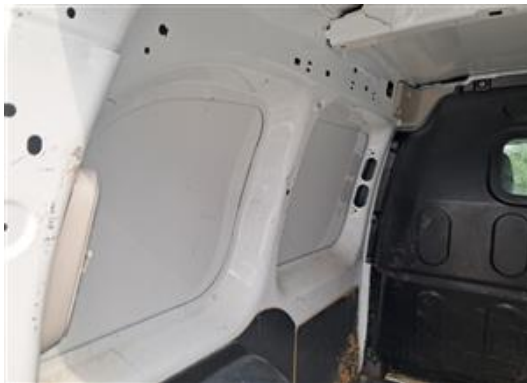
Daño Interior

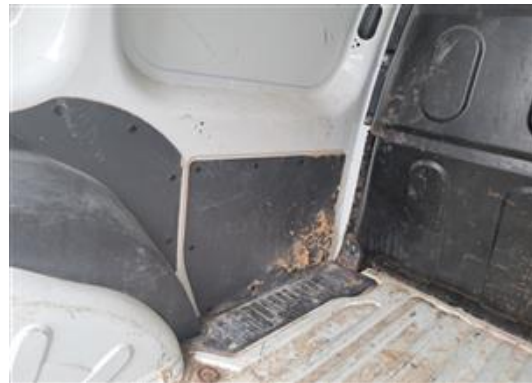
Daño Interior

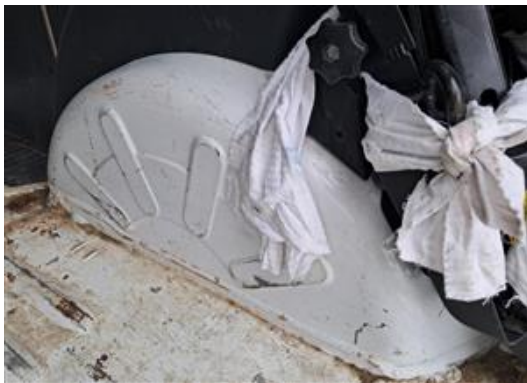
Daño Interior

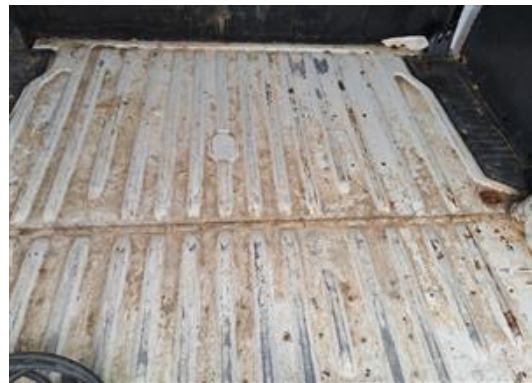
Daño Interior

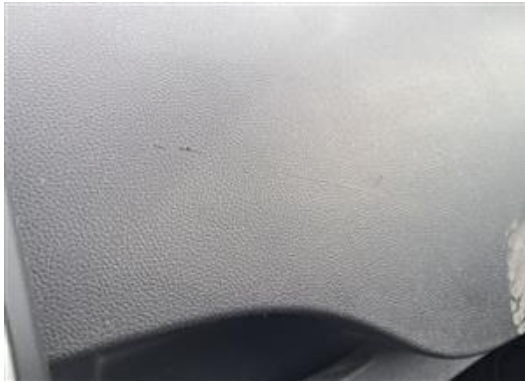
Daño Interior

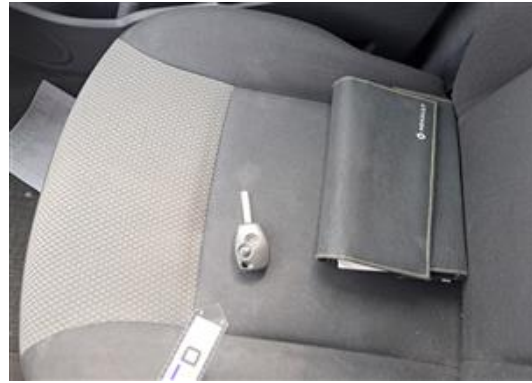
Faltante
