RENAULT GRAND SCENIC  
Grand Scénic dCi 110 Energy FAP eco2  
Bose Edition 7 pl

VIN NO VF1JZ89BH54546492  
Registration Number EA861YV

Inspection Report Summary

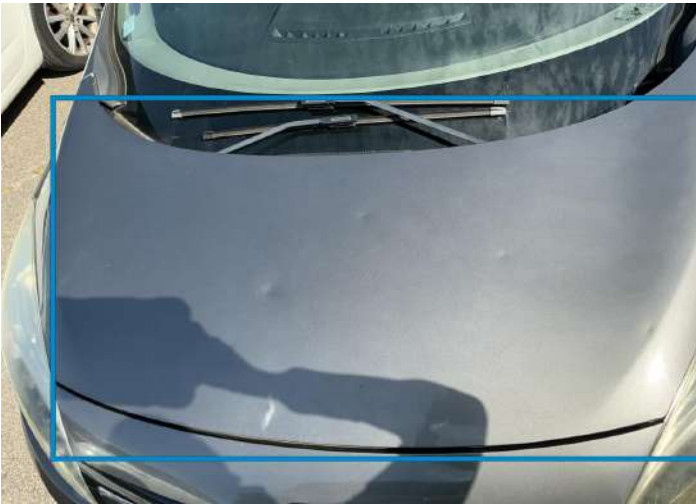
| Component | | Damage | Comments |
|---|---|---|---|
| 1 | Hood | Bodywork / Dent / Hail Area | |

1. Hood  
Bodywork / Dent / Hail Area -

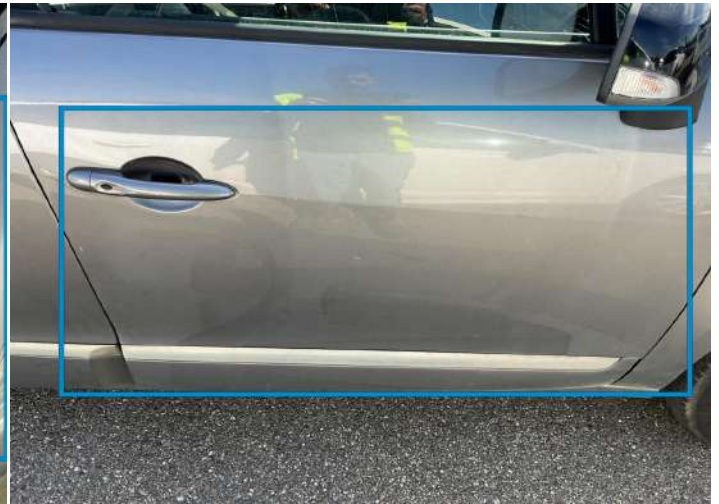
| Component | | Damage | Comments |
|---|---|---|---|
| 2 | Door / Front Right | Paint / Scratch / Line | |

2. Door / Front Right  
Paint / Scratch / Line -

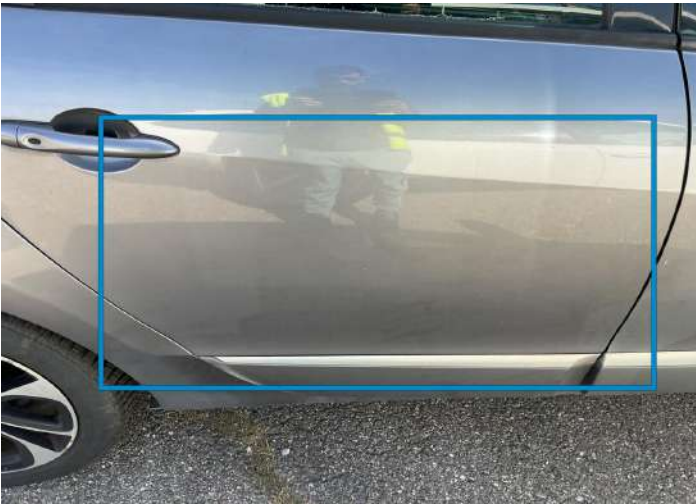
| Component | | Damage | Comments |
|---|---|---|---|
| 3 | Door / Back Right | Paint / Scratch / Line | |

3. Door / Back Right  
Paint / Scratch / Line -

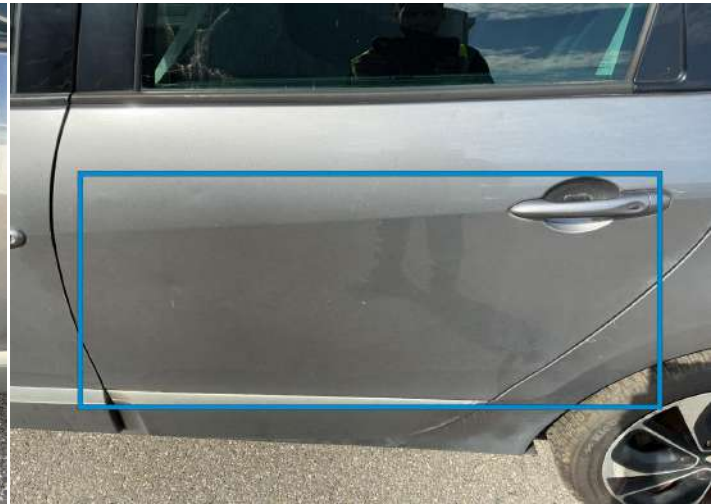
| Component | | Damage | Comments |
|---|---|---|---|
| 4 | Door / Back Left | Bodywork / Dent / Hail Area | |

4. Door / Back Left  
Bodywork / Dent / Hail Area -

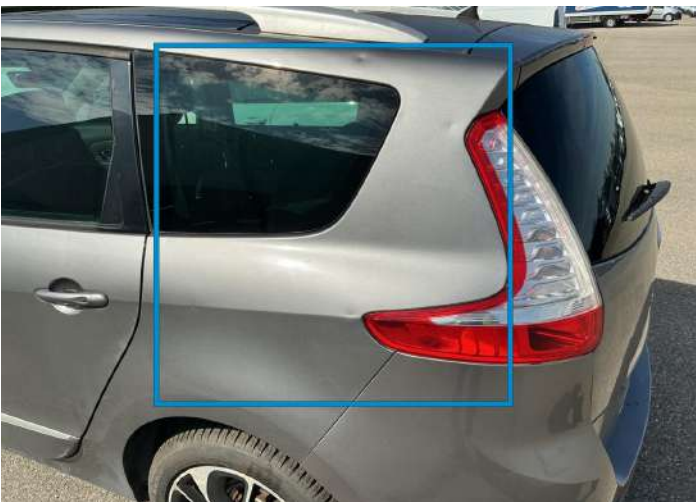
| Component | | Damage | Comments |
|---|---|---|---|
| 5 | Fender / Back Left | Bodywork / Dent / Hail Area | |

5. Fender / Back Left  
Bodywork / Dent / Hail Area -

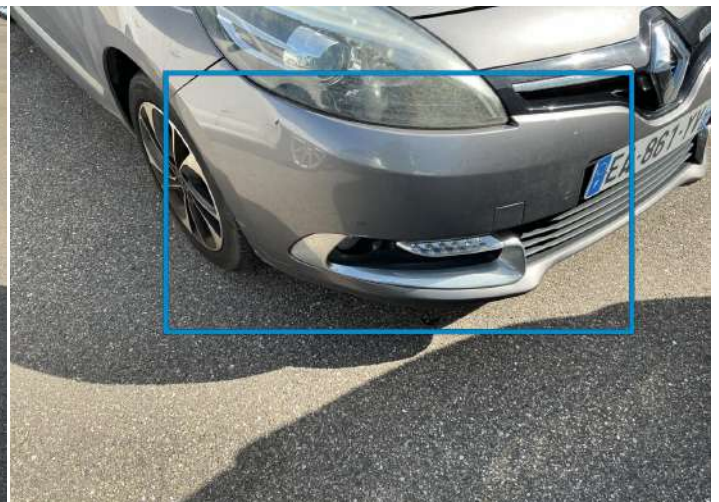
| Component | | Damage | Comments |
|---|---|---|---|
| 6 | Corner Bumper / Front Right | Paint / Scratch / Line | |

6. Corner Bumper / Front Right  
Paint / Scratch / Line -

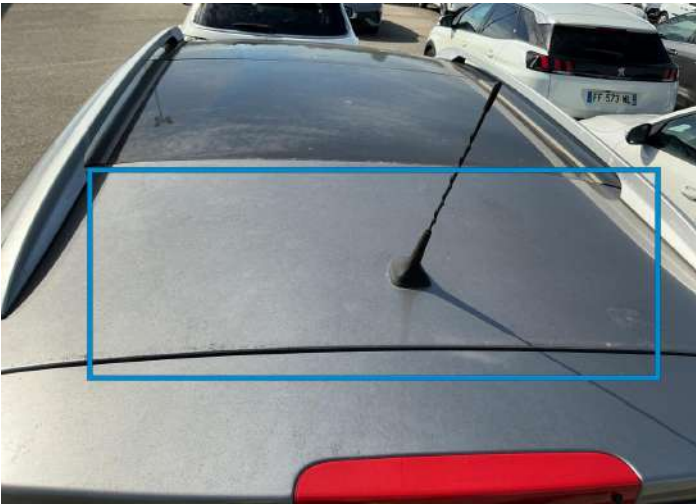
| Component | | Damage | Comments |
|---|---|---|---|
| 7 | Roof | Bodywork / Dent / Hail Area | |

7. Roof  
Bodywork / Dent / Hail Area -

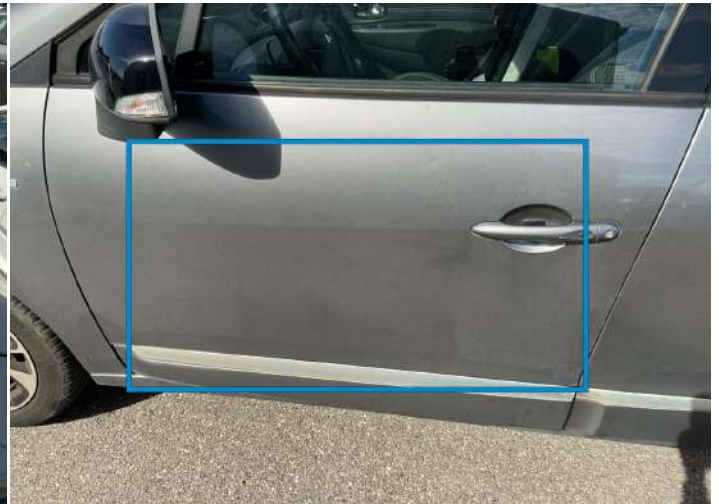
| Component | | Damage | Comments |
|---|---|---|---|
| 8 | Door / Front Left | Bodywork / Dent / Hail Area | |

8. Door / Front Left  
Bodywork / Dent / Hail Area -

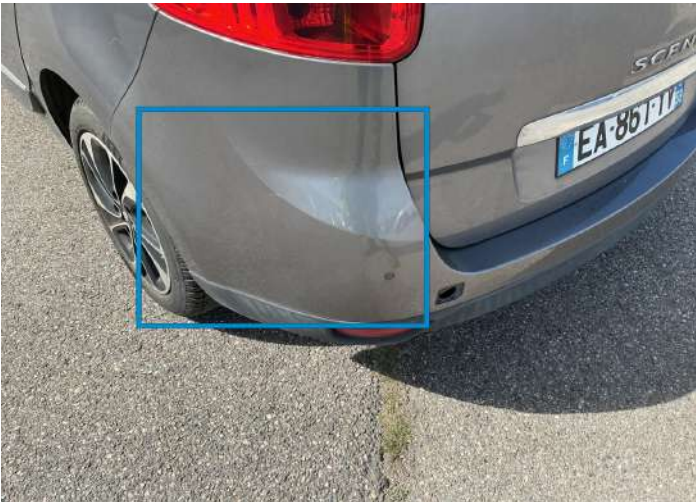
| Component | | Damage | Comments |
|---|---|---|---|
| 9 | Exhaust / Left | Paint / Scratch / Line | |

9. Exhaust / Left  
Paint / Scratch / Line -

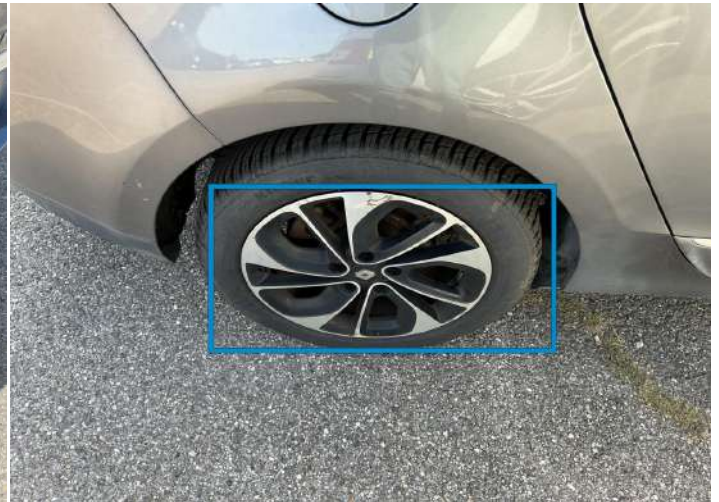
| Component | | Damage | Comments |
|---|---|---|---|
| 10 | Rim / Back Right | Out of Bodywork / Scratch | |

10. Rim / Back Right  
Out of Bodywork / Scratch -

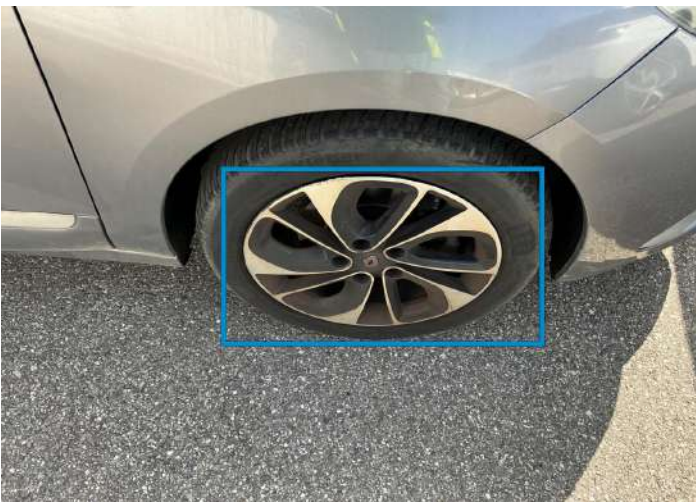
| Component | | Damage | Comments |
|---|---|---|---|
| 11 | Rim / Front Right | Out of Bodywork / Scratch | |

11. Rim / Front Right  
Out of Bodywork / Scratch -

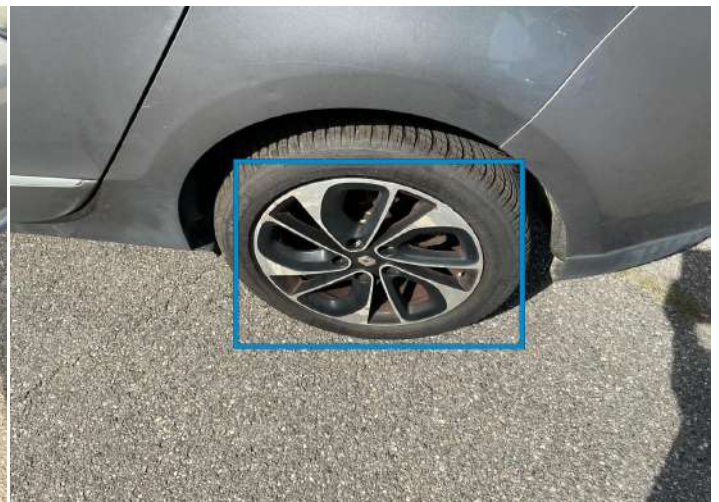
| 12 | Rim / Back Left | Out of Bodywork / Scratch |

12. Rim / Back Left  
Out of Bodywork / Scratch -

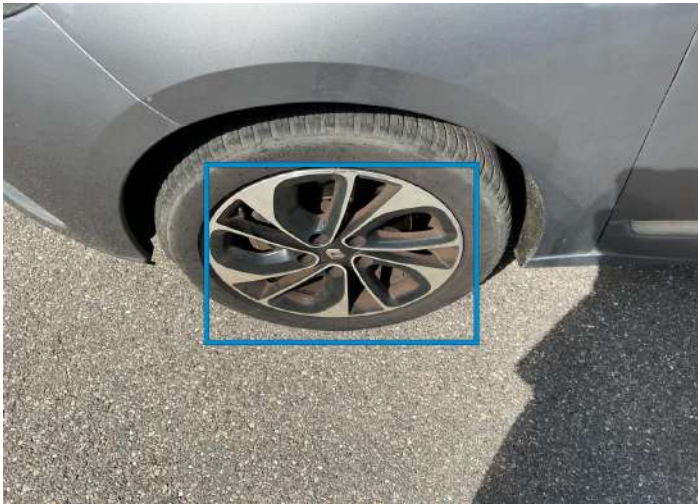
| 13 | Rim / Front Left | Out of Bodywork / Scratch |

13. Rim / Front Left  
Out of Bodywork / Scratch -

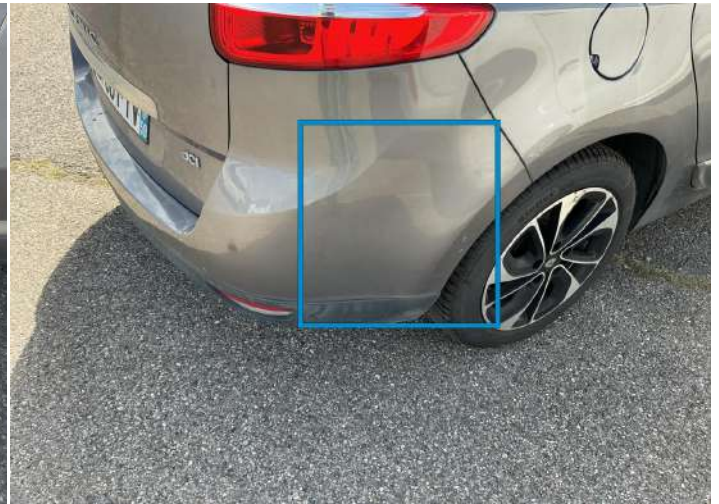
| 14 | Corner Bumper / Back Right | Paint / Scratch / Line |

14. Corner Bumper / Back Right  
Paint / Scratch / Line -

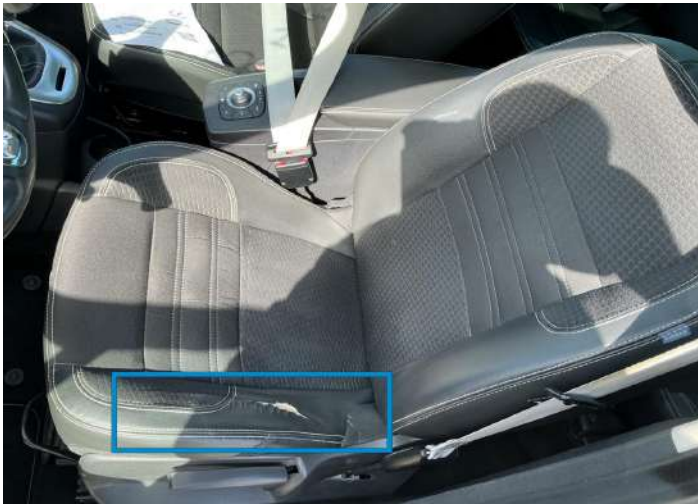
| 15 | Seat / Front Left | Interior / Ripped |

15. Seat / Front Left  
Interior / Ripped -

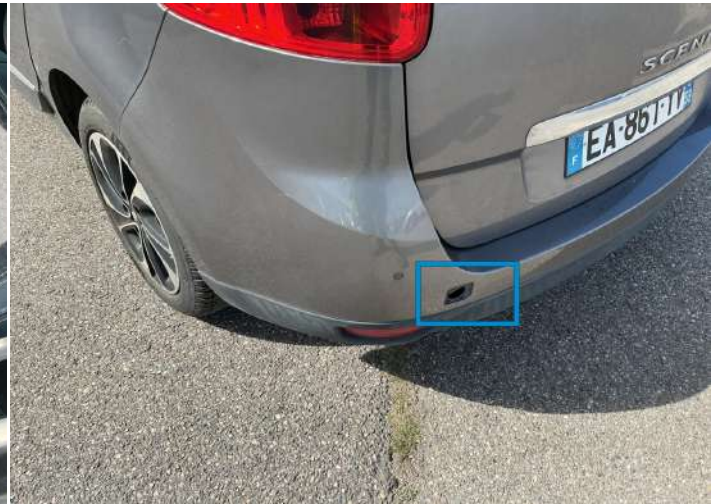
| 16 | Exhaust / Left | Missing Part |

16. Exhaust / Left  
Missing Part -

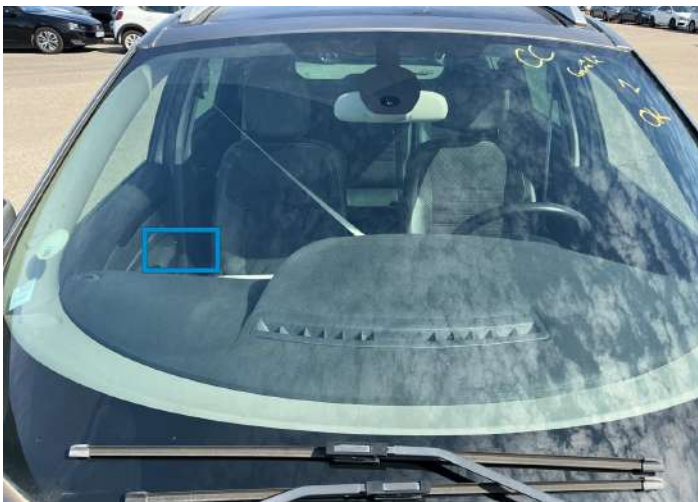
| 17 | Windshield / Front | Glass Break / Impact |

17. Windshield / Front  
Glass Break / Impact -

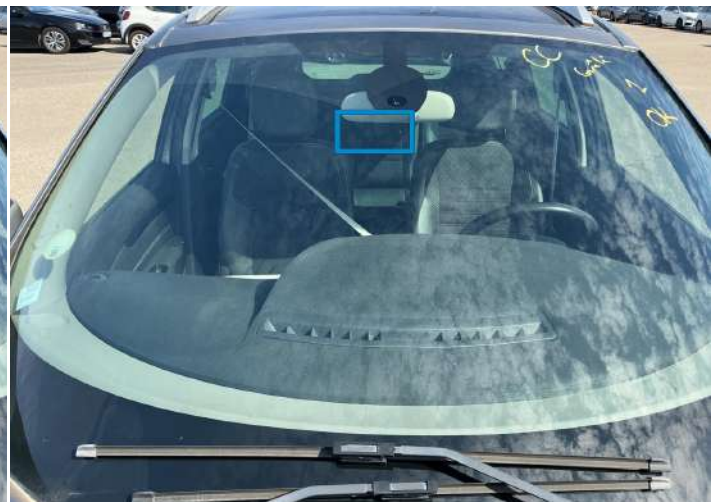
| 18 | Windshield / Front | Glass Break / Impact |

18. Windshield / Front  
Glass Break / Impact -
