## Inspection Report

#### Nissan Leaf Leaf Acenta 40 kWh - 2020

Vehicle Identification Number	SJNFAAZE1U0100555	Odometer Reading	70306 km
First Registration / Construction Year	2020-07-31 / 2020-07-01	Inspection Date / Place	2025-05-15 / Strängnäs
Fuel Type	Battery Electric Vehicle	Gearbox Type	Automatic
Colour	White	Number of Keys	2
Service Book Available	Missing	Service History	
Last Service Km / Date	- / -	Arrival Date	2025-05-13

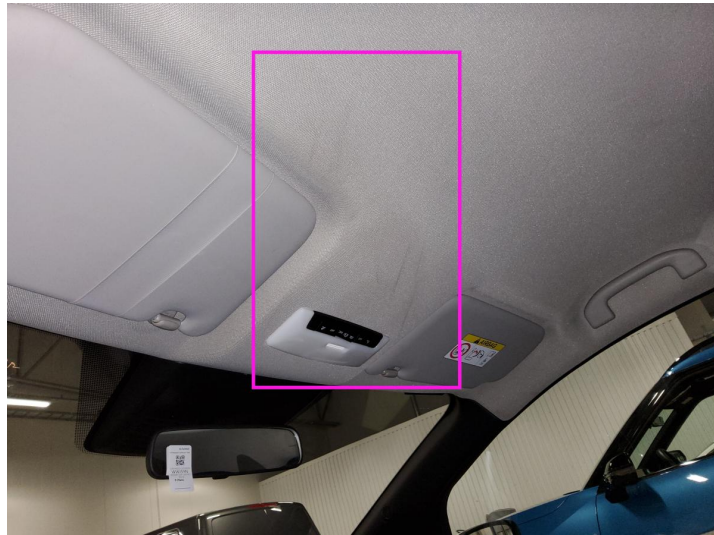
1. Roof Upholstery  
Interior / Dirty

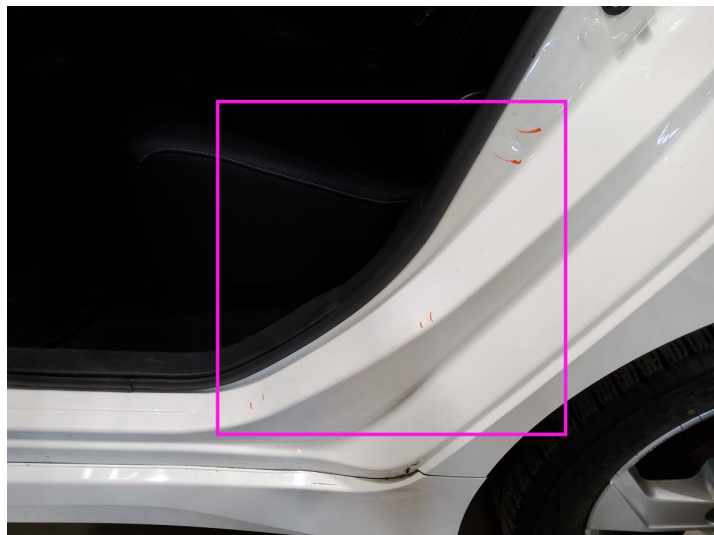
2. Door Step / Back Left  
Interior / Dented

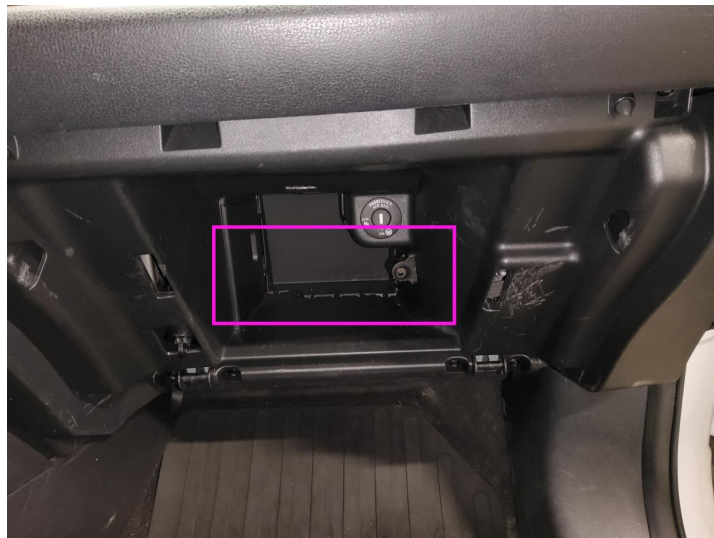
3. Service Book  
Interior / Missing

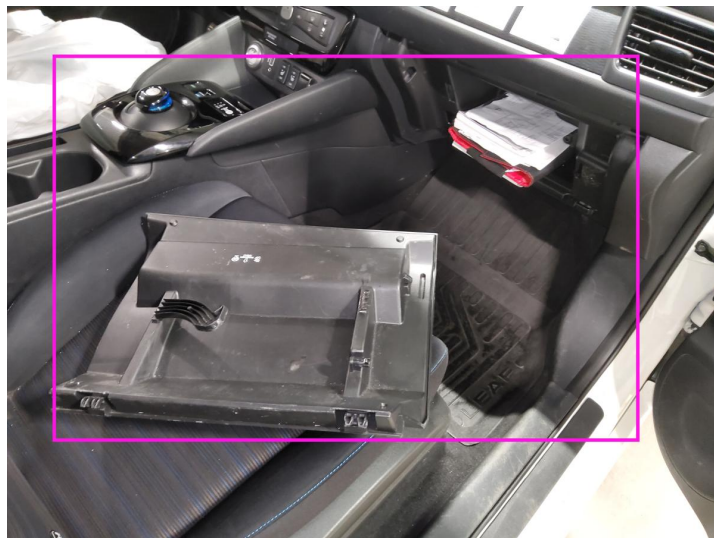
4. Glovebox  
Interior / Loose

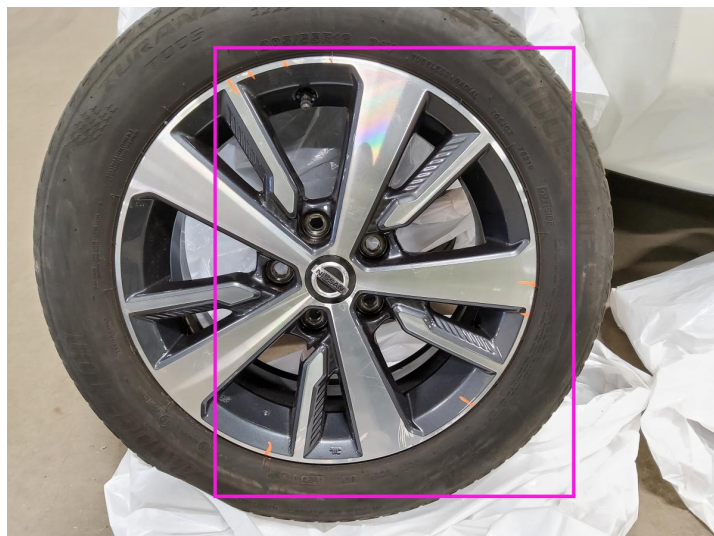
5. Rim / Front Left  
Out of Bodywork / Scratch

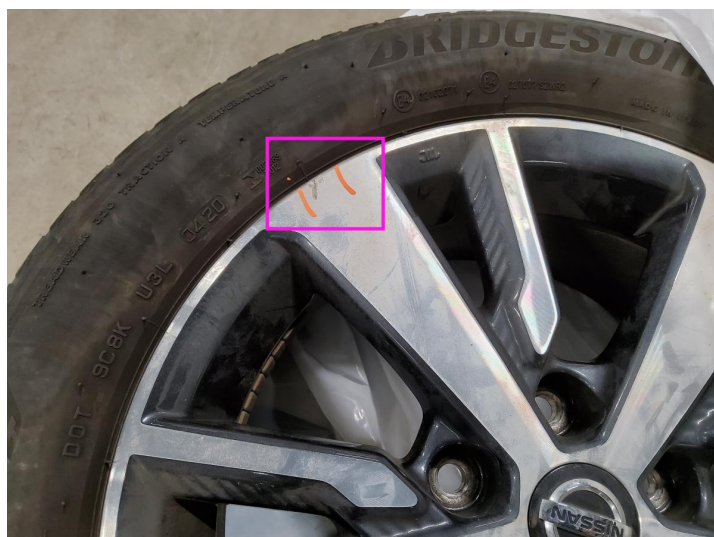
6. Rim / Front Right

Out of Bodywork / Scratch

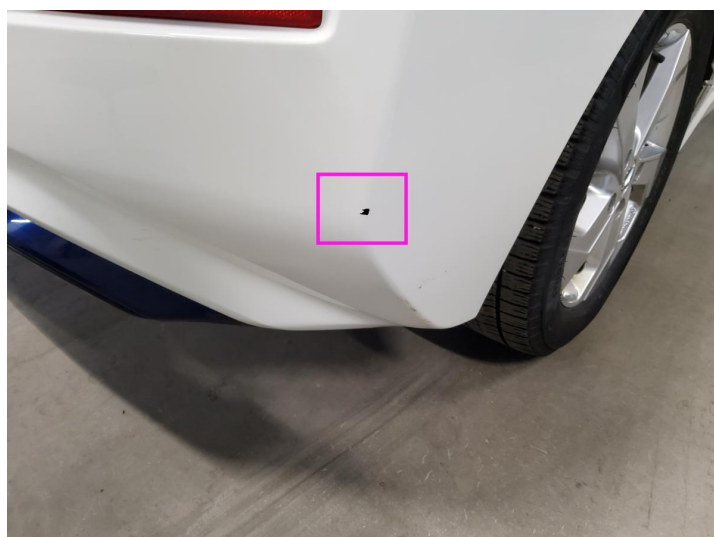
7. Shield / Back

Paint / Scratch / Line

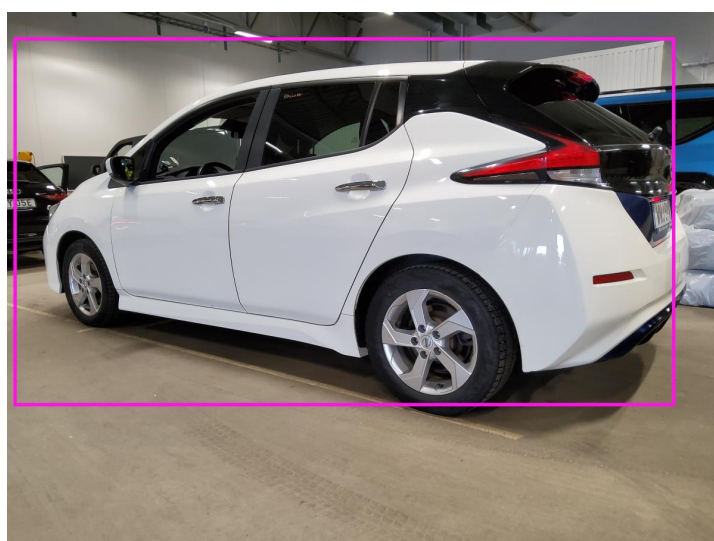
8.

Paint / Poor Previous Repair

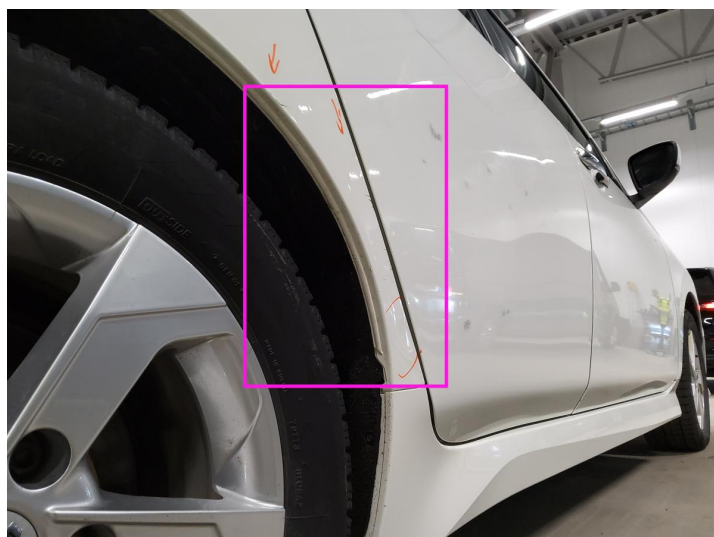
9. Fender / Back Right

Bodywork / Dent / Dent

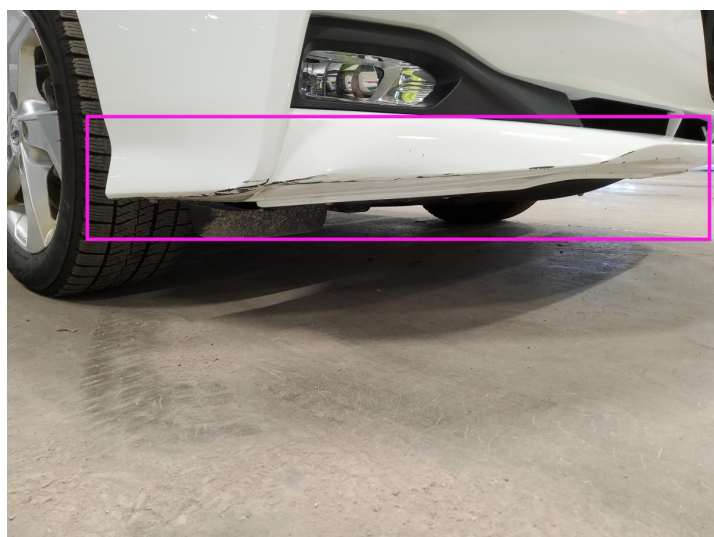
10. Shield / Front

Paint / Scratch / Scuff

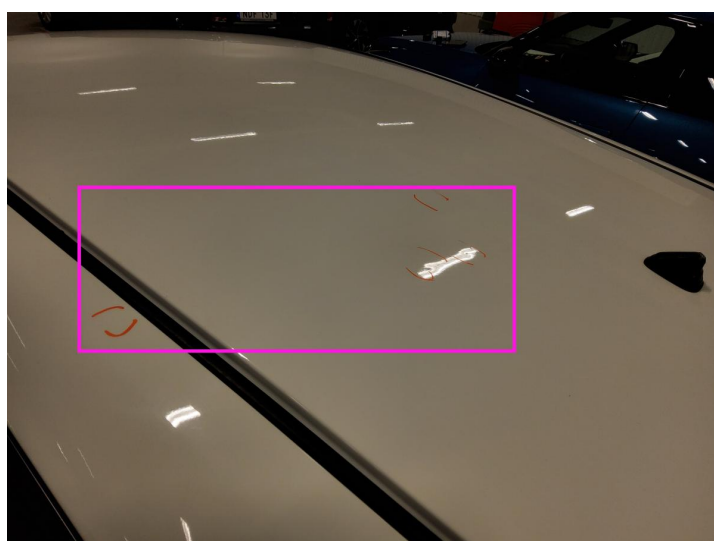
11. Roof

Bodywork / Dent / Hail Area
