## status report

| <b>Report number:</b> | <b>0000000835236-EN968</b> | <b>Off. Mark :</b> | <b>SLS-DC 37</b> |

#### Hyundai Kona (OS)(2017->) Edition 30+ Elektro 2WD

| Vehicle identification number .: | <b>TMAK281HFNJ053258</b> | mileage read: | <b>52967 km</b> |

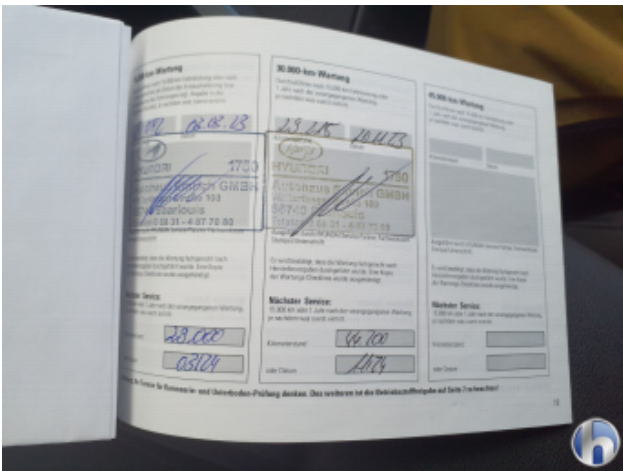
Service book / proof

| Implemented technical examination | |
|---|---|
| <b>reference:</b> | *Serviceintervall nach Herstellervorgaben überzogen (12 Monate / 15.000 km) Service 11/2024 nicht durchgeführt. Wertminderung sowie Verlust der Herstellergarantie und jeglicher Kulanz. |

| 4. | Serviceintervall nicht<br>gepflegt -Wertminderung | Not okay |

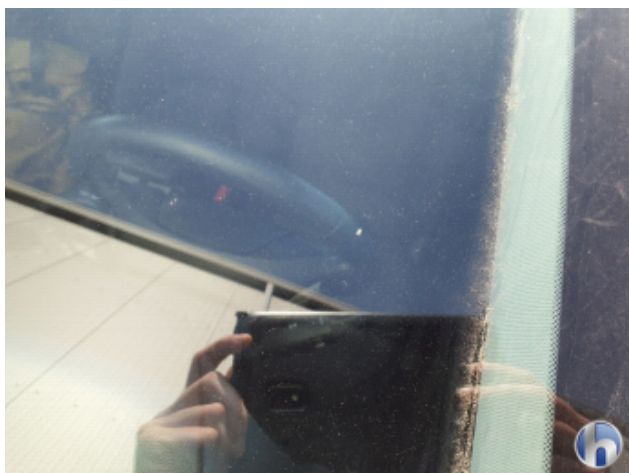
1. Windshield

| Damage | | | |
|---|---|---|---|
| 1. | Windshield | Wear and tear | Without repair |

**Wear and tear - Without repair**
