## status report

Report number: 0000000814525-EN926  
reference number: 30859935

#### Hyundai Kona (OS)(2017->) Trend Elektro 2WD

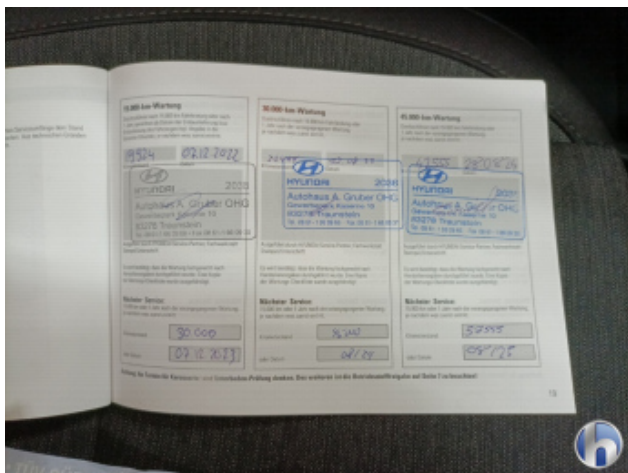
Service book / proof

| <b>reference:</b> | *Serviceintervall nach Herstellervorgaben überzogen (12 Monate / 15.000 km) Verlust der Herstellergarantie und jeglicher Kulanz möglich. |

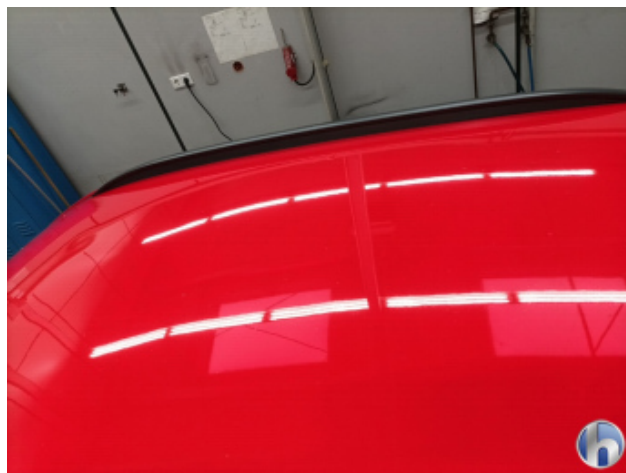
| <b>Layers of paint thickness measurement:</b> | <b>Out of tolerance</b><br>At the vehicle , a resist layer thickness measurement was carried out on the body outer skin.<br>The measured values were outside the tolerances of original finishes . |

| | Component | Damage | Rep kind |
|---|---|---|---|
| 1. | Roof | Subsequently painted | Without repair |

1. Roof  
Subsequently painted - Without repair

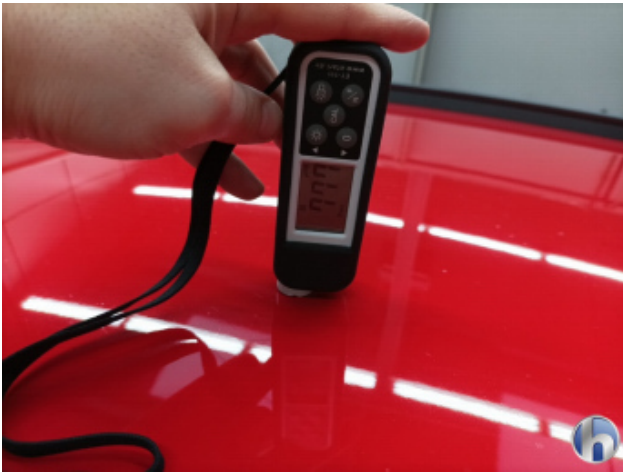
1. Roof  
Subsequently painted - Without repair
