# INSPECTION REPORT

**End of contract**

| License plate | NT8635 |
| Make | Opel Viv.Fg TD 150 3100 L3H1 E |

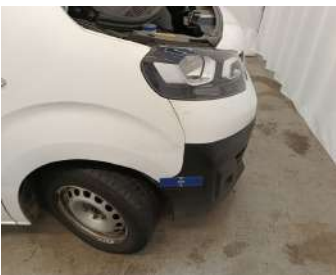
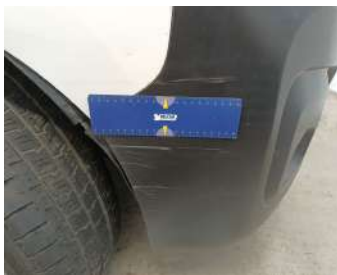
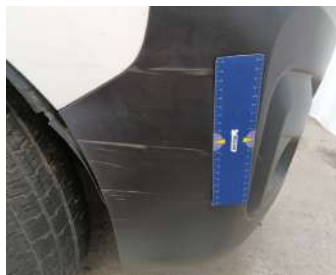
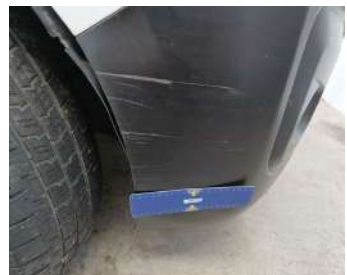
Bumper Front // Replace without painting-scratch

| Damages | Type | Acceptable |
|---|---|---|
| 17 | Bumper Front // Replace without painting | Y |

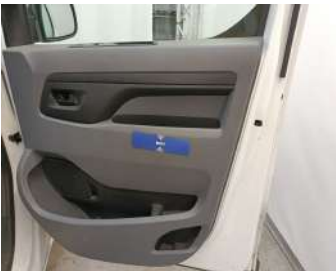
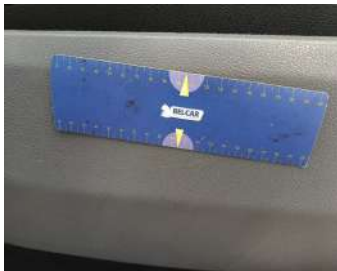
Front Right Door Interior Coating // Replace Completely-scratch

| Damages | Type | Acceptable |
|---|---|---|
| 624 | Front Right Door Interior Coating // Replace Completely | Y |

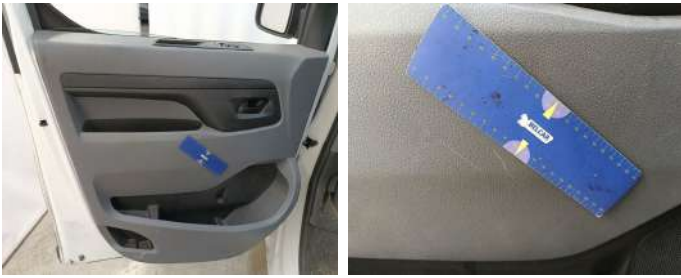
Front Left Door Interior Coating // Replace Completely-scratch

| Damages | Type | Acceptable |
|---|---|---|
| 614 | Front Left Door Interior Coating // Replace Completely | Y |

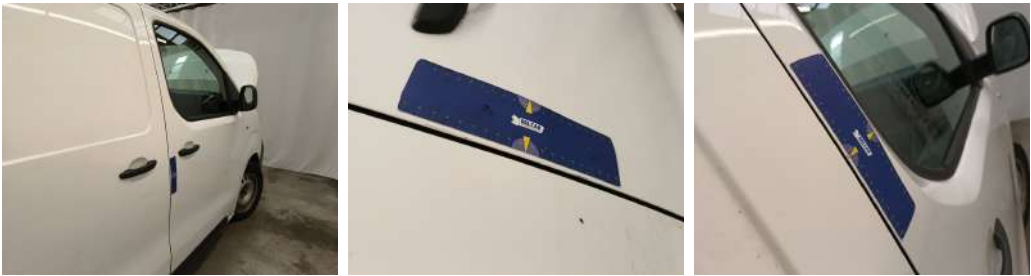
Door Front Right // Smart Repair Small-scratch

| Damages | Type | Acceptable |
|---|---|---|
| 210 | Door Front Right // Smart Repair Small | Y |

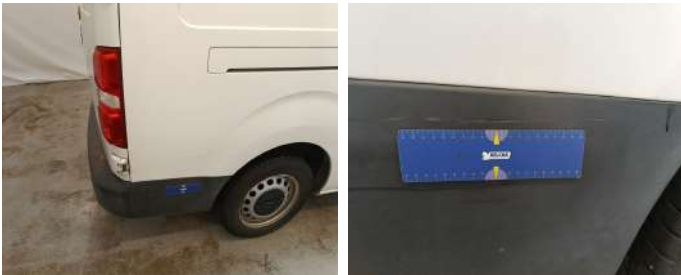
Bumper Rear // Replace without painting-scratch

| Damages | Type | Acceptable |
|---|---|---|
| 137 | Bumper Rear // Replace without painting | Y |

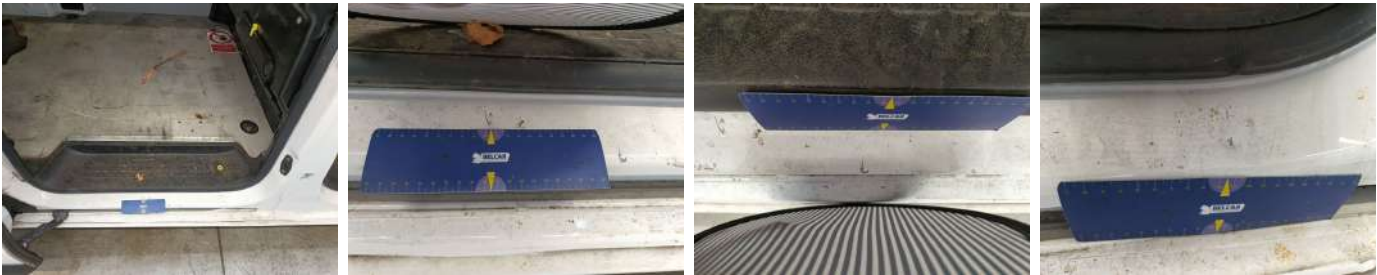
Rocker Panel Right // Smart Repair Medium-scratch + dent

| Damages | Type | Acceptable |
|---|---|---|
| 201 | Rocker Panel Right // Smart Repair Medium | Y |

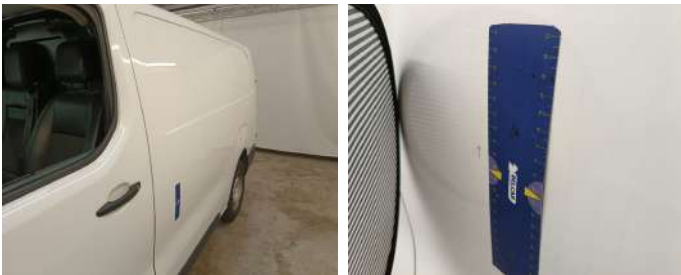
Wing Rear Left // Repair & Painting-scratch + dent

| Damages | Type | Acceptable |
|---|---|---|
| 114 | Wing Rear Left // Repair & Painting | Y |

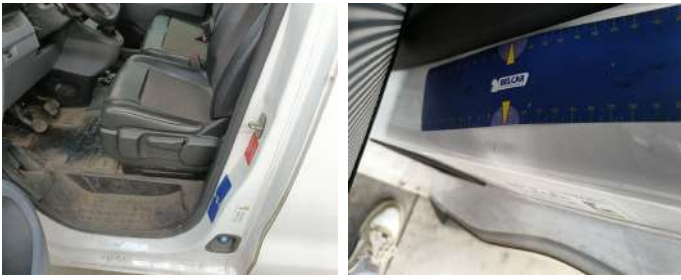
Rocker Panel Left // Smart Repair Medium-scratch + dent

| Damages | Type | Acceptable |
|---|---|---|
| 91 | Rocker Panel Left // Smart Repair Medium | Y |

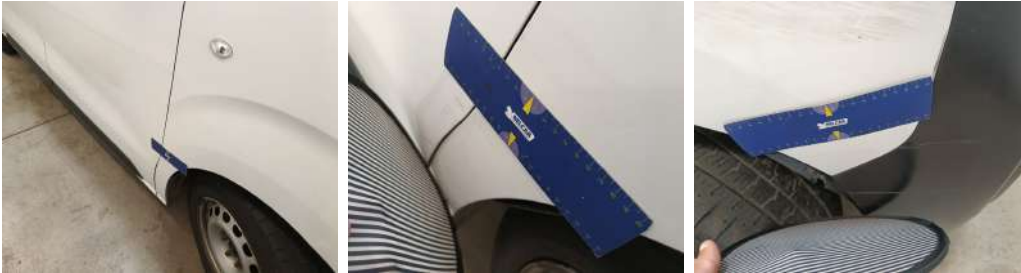
Wing Front right // Repair & Painting-scratch + dent

| Damages | Type | Acceptable |
|---|---|---|
| 234 | Wing Front right // Repair & Painting | Y |

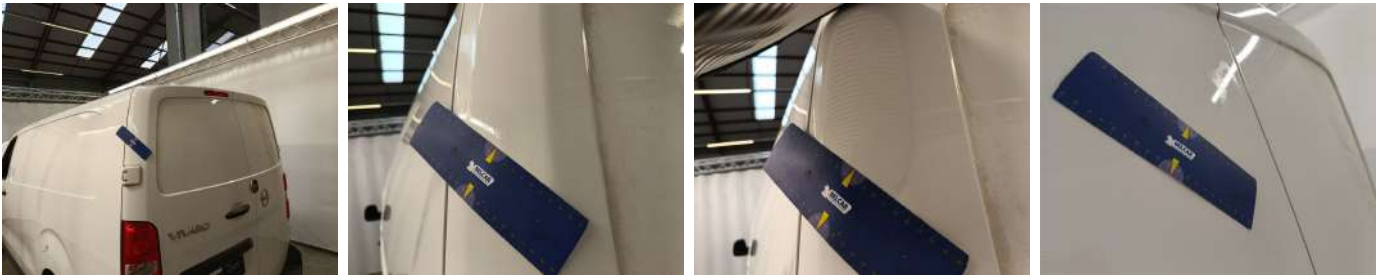
Rear Loading Door Left // Repair & Painting-bad repair

| Damages | Type | Acceptable |
|---|---|---|
| 294 | Rear Loading Door Left // Repair & Painting | N |

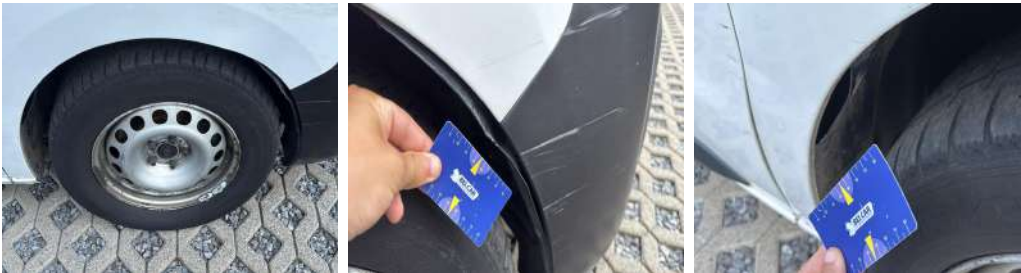
Wing Front right / Inner Fender / Replace-cracked

| Damages | Type | Acceptable |
|---|---|---|
| 239 | Wing Front right / Inner Fender / Replace | N |

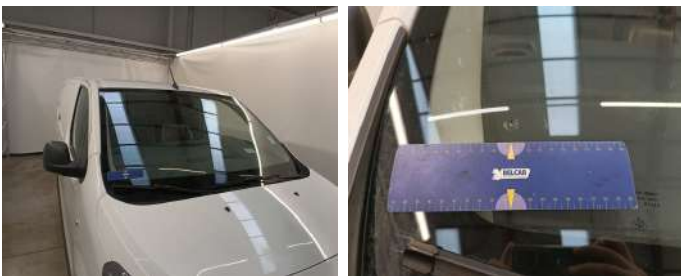
Windshield // Replace-glass damage

| Damages | Type | Acceptable |
|---|---|---|
| 41 | Windshield // Replace | Y |

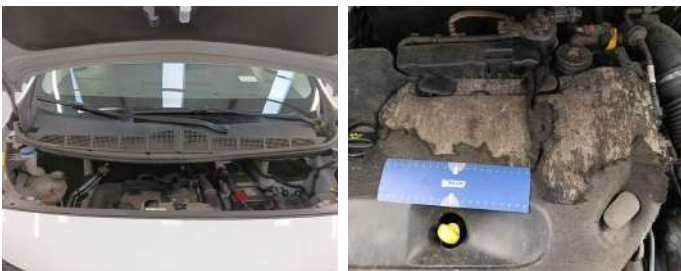
Front Bonnet / Insulation / Replace-tear

| Damages | Type | Acceptable |
|---|---|---|
| 38 | Front Bonnet / Insulation / Replace | N |

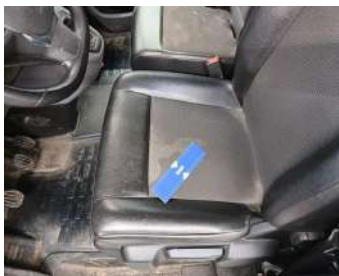
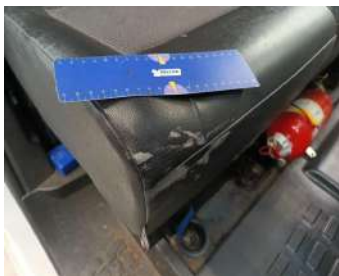
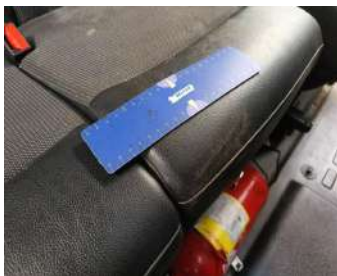
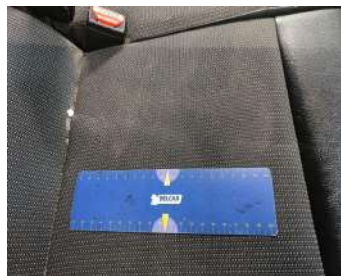
Interior Cleaning // Small-stain

| Damages | Type | Acceptable |
|---|---|---|
| 860 | Interior Cleaning // Small | N |

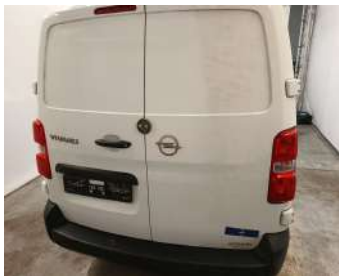
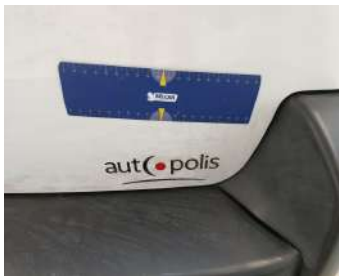
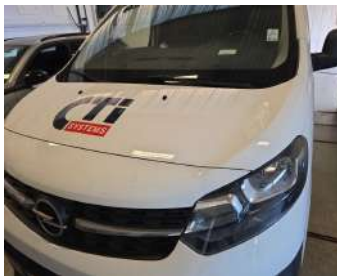
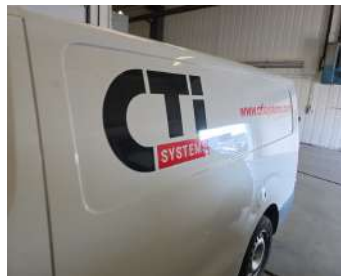
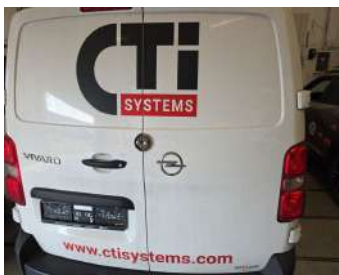
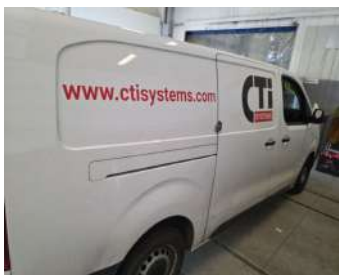
Lettering Removal 15min-Remainder stickers

| Damages | Type | Acceptable |
|---|---|---|
| 654 | Lettering Removal 15min | N |
