## status report

| <b>Report number:</b> | <b>0000000841933-EN968</b> | | |

#### Hyundai Kona (OS)(2017->) Edition 30+ Elektro 2WD

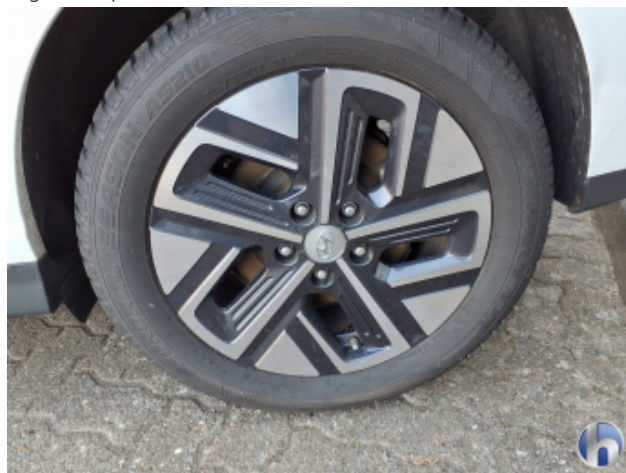
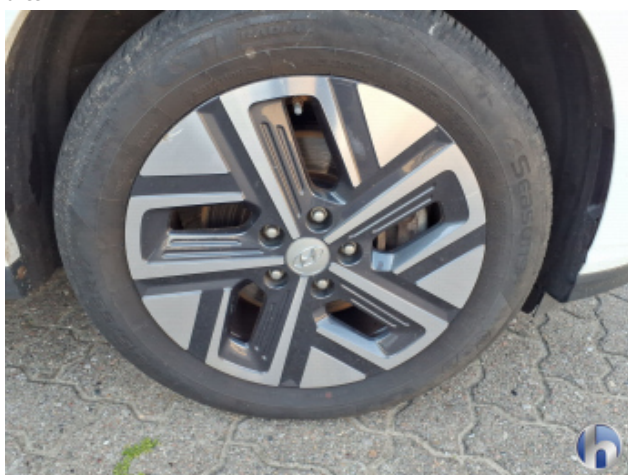
| | All weather tire | Aluminium original |
|---|---|---|
| 1st axis - Left / states . | - | 215/55/R17/-- 3 mm |
| 1st axis - right / states . | - | 215/55/R17/-- 3 mm |
| 2nd axis - Left / states . | - | 215/55/R17/-- 4 mm |
| 2nd axis - right / states . | - | 215/55/R17/-- 4 mm |
| Traffic Safety: | Not roadworthy | |

tires

| 22. | 4 Reifen | Not safe for road traffic | Replace |

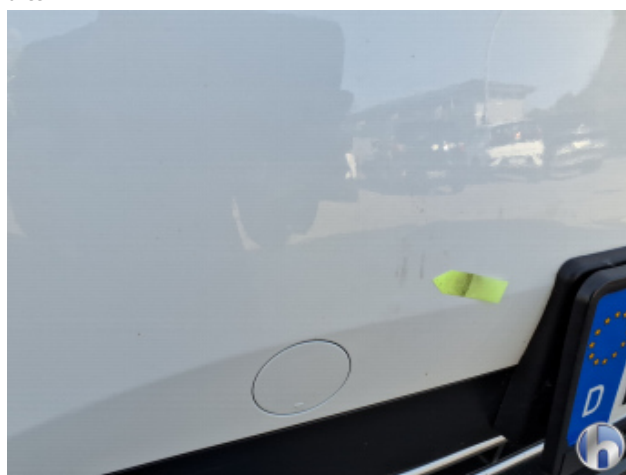
1. Front bumper  
Wear and tear - Without repair

| | Component | Damage | Rep kind |
|---|---|---|---|
| 1. | Front bumper | Wear and tear | Without repair |

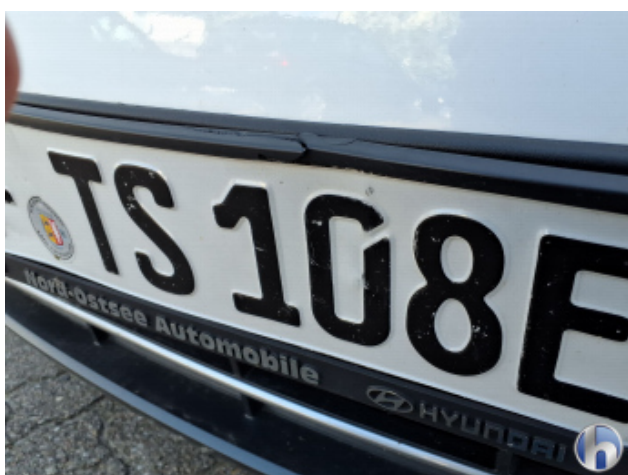
2. Front bumper  
Wear and tear - Without repair

| | Component | Damage | Rep kind |
|---|---|---|---|
| 2. | Front bumper | Wear and tear | Without repair |

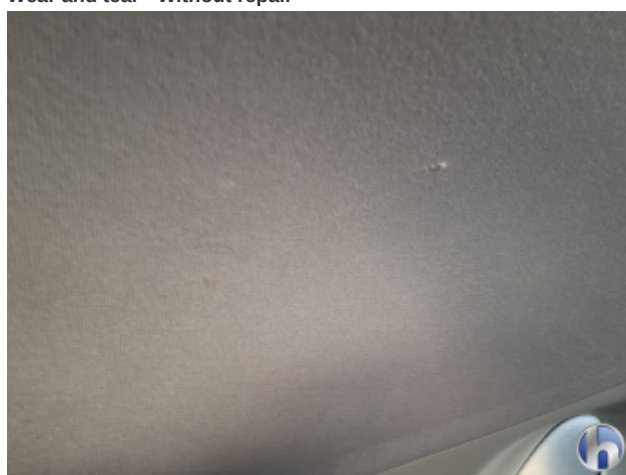
3. Roof  
Deep scratch - Smart repair

| | Component | Damage | Rep kind |
|---|---|---|---|
| 3. | Roof | Deep scratch | Smart repair |

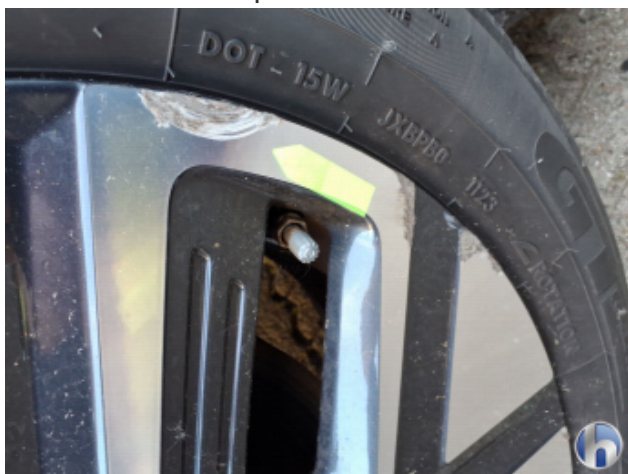
6. Rim front - left  
Damaged - Smart repair

| | Component | Damage | Rep kind |
|---|---|---|---|
| 6. | Rim front - left | Damaged | Smart repair |

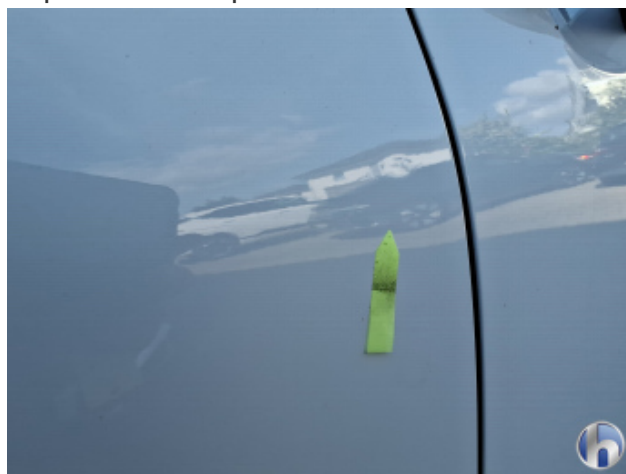
7. Rear Door - Right  
Dented - Gentle refurbishing

| | Component | Damage | Rep kind |
|---|---|---|---|
| 7. | Rear Door - Right | Dented | Gentle refurbishing |

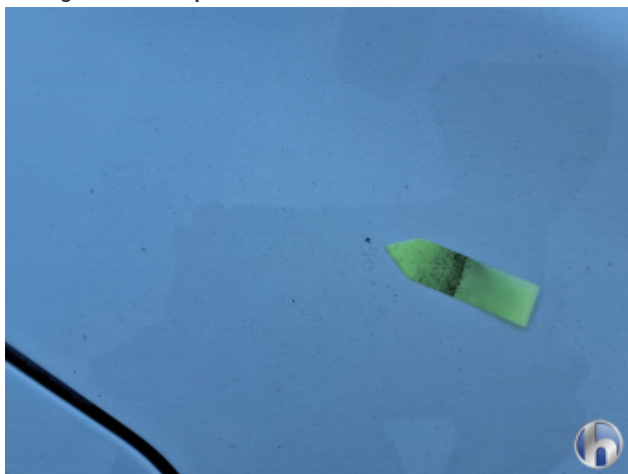
8. Hood  
Wear and tear - Without repair

| | Component | Damage | Rep kind |
|---|---|---|---|
| 8. | Hood | Wear and tear | Without repair |

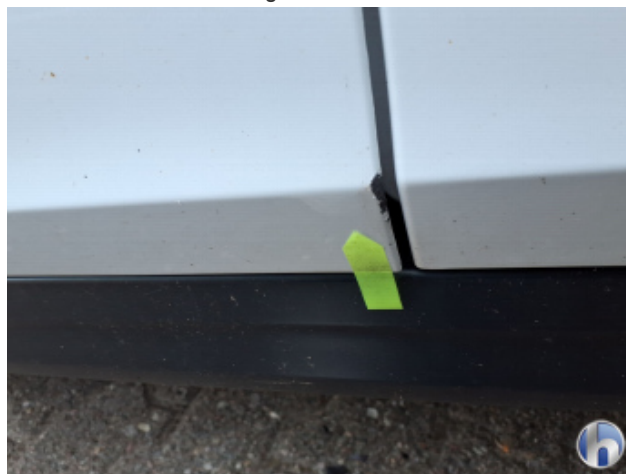
9. Front door - left  
Deep scratch - Smart repair

| | Component | Damage | Rep kind |
|---|---|---|---|
| 9. | Front door - left | Deep scratch | Smart repair |

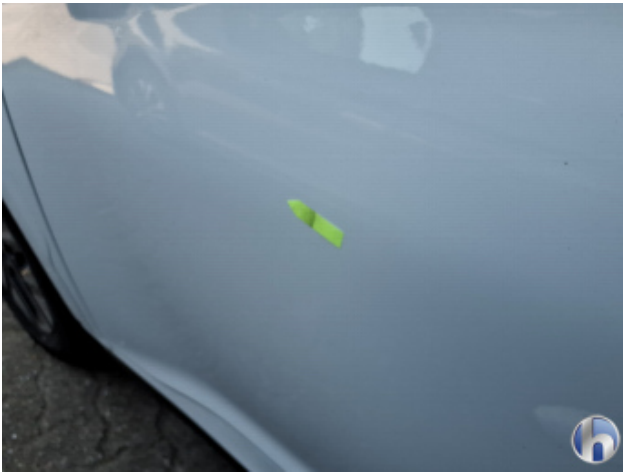
10. Front door - left  
Wear and tear - Without repair

| | Component | Damage | Rep kind |
|---|---|---|---|
| 10. | Front door - left | Wear and tear | Without repair |

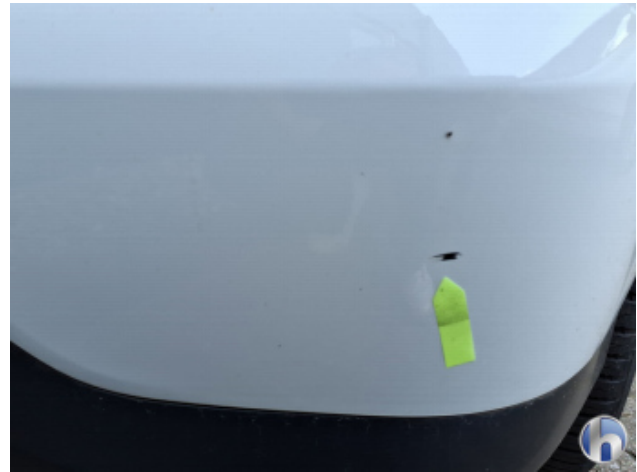
11. Rear Bumper  
Deep scratch - Smart repair

| | Component | Damage | Rep kind |
|---|---|---|---|
| 11. | Rear Bumper | Deep scratch | Smart repair |

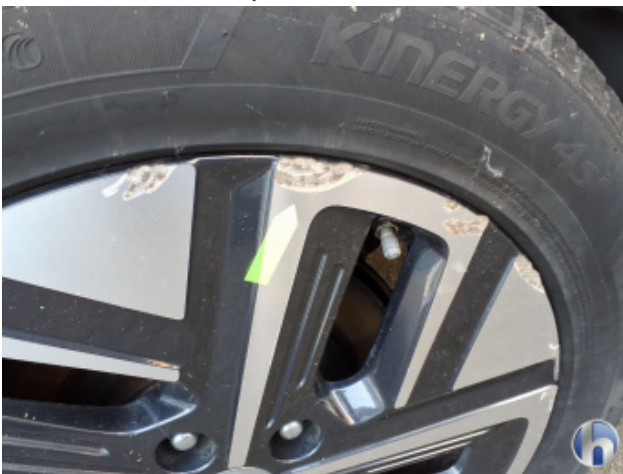
12. Rim rear - right  
Damaged - Smart repair

| | Component | Damage | Rep kind |
|---|---|---|---|
| 12. | Rim rear - right | Damaged | Smart repair |

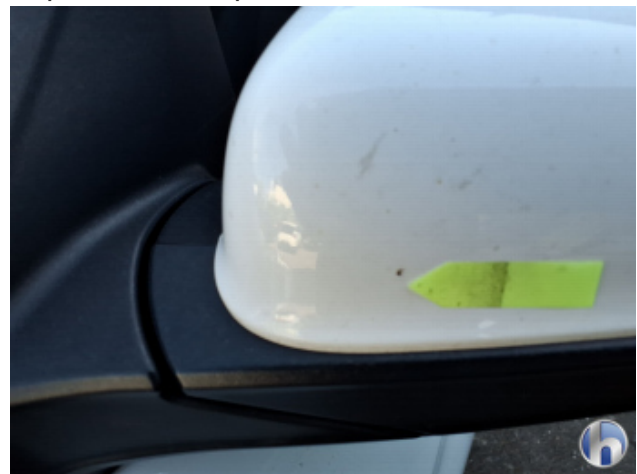
13. Outside mirror - left  
Chipping from stones - Smart repair

| | Component | Damage | Rep kind |
|---|---|---|---|
| 13. | Outside mirror - left | Chipping from stones | Smart repair |

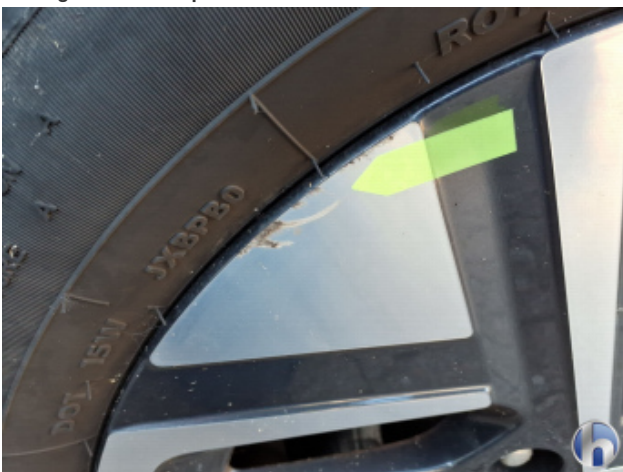
14. Rim front - right  
Damaged - Smart repair

| | Component | Damage | Rep kind |
|---|---|---|---|
| 14. | Rim front - right | Damaged | Smart repair |

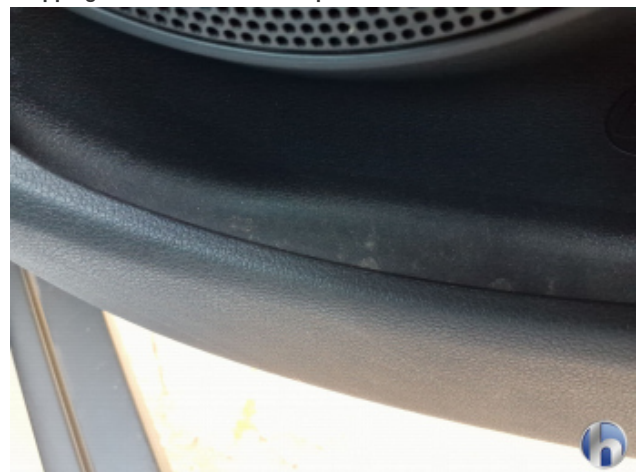
15. covering  
Wear and tear - Without repair

| | Component | Damage | Rep kind |
|---|---|---|---|
| 15. | covering | Wear and tear | Without repair |

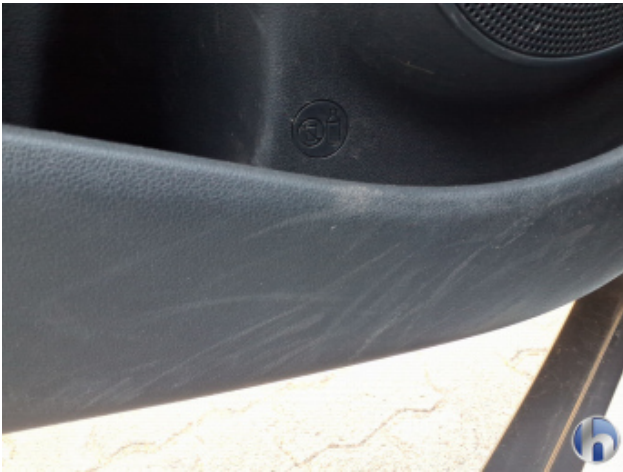
16. covering  
Wear and tear - Without repair

| | Component | Damage | Rep kind |
|---|---|---|---|
| 16. | covering | Wear and tear | Without repair |

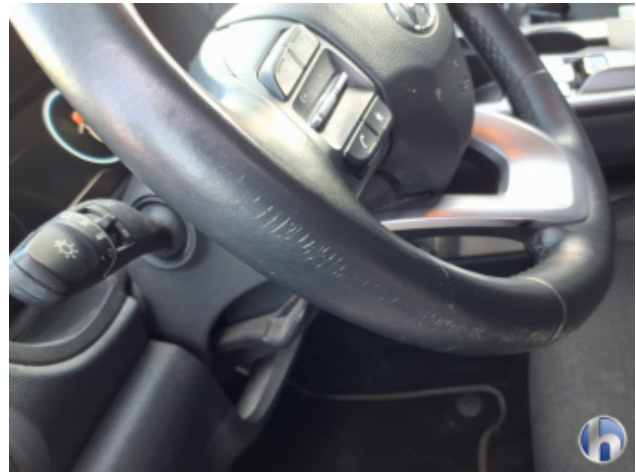
17. Steering wheel (leather)  
Deep scratch - Replace

| | Component | Damage | Rep kind |
|---|---|---|---|
| 17. | Steering wheel (leather) | Deep scratch | Replace |

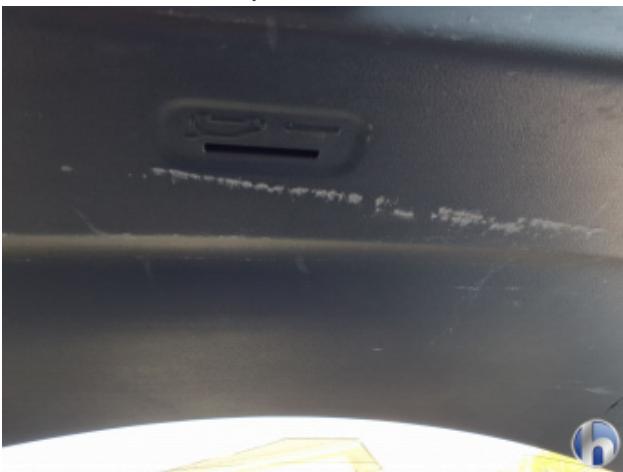
18. tailgate trim  
Damaged - Replace

| | Component | Damage | Rep kind |
|---|---|---|---|
| 18. | tailgate trim | Damaged | Replace |

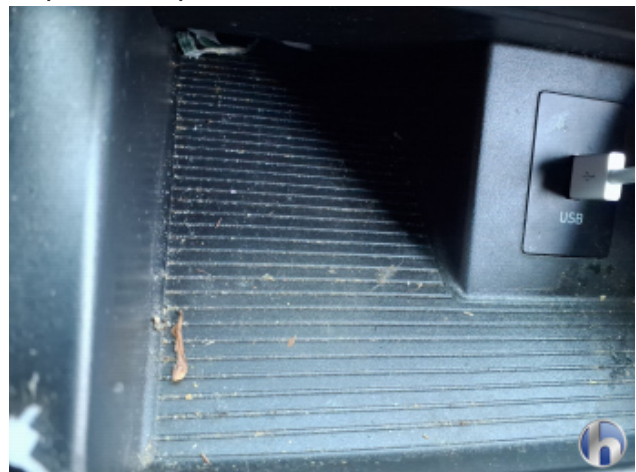
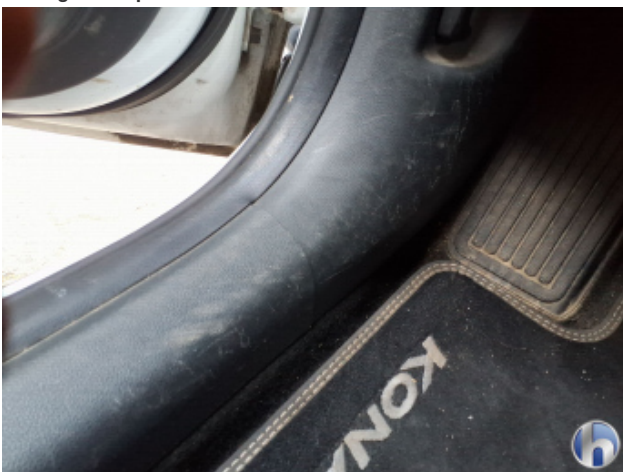
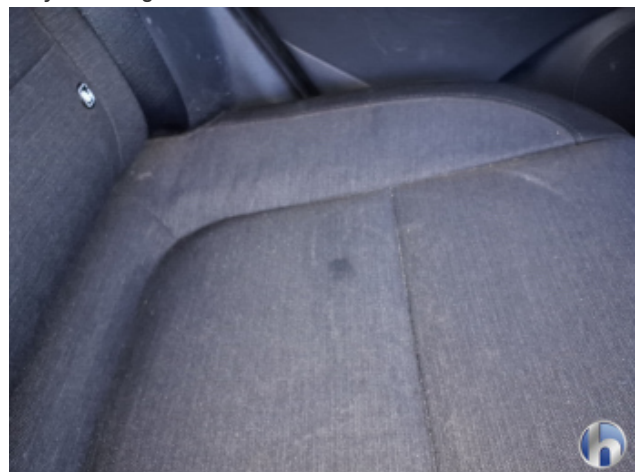
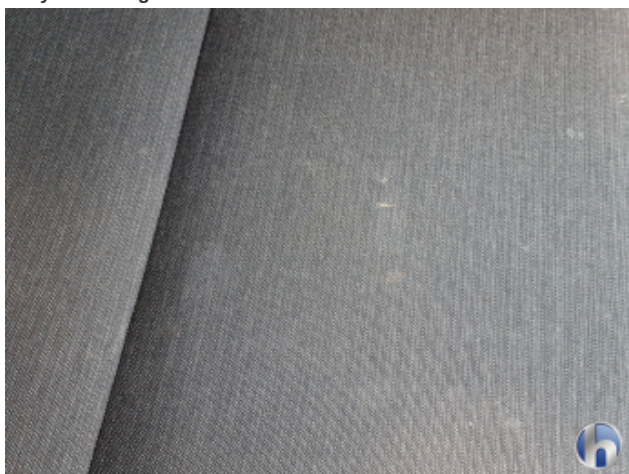
19. Sitz Innenraum rechts vorne  
Dirty - cleaning

19. Sitz Innenraum rechts vorne  
**Dirty - cleaning**

| 19. | Sitz Innenraum rechts vorne | Dirty | cleaning |
