## RENAULT Master

### 2.3 DCI 135 PACK COMFORT L3H2

## INSPECTION DETAILS

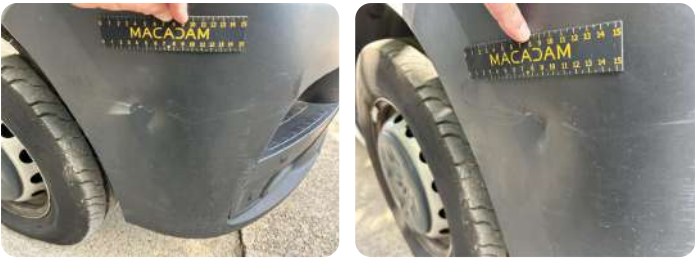
3 | Bumper F

| Damage type | Dent(s) |
| Severity | Unknown |
| Cause | Use/wear |

| Repair mode | Smart repair |

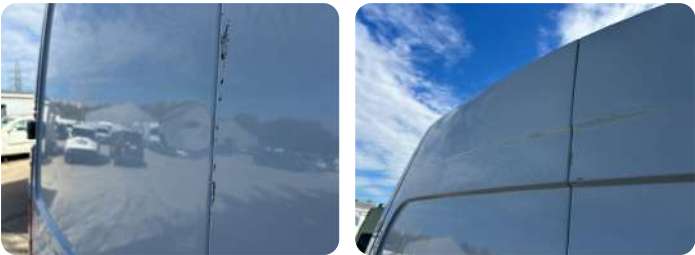
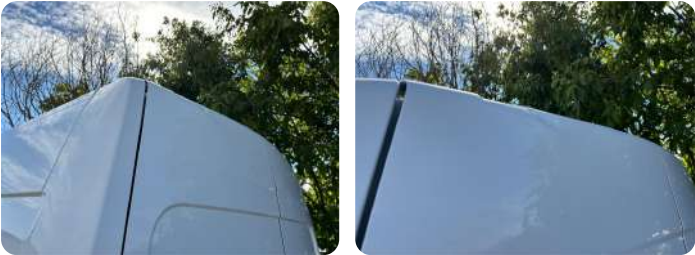
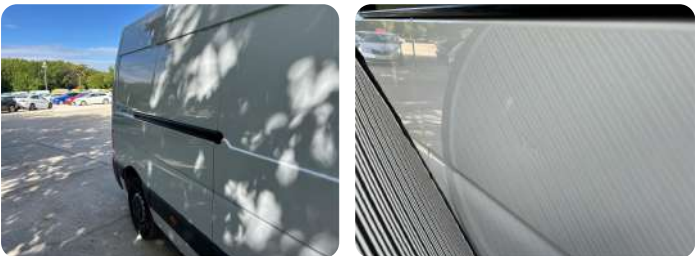
5 | Tailgate / Boot

| Damage type | Dent(s) and scratch(es) |
| Severity | >50%, medium |
| Cause | Use/wear |

| Repair mode | Repair and paint (complete) |

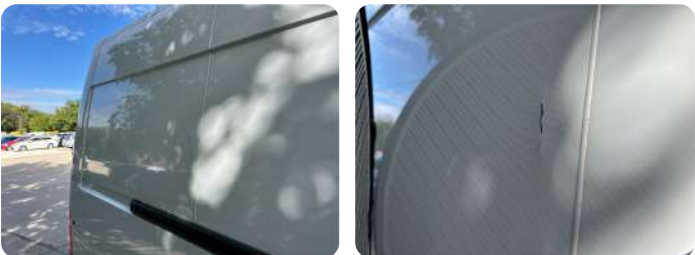
6 | Bodywork

| Damage type | Dent(s) |
| Severity | Unknown |
| Cause | Use/wear |

Körben apró horpadások, karcok. Raktér részen kinyomódások.

| Repair mode | No repair |
