# RENAULT ESPACE

## Espace dCi 160 Energy Twin Turbo Intens EDC

VIN NO VF1RFC00455383361  
Registration Number EC735LJ

### Inspection Report Summary

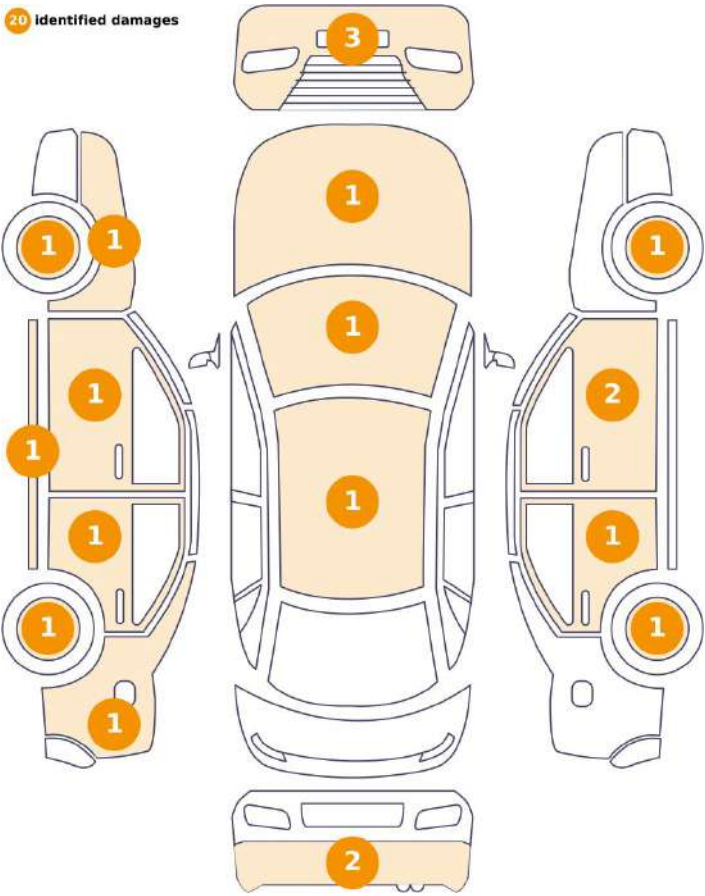
20 Identified damages

Component	Damage	Comments
1 Door / Front Right	Paint / Stone Chip	
2 Rim / Front Left	Out of Bodywork / Scratch	
3 Panel Filling / Front Right	Interior / Worn - out	
4 Hood	Paint / Scratch / Line	
5 Corner Bumper / Front Left	Paint / Scratch / Line	
6 Roof	Paint / Scratch / Line	
7 Tailgate Upholstery / Back	Interior / Worn - out	
8 Bumper / Front	Paint / Stone Chip	
9 Fender / Back Left	Paint / Scratch / Line	
10 Fender / Front Left	Paint / Scratch / Line	
11 Panel Filling / Front Left	Interior / Worn - out

12	Door / Back Right	Bodywork / Dent / Dent	Plus éclats zone gravillonnées sur l'ensemble du bas de la porte.
13	Panel Filling / Back Right	Interior / Worn - out	
14	Panel Filling / Back Left	Interior / Worn - out	
15	Seat Cushion / Front Left	Interior / Worn - out	
16	Trunk Upholstery / Back	Interior / Worn - out	
17	Rocker Panel / Center Left	Paint / Stone Chip	
18	Rim / Back Left	Out of Bodywork / Scratch	
19	Rim / Front Right	Out of Bodywork / Scratch	
20	Seat Cushion / Front Right	Interior / Worn - out	
21	Door / Front Left	Paint / Scratch / Line	
22	Rim / Back Right	Out of Bodywork / Scratch	
23	Glovebox	Interior / Worn - out	
24	Bumper / Back	Paint / Scratch / Line	
25	Mirror Shell / Front Right	Paint / Scratch / Line	
26	Corner Bumper / Back Left	Paint / Scratch / Line	
27	Steering Wheel / Front	Interior / Worn - out	
28	Corner Bumper / Front Right	Paint / Scratch / Line	
29	Door / Back Left	Paint / Scratch / Line

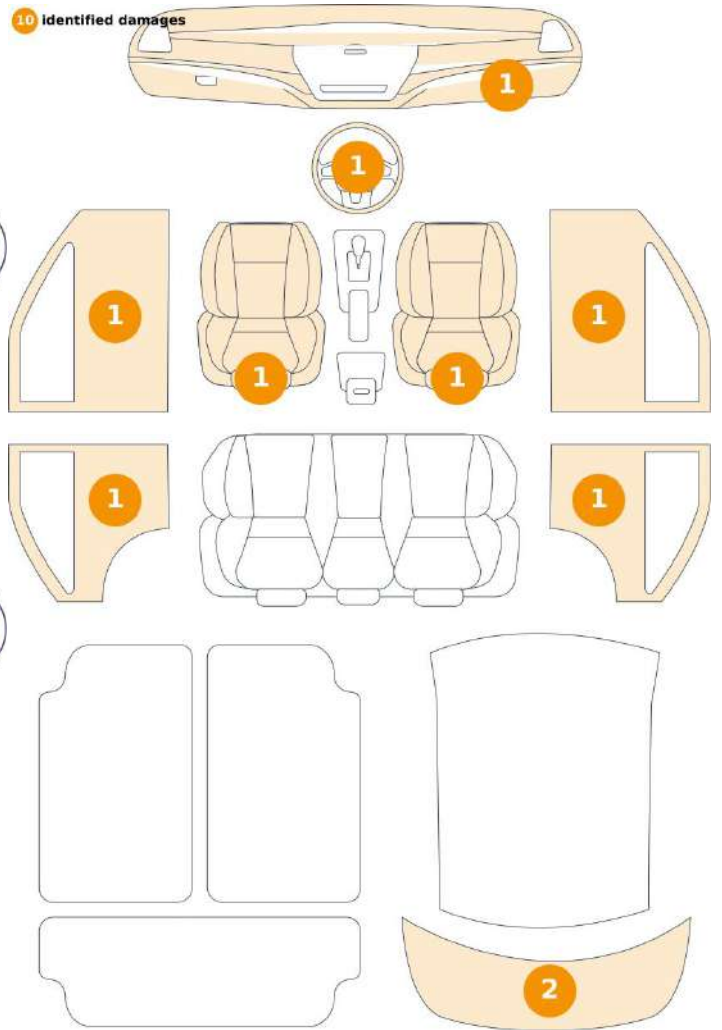
10 Identified damages
