# HYUNDAI KONA Kona Electrique 64 kWh - 204 ch Creative

VIN NO TMAK381GFNJ056394 Registration Number GF425TS

Customer	BCAuto Encheres	Report Number	P20250919104319
Inspection Date / Place	2025-09-19 / BCA AUNAY	Cosmetic Grade	3

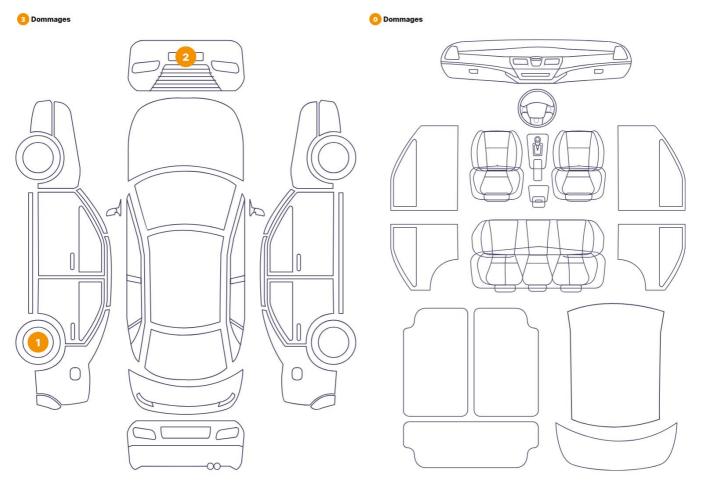
## Cosmetic Damage

Component	Damage	Comments
1 Mud Flap / Back Left	Paint / Chipping	
2 Corner Bumper / Front Right	Bodywork / Breakage	
3 Bumper / Front	Paint / Chipping
