HYUNDAI KONA Kona Electrique 39 kWh - 136 ch Intuitive

VIN NO TMAK281HFNJ054814 Registration Number GF836QB

Inspection Report Summary

Customer	BCAuto Encheres	Report Number	P20250725071950
Inspection Date / Place	2025-07-28 / BCA	Cosmetic Grade	1

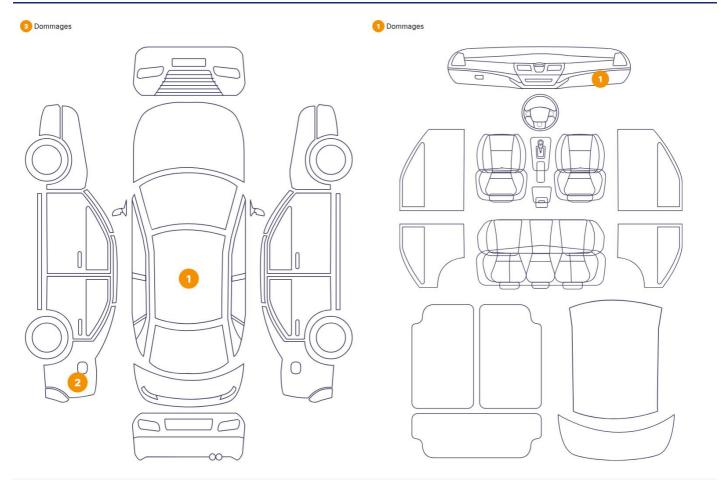
Cosmetic Damage

Component	Damage	Comments
1	Steering Wheel / Front	Interior / Scratched	
2	Fender / Back Left	Paint / Chipping	
3	Fender / Back Left	Paint / Chipping	
4	Roof Molding / Left	Paint / Poor Previous Repair
