NISSAN LEAF Leaf Electrique 40kWh N-Connecta

VIN NO SJNFAAZE1U0044479 Registration Number FD213CC

Inspection Report Summary

| Customer | BCAuto Encheres | Report Number | P20250703114740 |

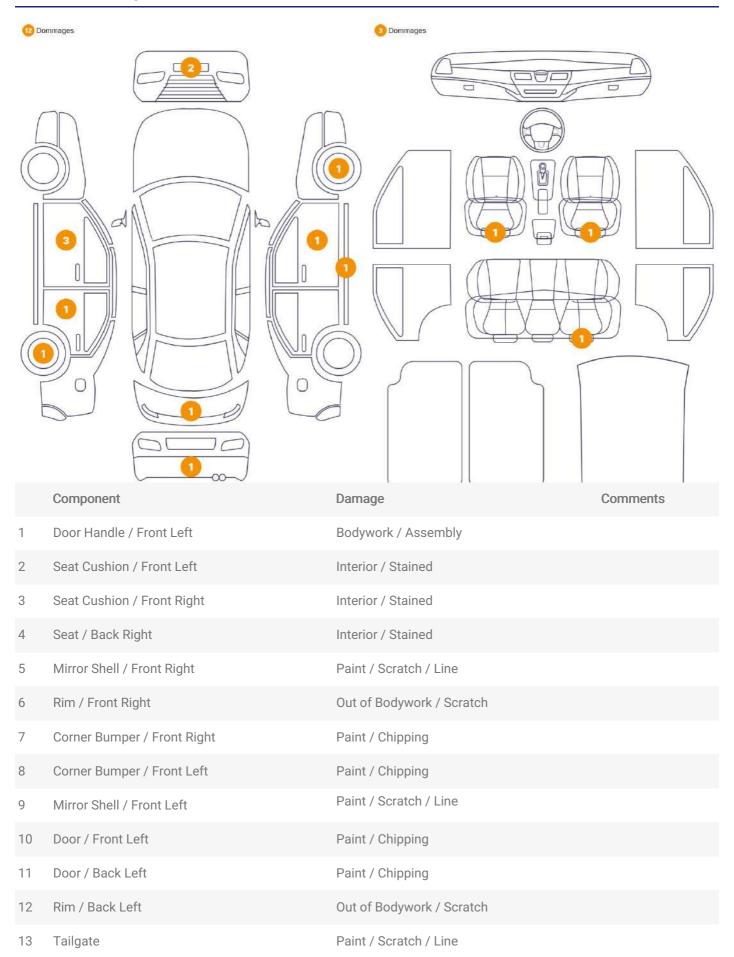
| 14 | Corner Bumper / Back Right | Paint / Scratch / Line |
| 15 | Rocker Panel / Center Right | Paint / Scratch / Line |
