RENAULT GRAND SCENIC  
Grand Scénic dCi 110 Energy FAP eco2  
Bose Edition 7 pl

VIN NO VF1JZ89BH54546492  
Registration Number EA861YV

Inspection Report Summary

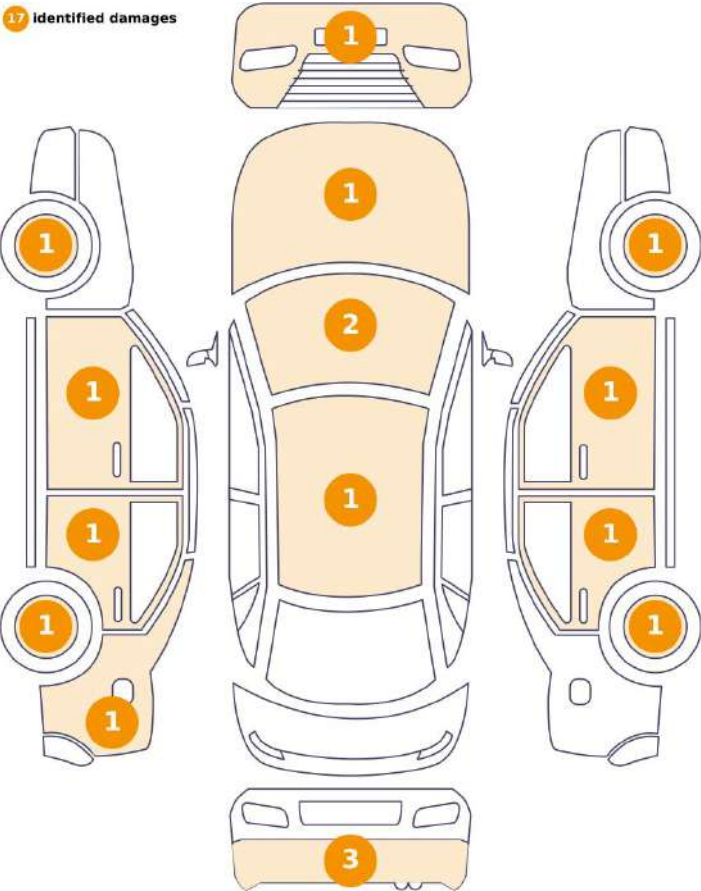
17 Identified damages

| Component | | Damage | Comments |
|---|---|---|---|
| 1 | Hood | Bodywork / Dent / Hail Area | |
